C I T Y O F
RENO
Memorandum

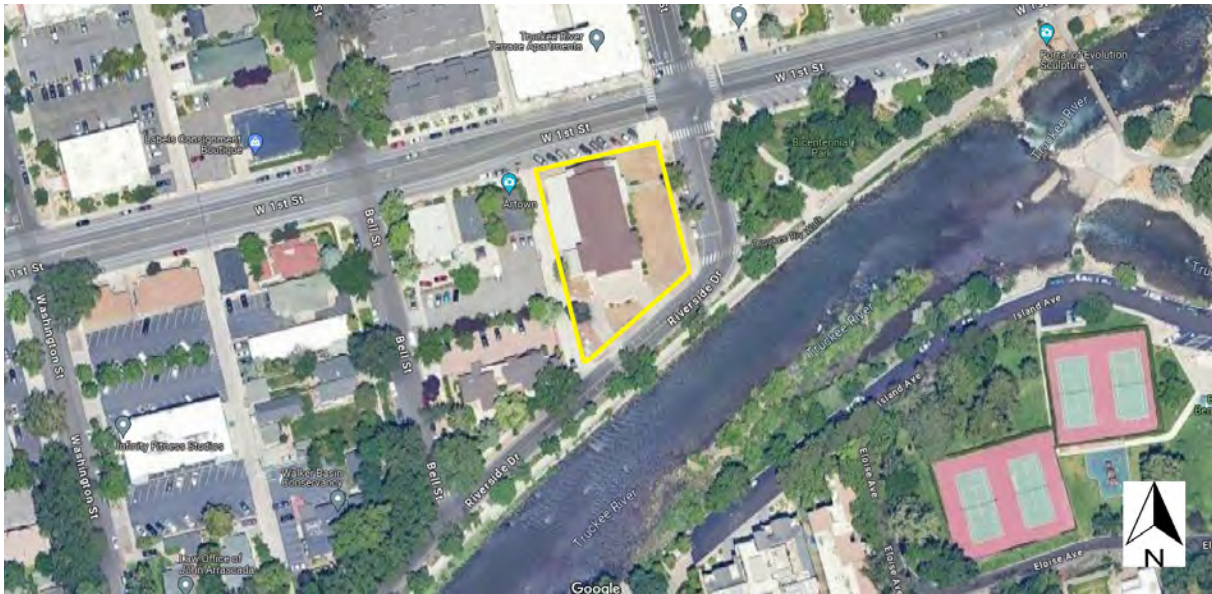
Aerial imagery of the First Church of Christ, Scientist. Subject property outlined in yellow. (Google Maps aerial, 2024; amended by ARG)

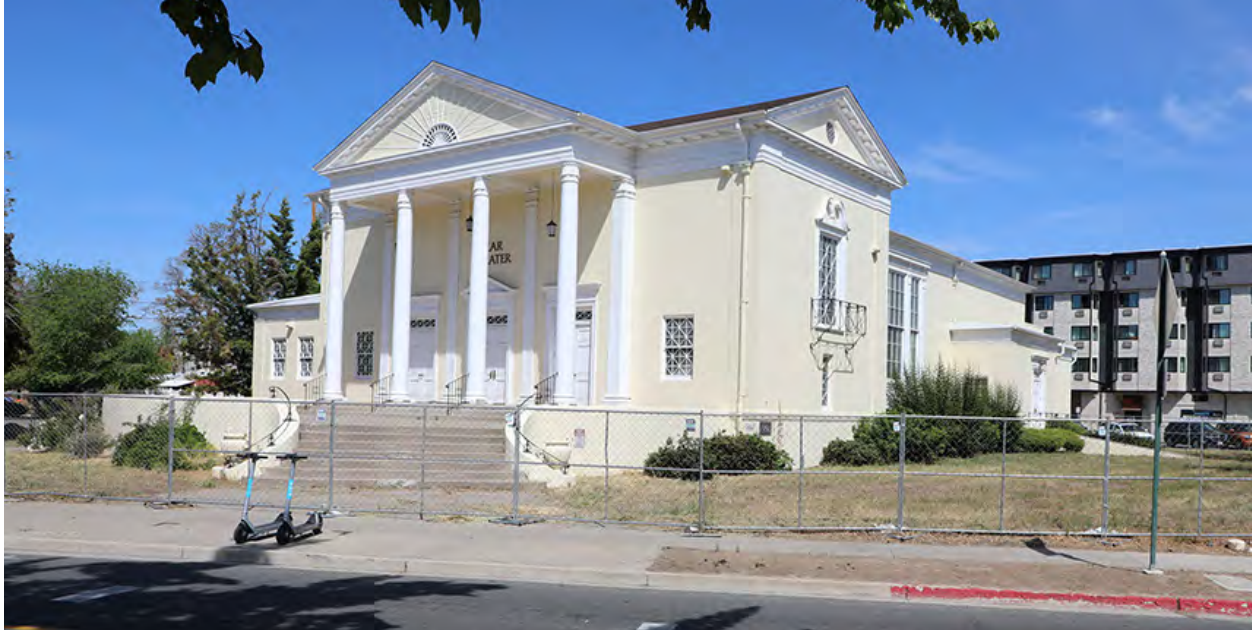
Lear Theater, primary (south) and east façades, view northwest (ARG 2024)

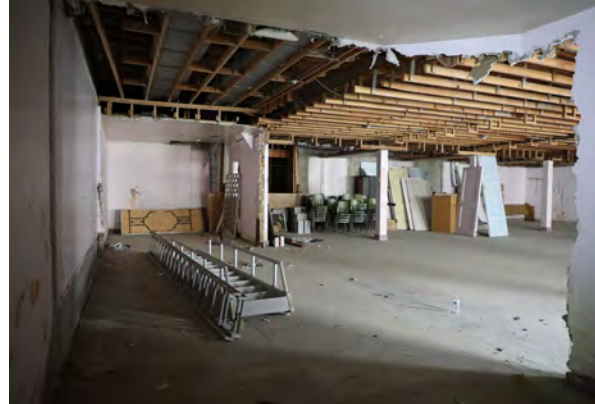
Lear Theater, basement, view northwest (ARG 2024)

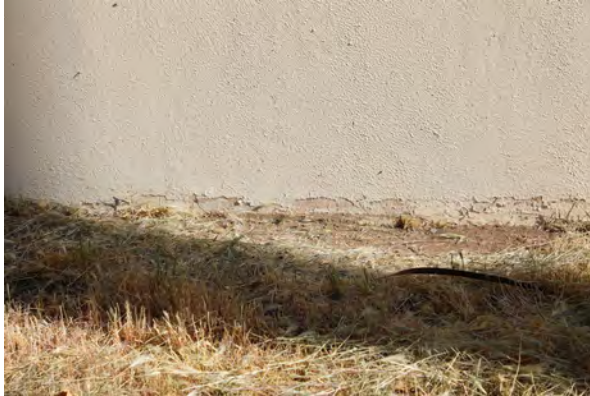
Figure 01: Deteriorated paint at the base of the exterior stucco walls along the south elevation

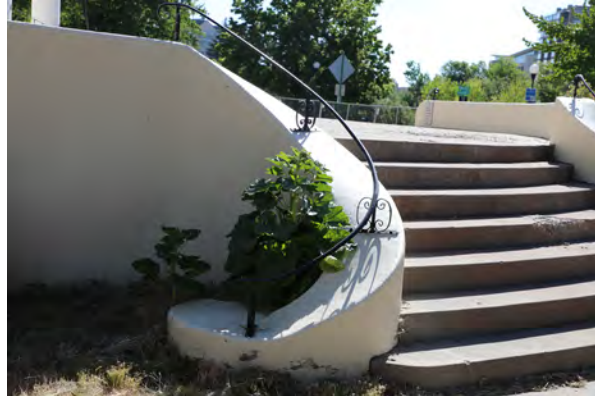
Figure 02: Non-compliant handrails at the southwest stair

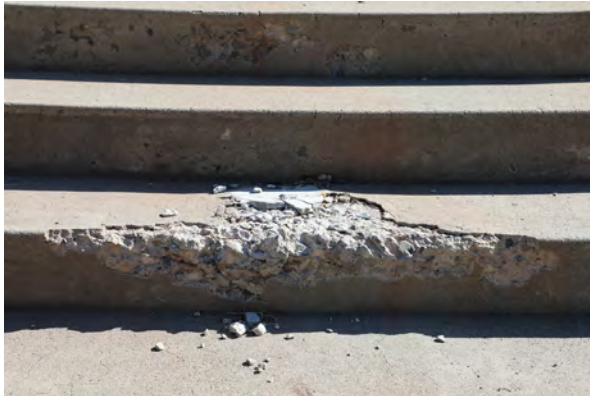
Figure 03: Significant deterioration of the concrete steps at the southwest stair

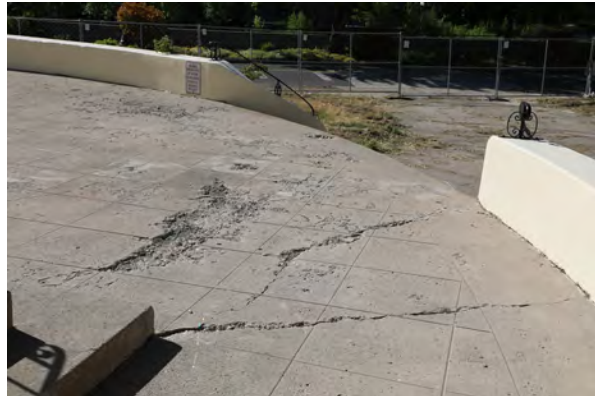
Figure 04: Significant spalling of the concrete of the south entrance Terrace

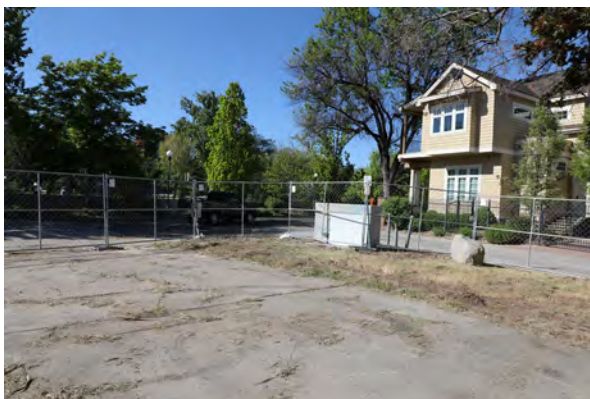
Figure 05: Extensive plant growth and spalling of the walk path at the south entry

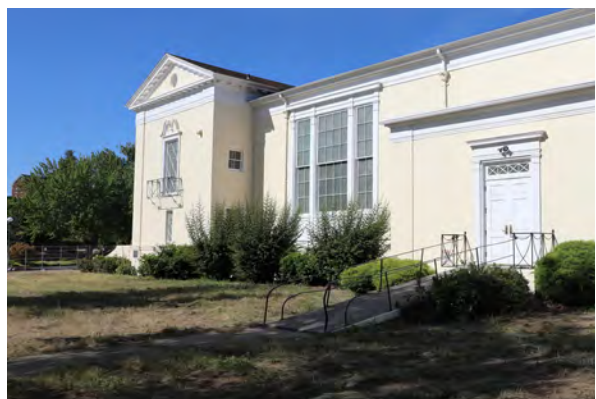
Figure 06: Non-compliant ramp and sidewalk overgrown with vegetation at the east entry

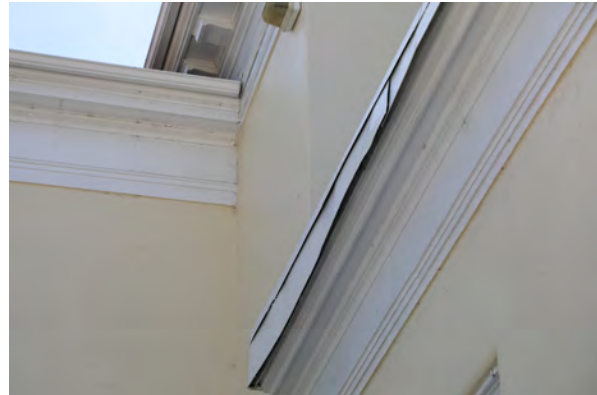
Figure 07: Unsecured sheet metal flashing at north wall of the west wing

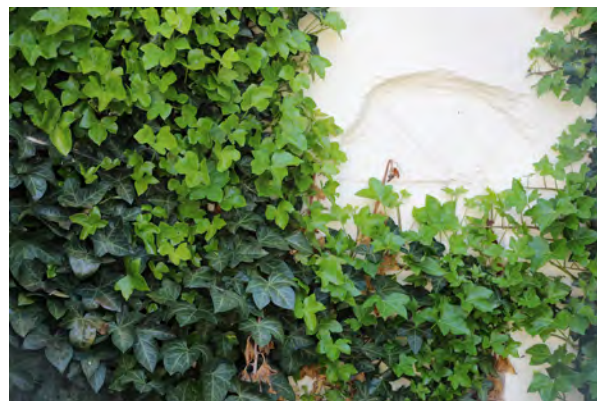
Figure 09: Extensive ivy growth at the west wall of the west wing

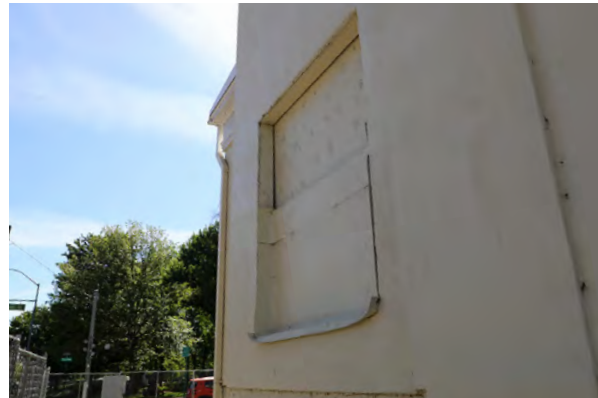
Figure 10: Boarded opening at the east end of the north façade

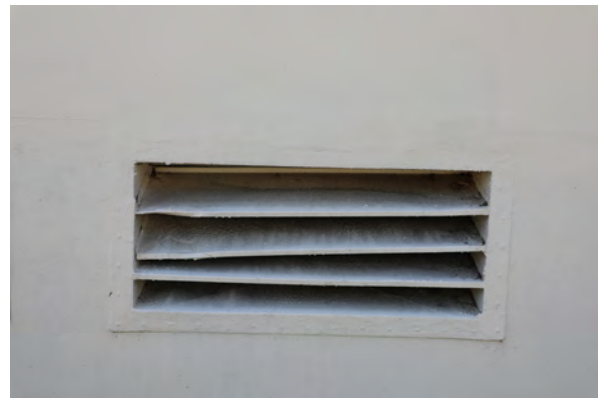
Figure 11: Damaged fins of the louver at the north elevation

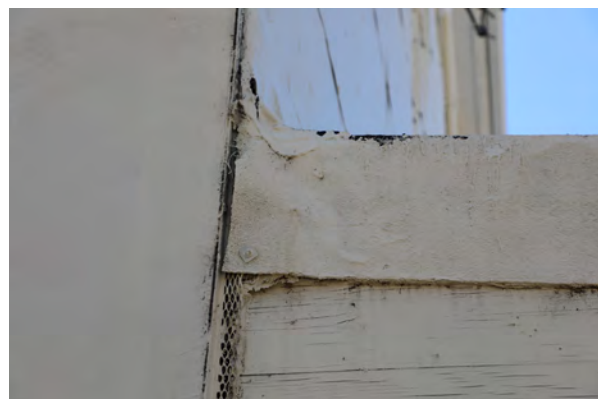
Figure 12: Exposed stucco lath between northwest addition and the temporary wall and roof of the unfinished west addition

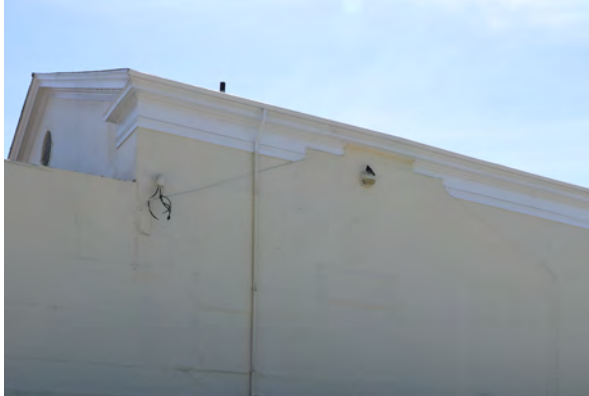
Figure 13: Temporary membrane at the west elevation

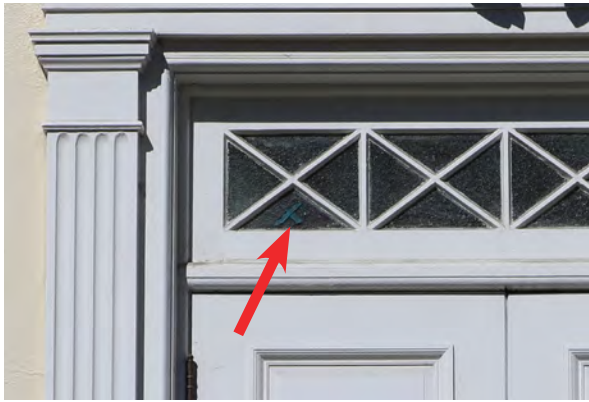
Figure 14: Cracked glazing at east entry transom

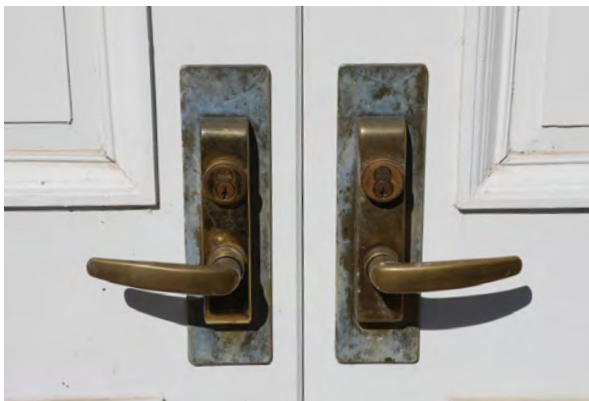
Figure 15: Tarnished hardware at east entry (Door 1-04)

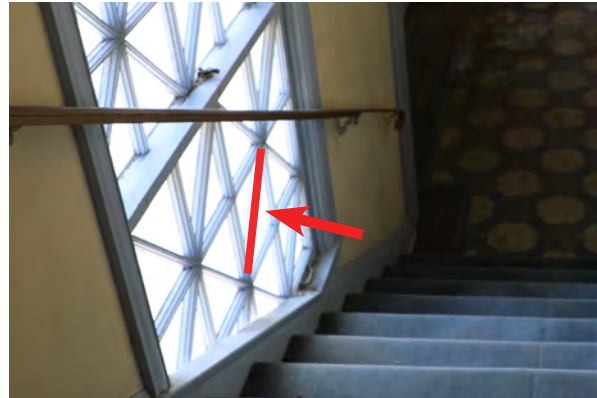
Figure 16: Missing interior muntin at Window 1-12

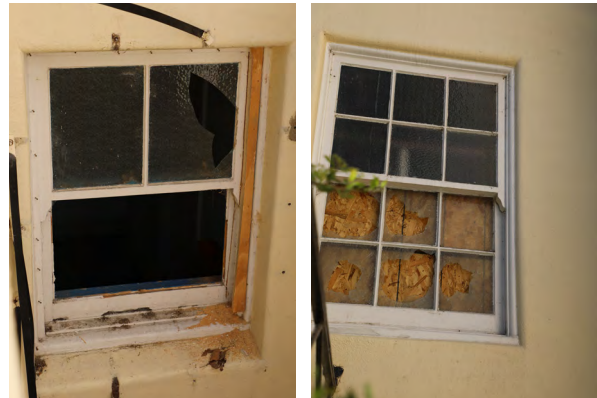
Figure 17: Damaged sash and broken or missing glazing at Windows 0-10 (left) and 1-10 (right)

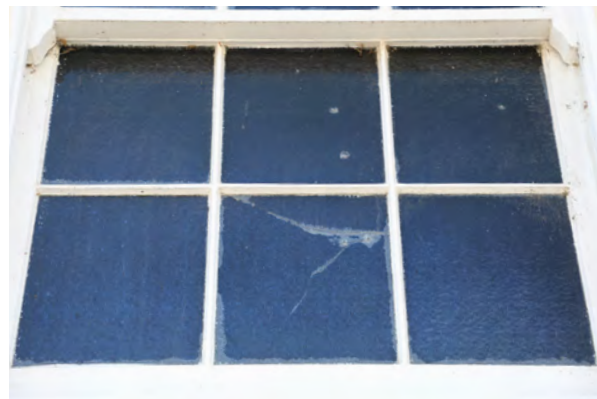
Figure 18: Damaged glazing at Window 1-01 on the north wall

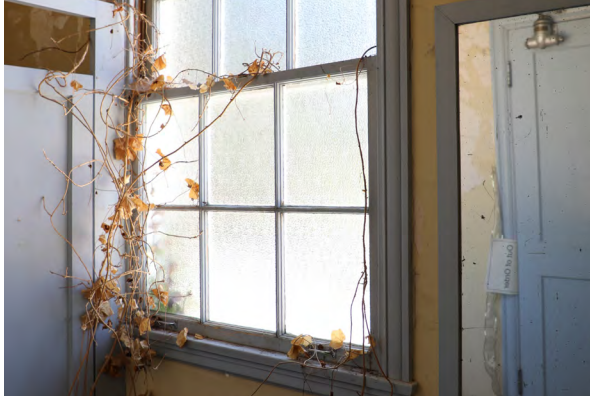
Figure 19: Ivy growth at window 1-20 in the Women's Restroom (Room 112)

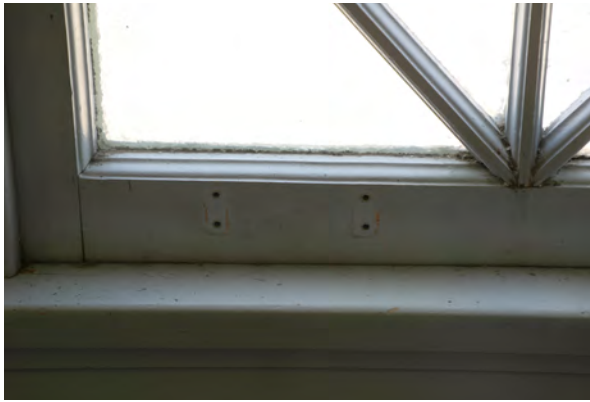
Figure 20: Missing hardware at bottom sash of Window 1-16 in the West Lobby (Room 115)

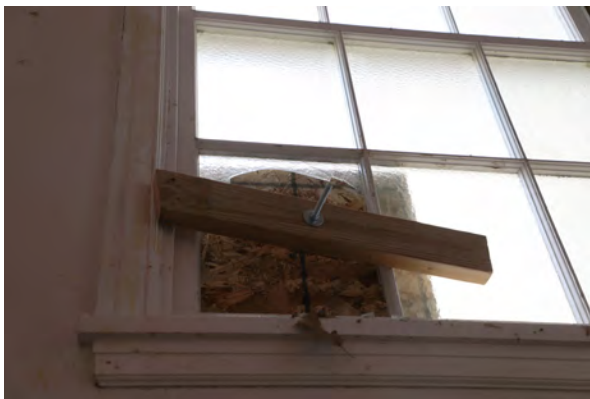
Figure 21: Broken glazing in bottom sash of Window 1-05 at the northern stairs (Room 008)

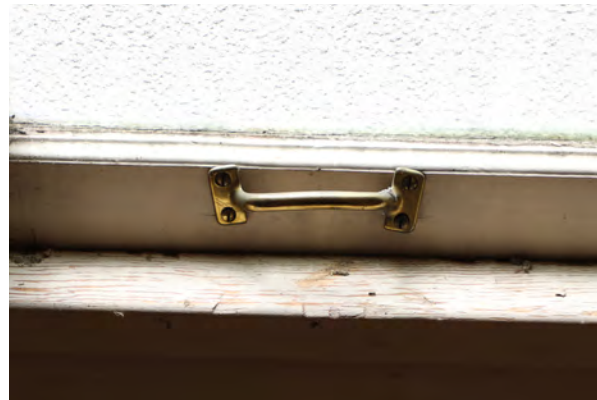
Figure 22: Damaged (bent) hardware at Window 2-04 in the Committee Room (Room 204)

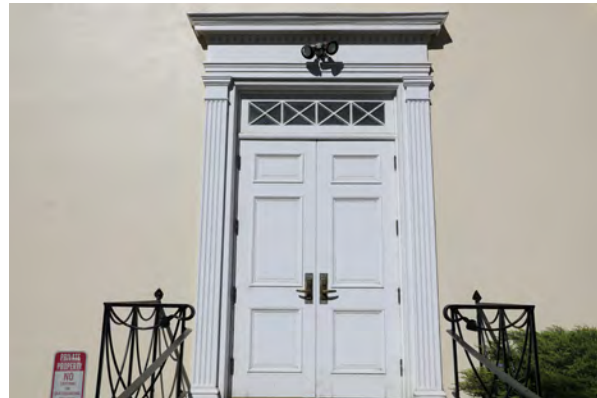
Figure 23: Exterior flood light at the East Entry

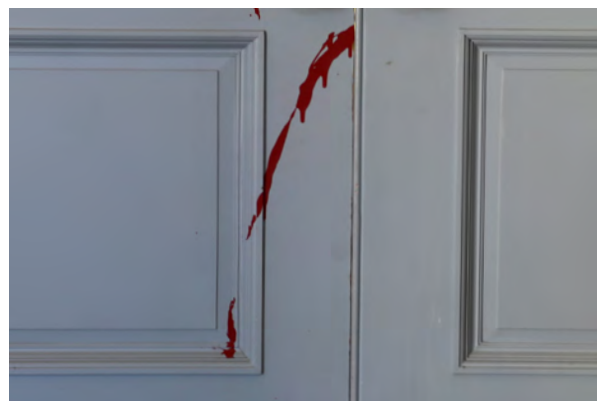
Figure 24: Red paint on Door 1-08 in the Foyer, Room 101

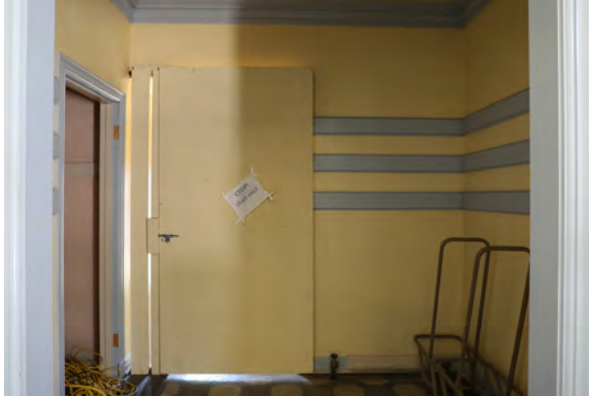
Figure 25: Makeshift plywood door in Lobby (Room 103) and missing door to Closet at the left

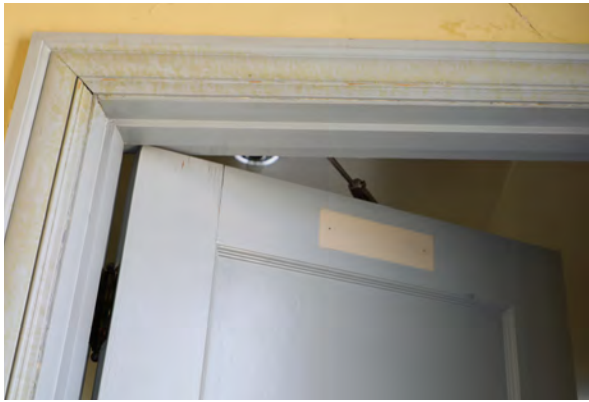
Figure 26: Missing paint at the top rail of the Men's Restroom (Room 105) door and yellow residue visible at the trim

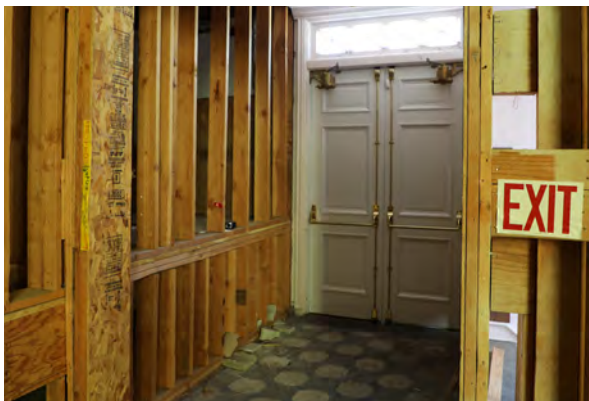
Figure 27: Unfinished construction at the East Entry (Room 109) showing rough opening and wall framing

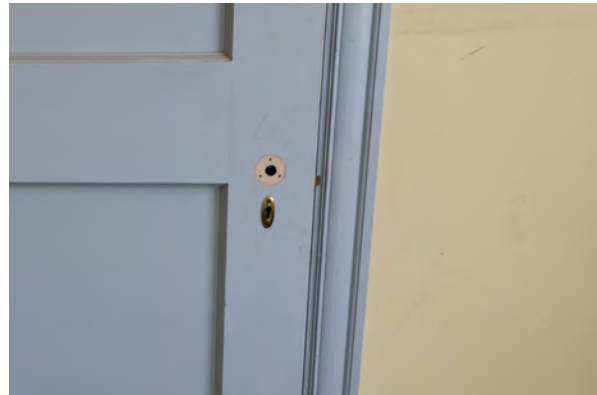
Figure 28: Missing hardware at Door 1-05

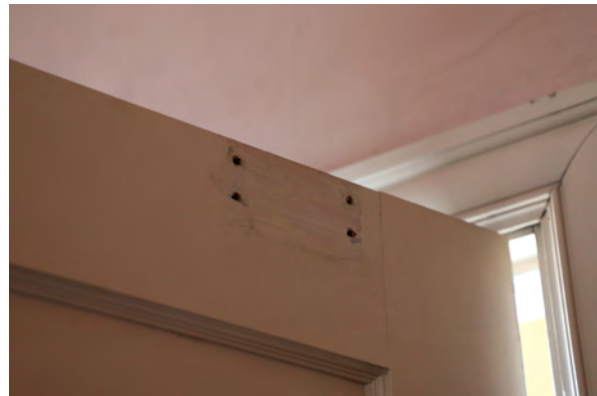
Figure 29: Missing door closer at Women's Restroom, Door 2-01

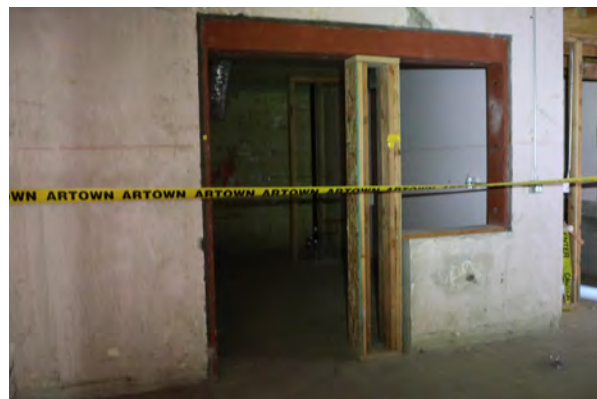
Figure 30: Unfinished openings in basement

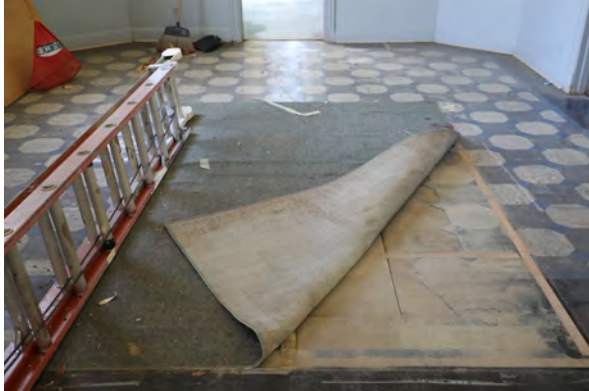
Figure 31: Fire damaged and missing vinyl tile under a temporary carpet section in the west Lobby (Room 115)

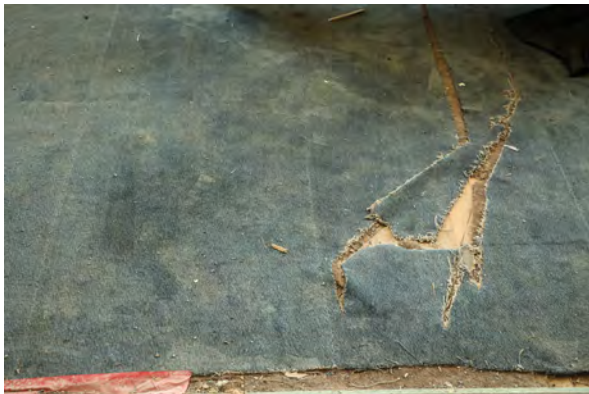
Figure 32: Damaged and worn broadloom carpet in Auditorium (Room 107)

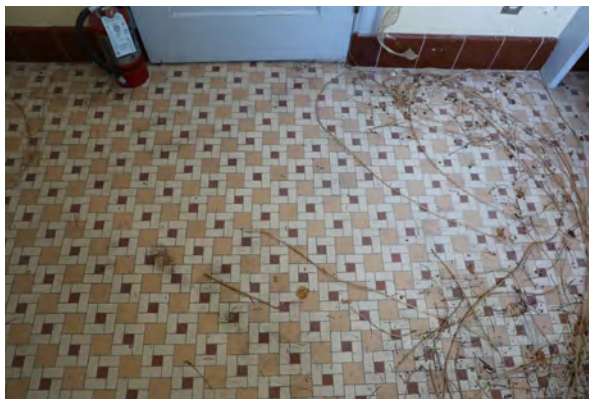
Figure 33: Dirt accumulation at original tile in Women's Restroom (Room 112)

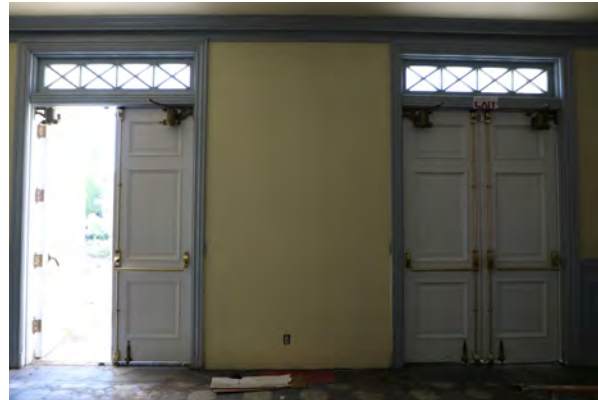
Figure 34: Missing wainscot between Door 1-14 and Door 1-15 in the Foyer (Room 101)

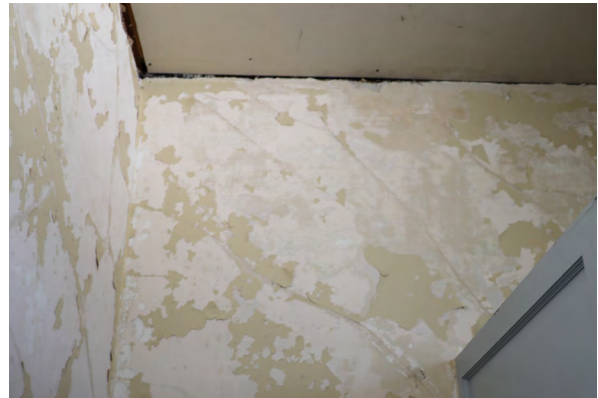
Figure 35: Severely damaged paint finish and plaster, possibly caused by ivy removal in the west Women's Restroom (Room 112)

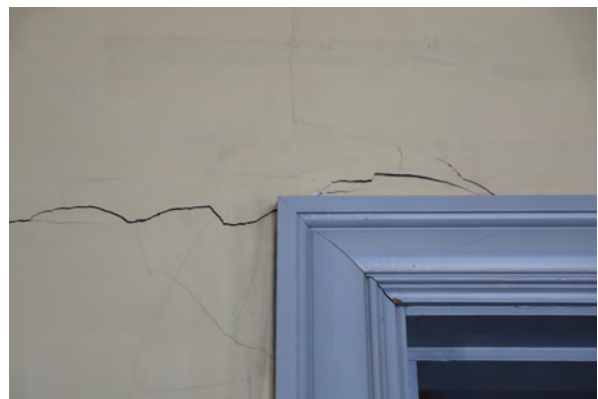
Figure 36: Significant cracking of plaster at cased opening on the north wall of west Lobby (Room 115)

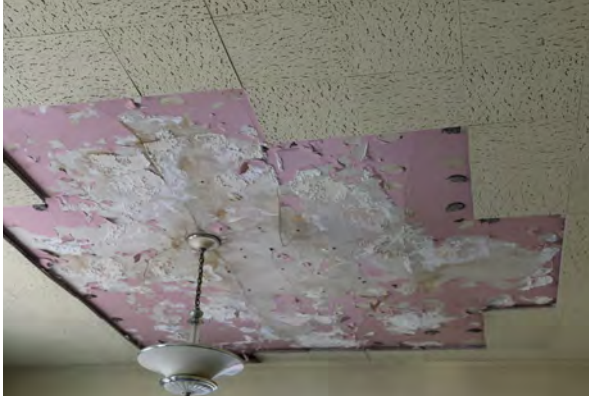
Figure 37: Missing acoustic tile and damaged historic finish at ceiling of the Literature Room (Room 114)

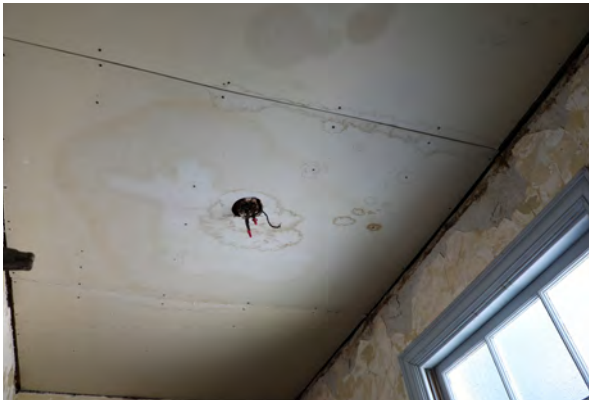
Figure 38: Moisture damage, unfinished drywall, and removed light fixture at ceiling of west Women's Restroom (Room 112)

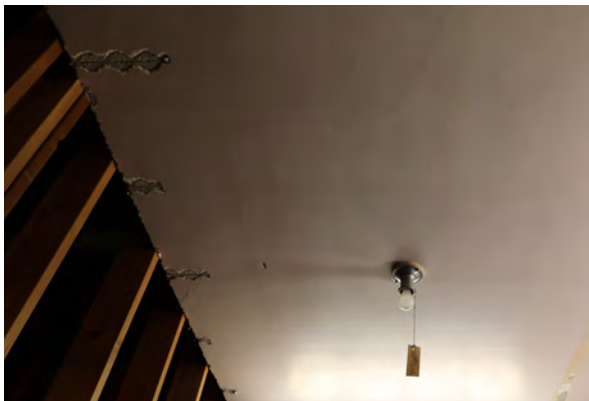
Figure 39: Loss of finish material and plaster at ceiling of east Entry (Room 109)

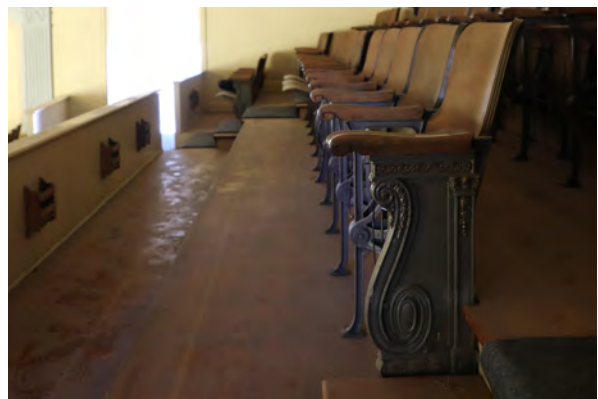
Figure 42: Original theater seating showing slight wear and tear and dust accumulation at Balcony (Room 203)

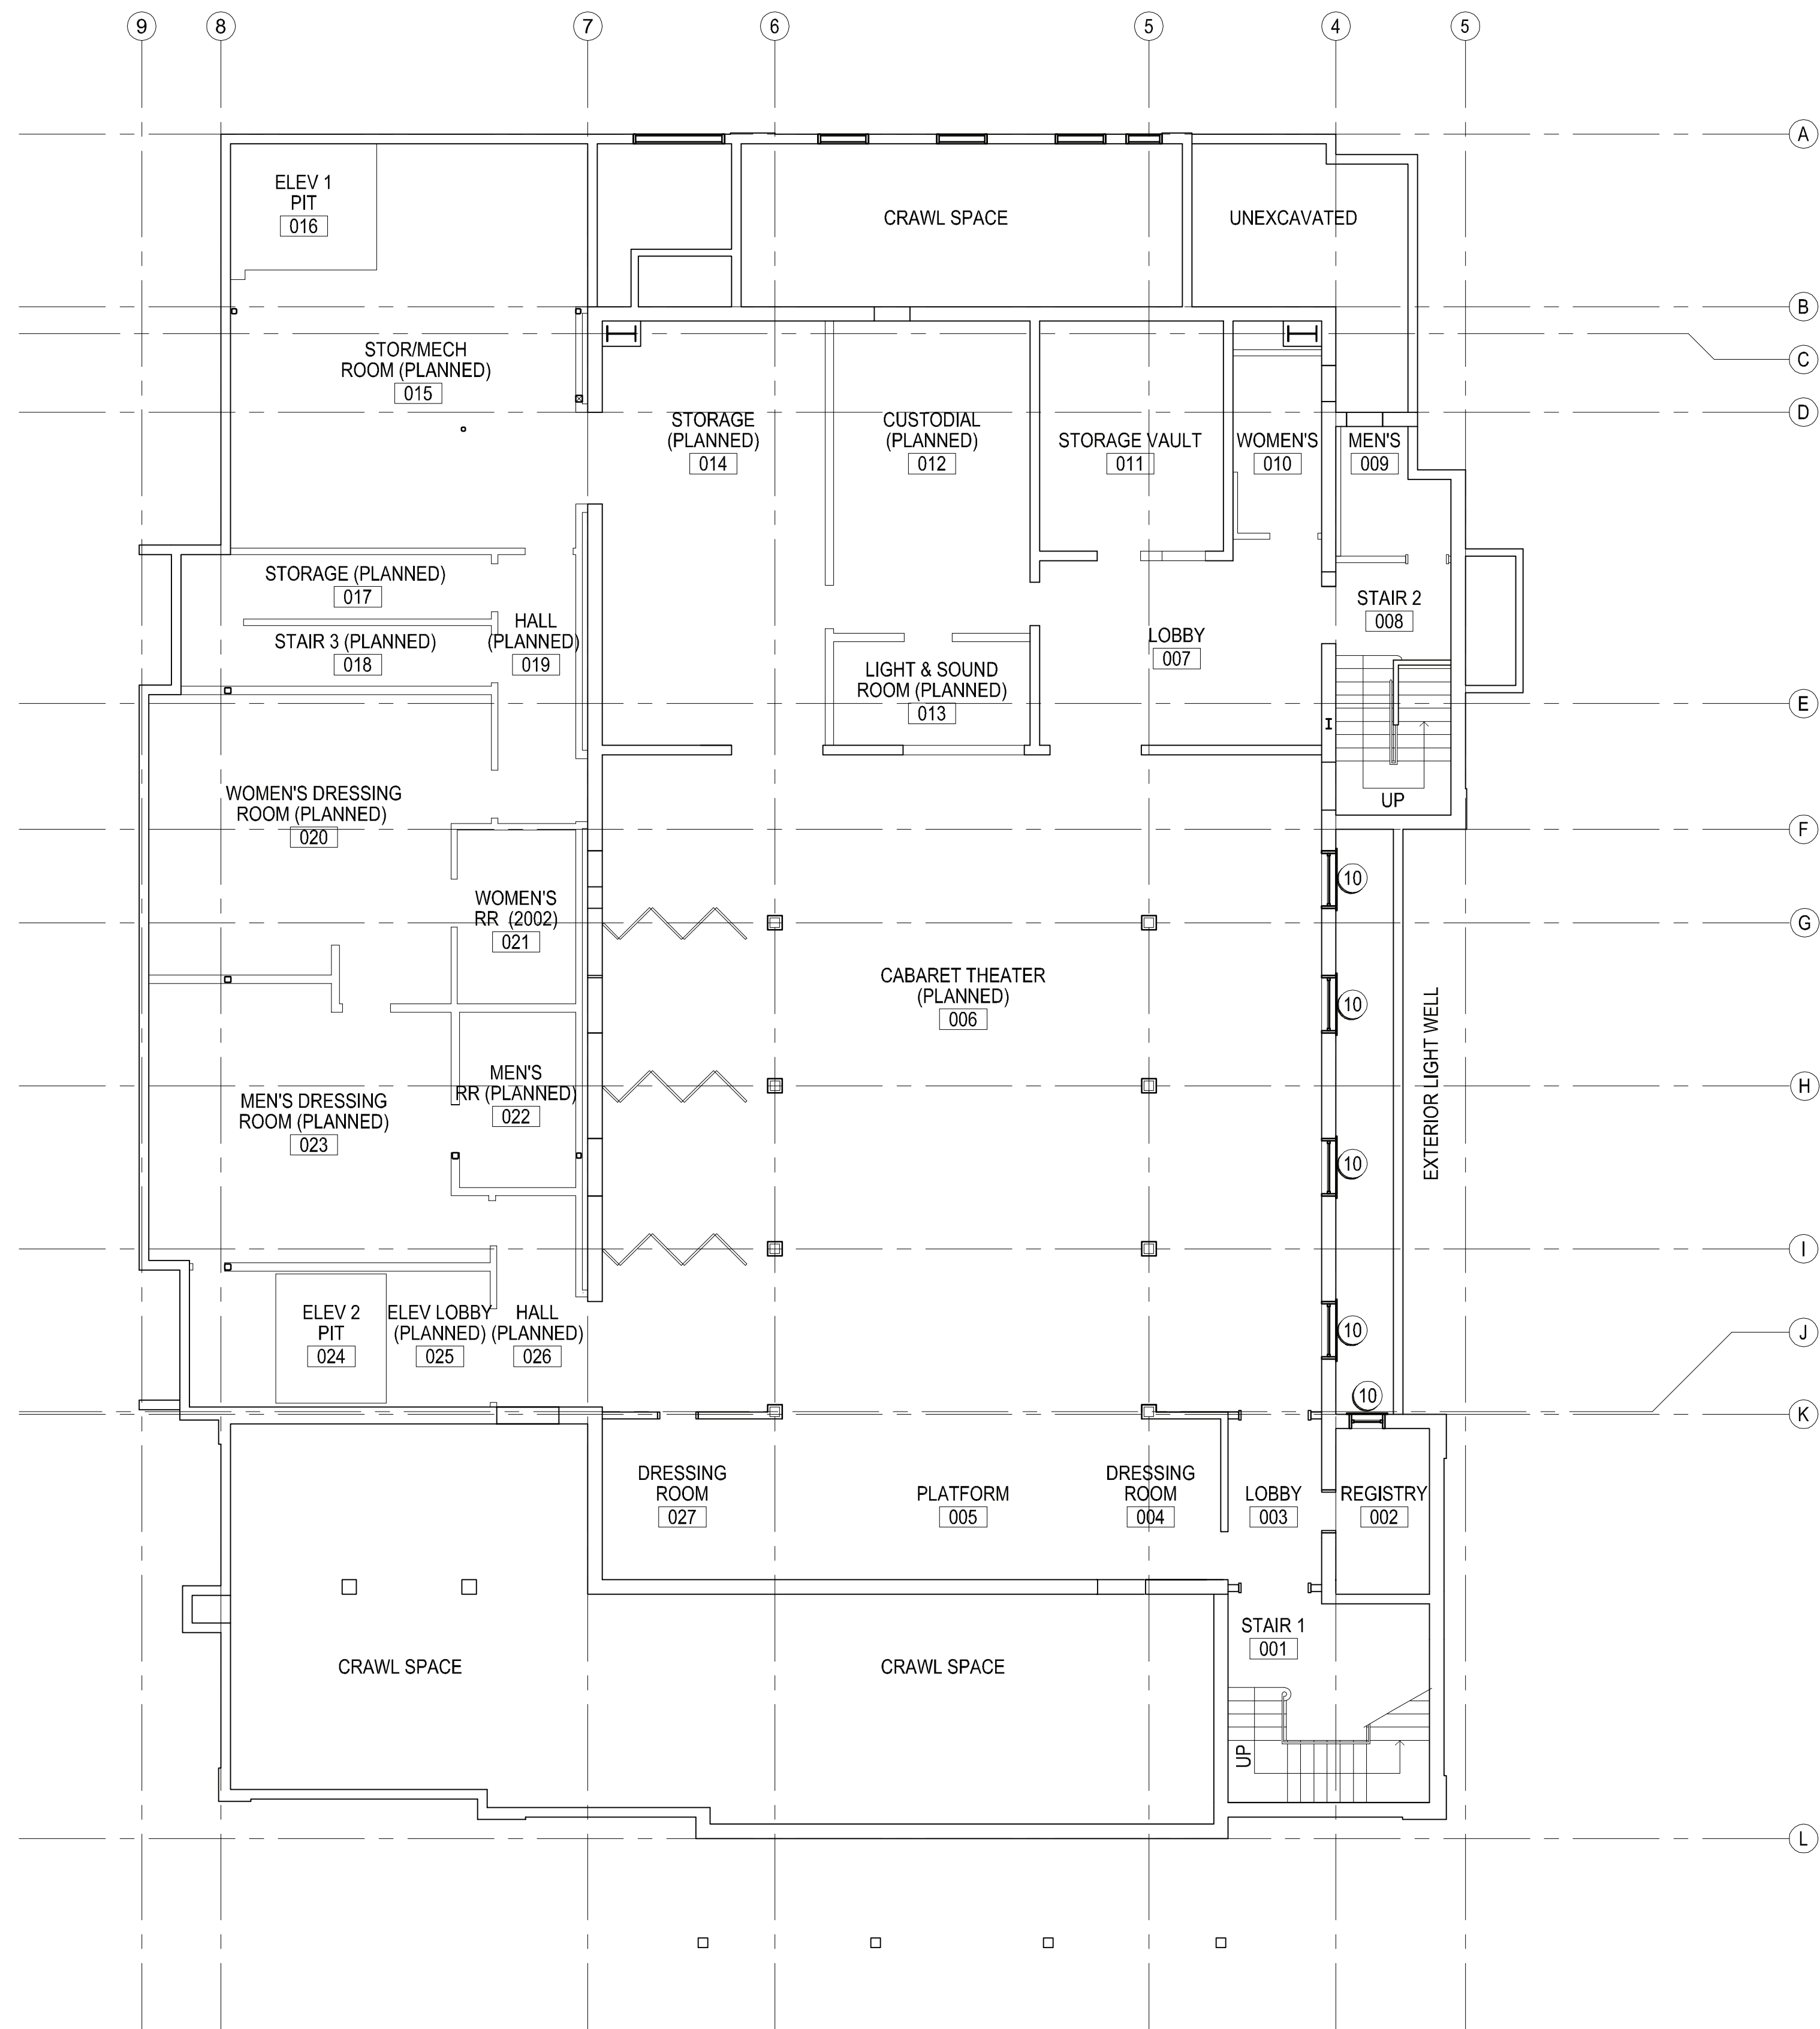
1 STABILIZATION PLAN - BASEMENT
 A1.00S SCALE: 1/8" = 1'-0"

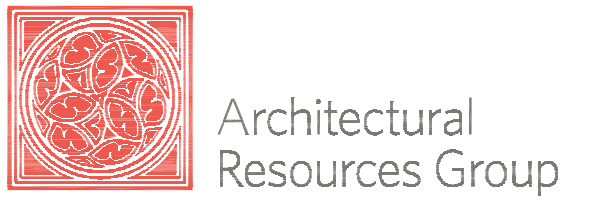
Pier 9, The Embarcadero, Suite 107
 San Francisco, California 94111
 415 421 1680

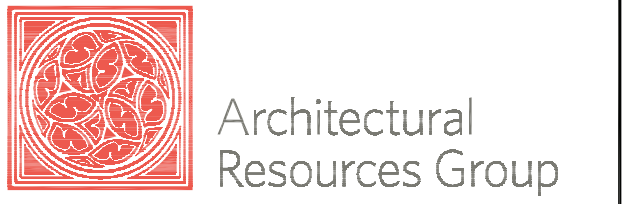
Pier 9, The Embarcadero, Suite 107
 San Francisco, California 94111
 415 421 1680

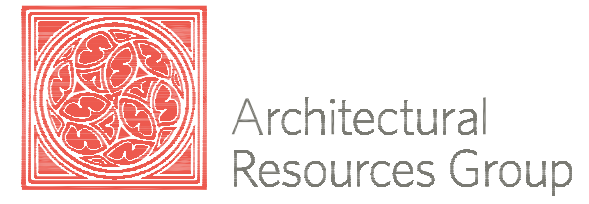
Pier 9, The Embarcadero, Suite 107
 San Francisco, California 94111
 415 421 1680

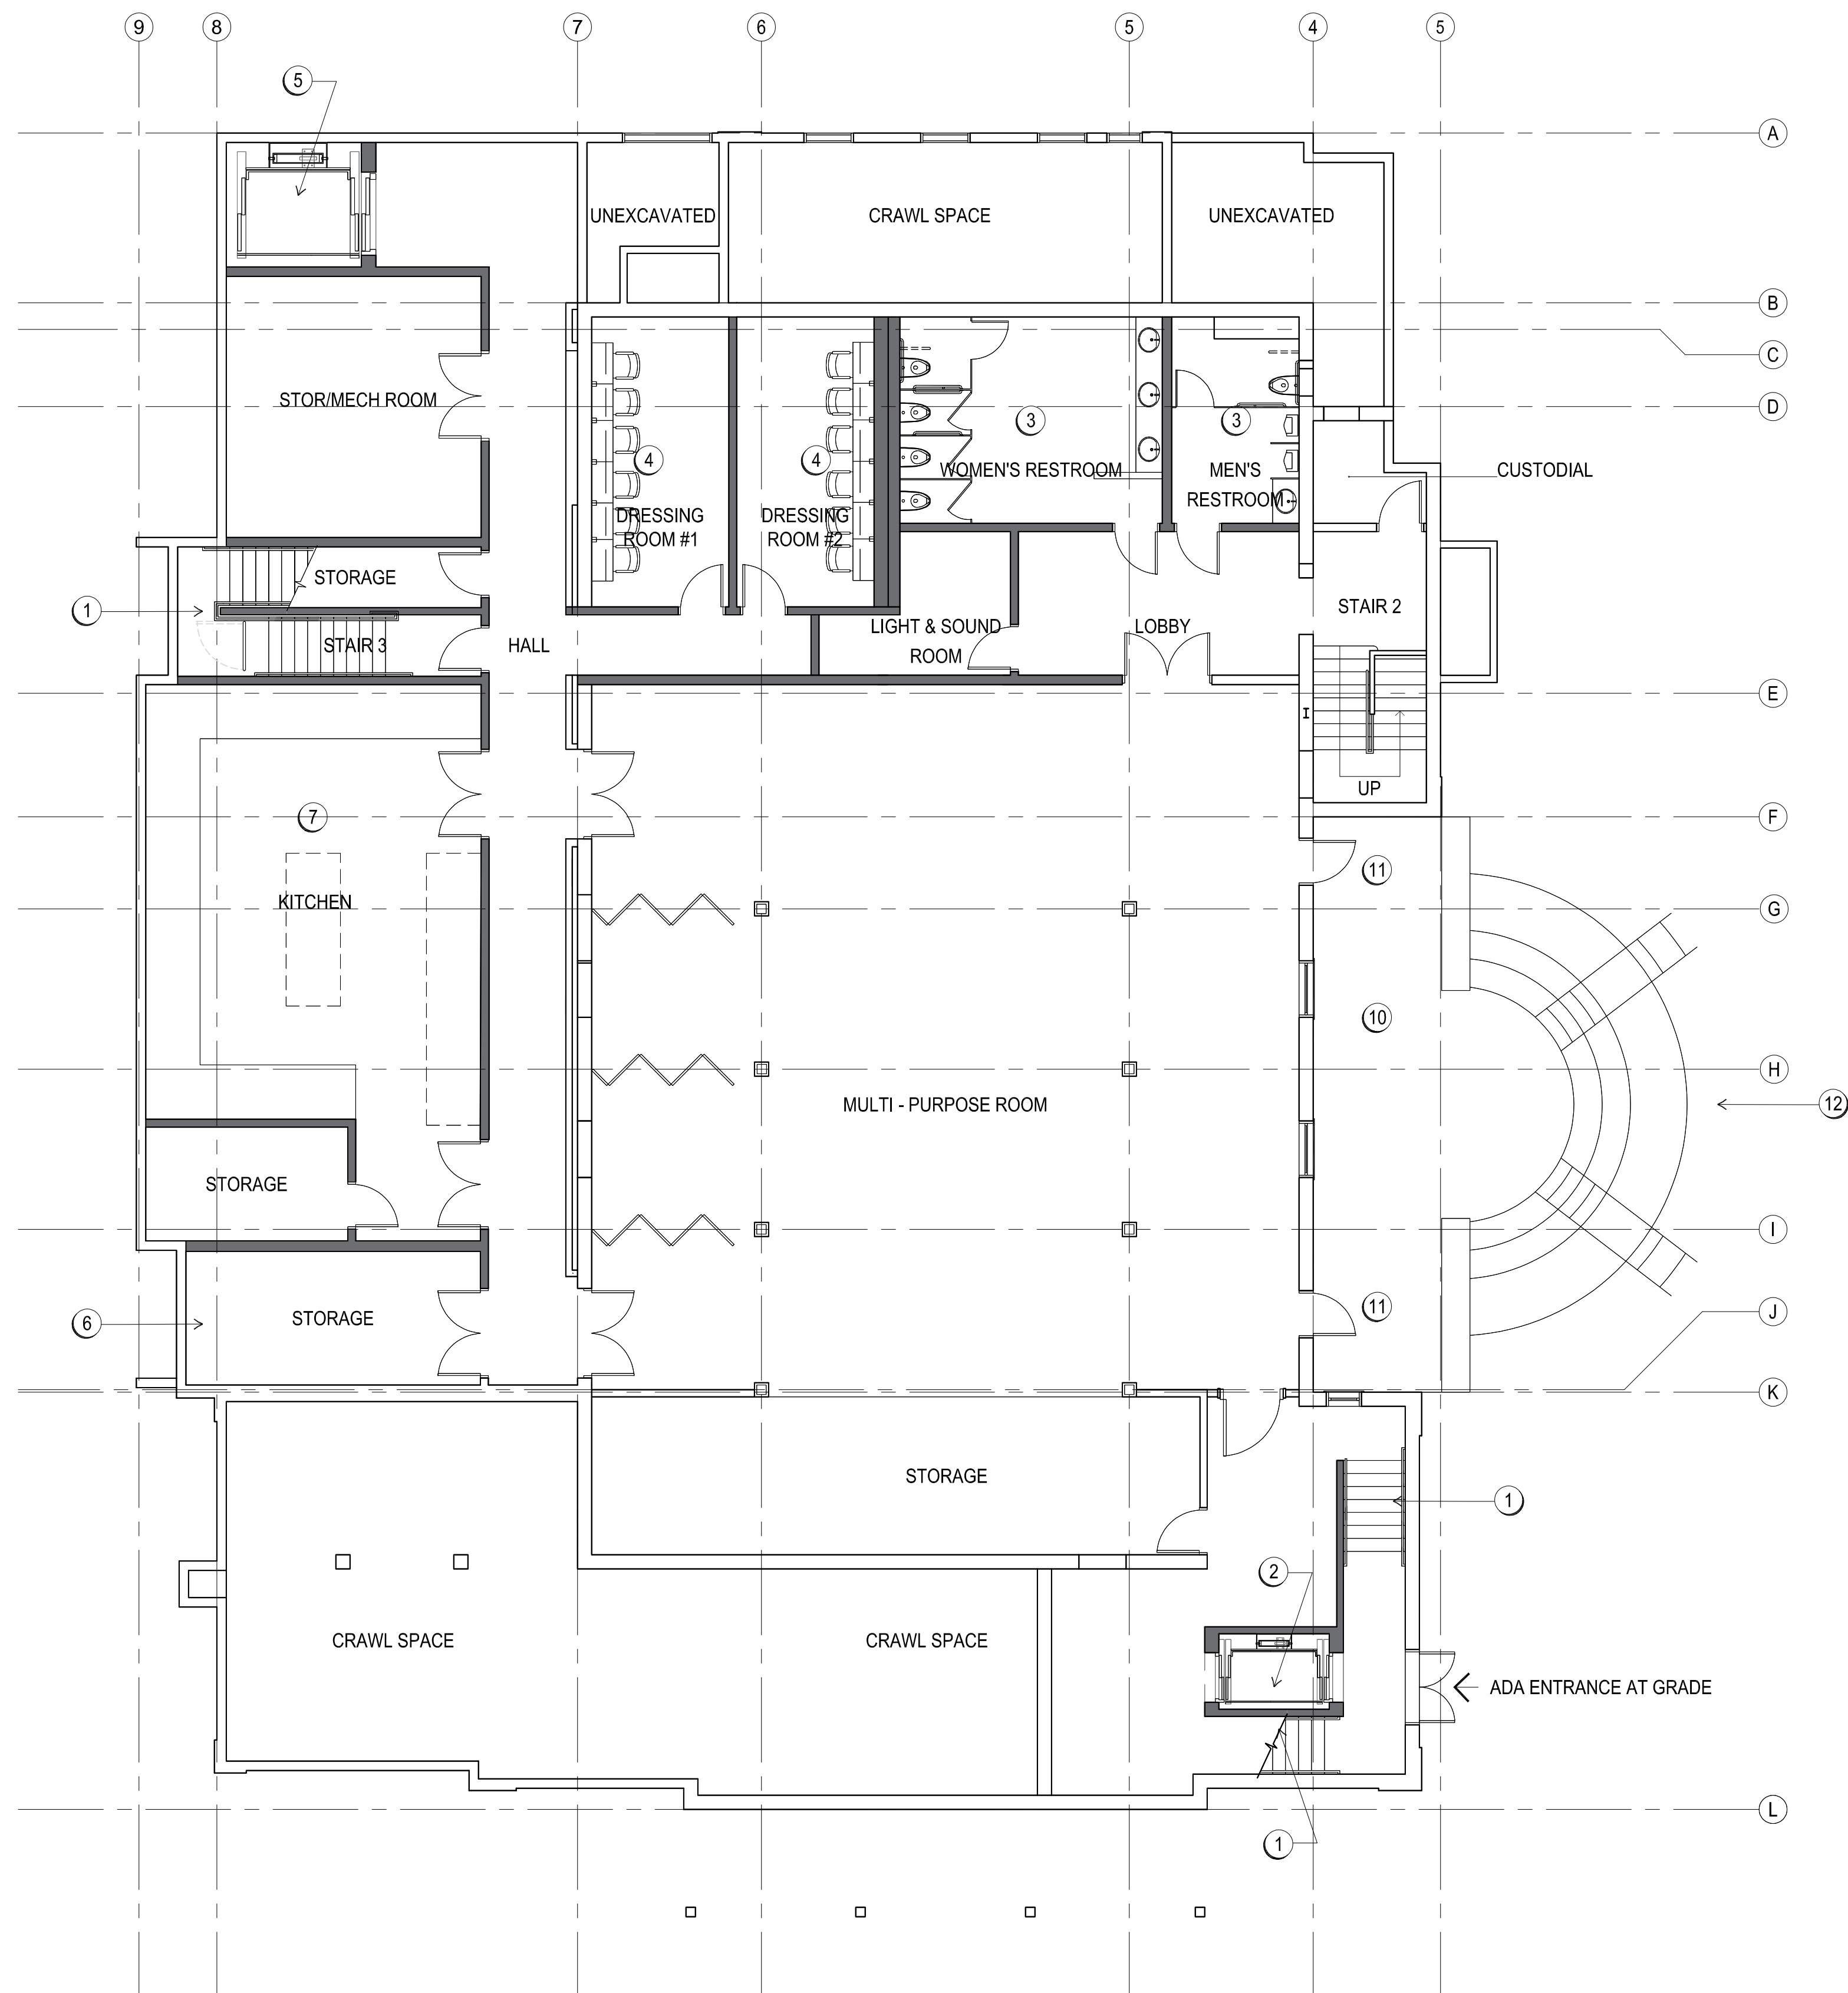
GENERAL FLOOR PLAN NOTES
