C I T Y O F
RENO
Memorandum

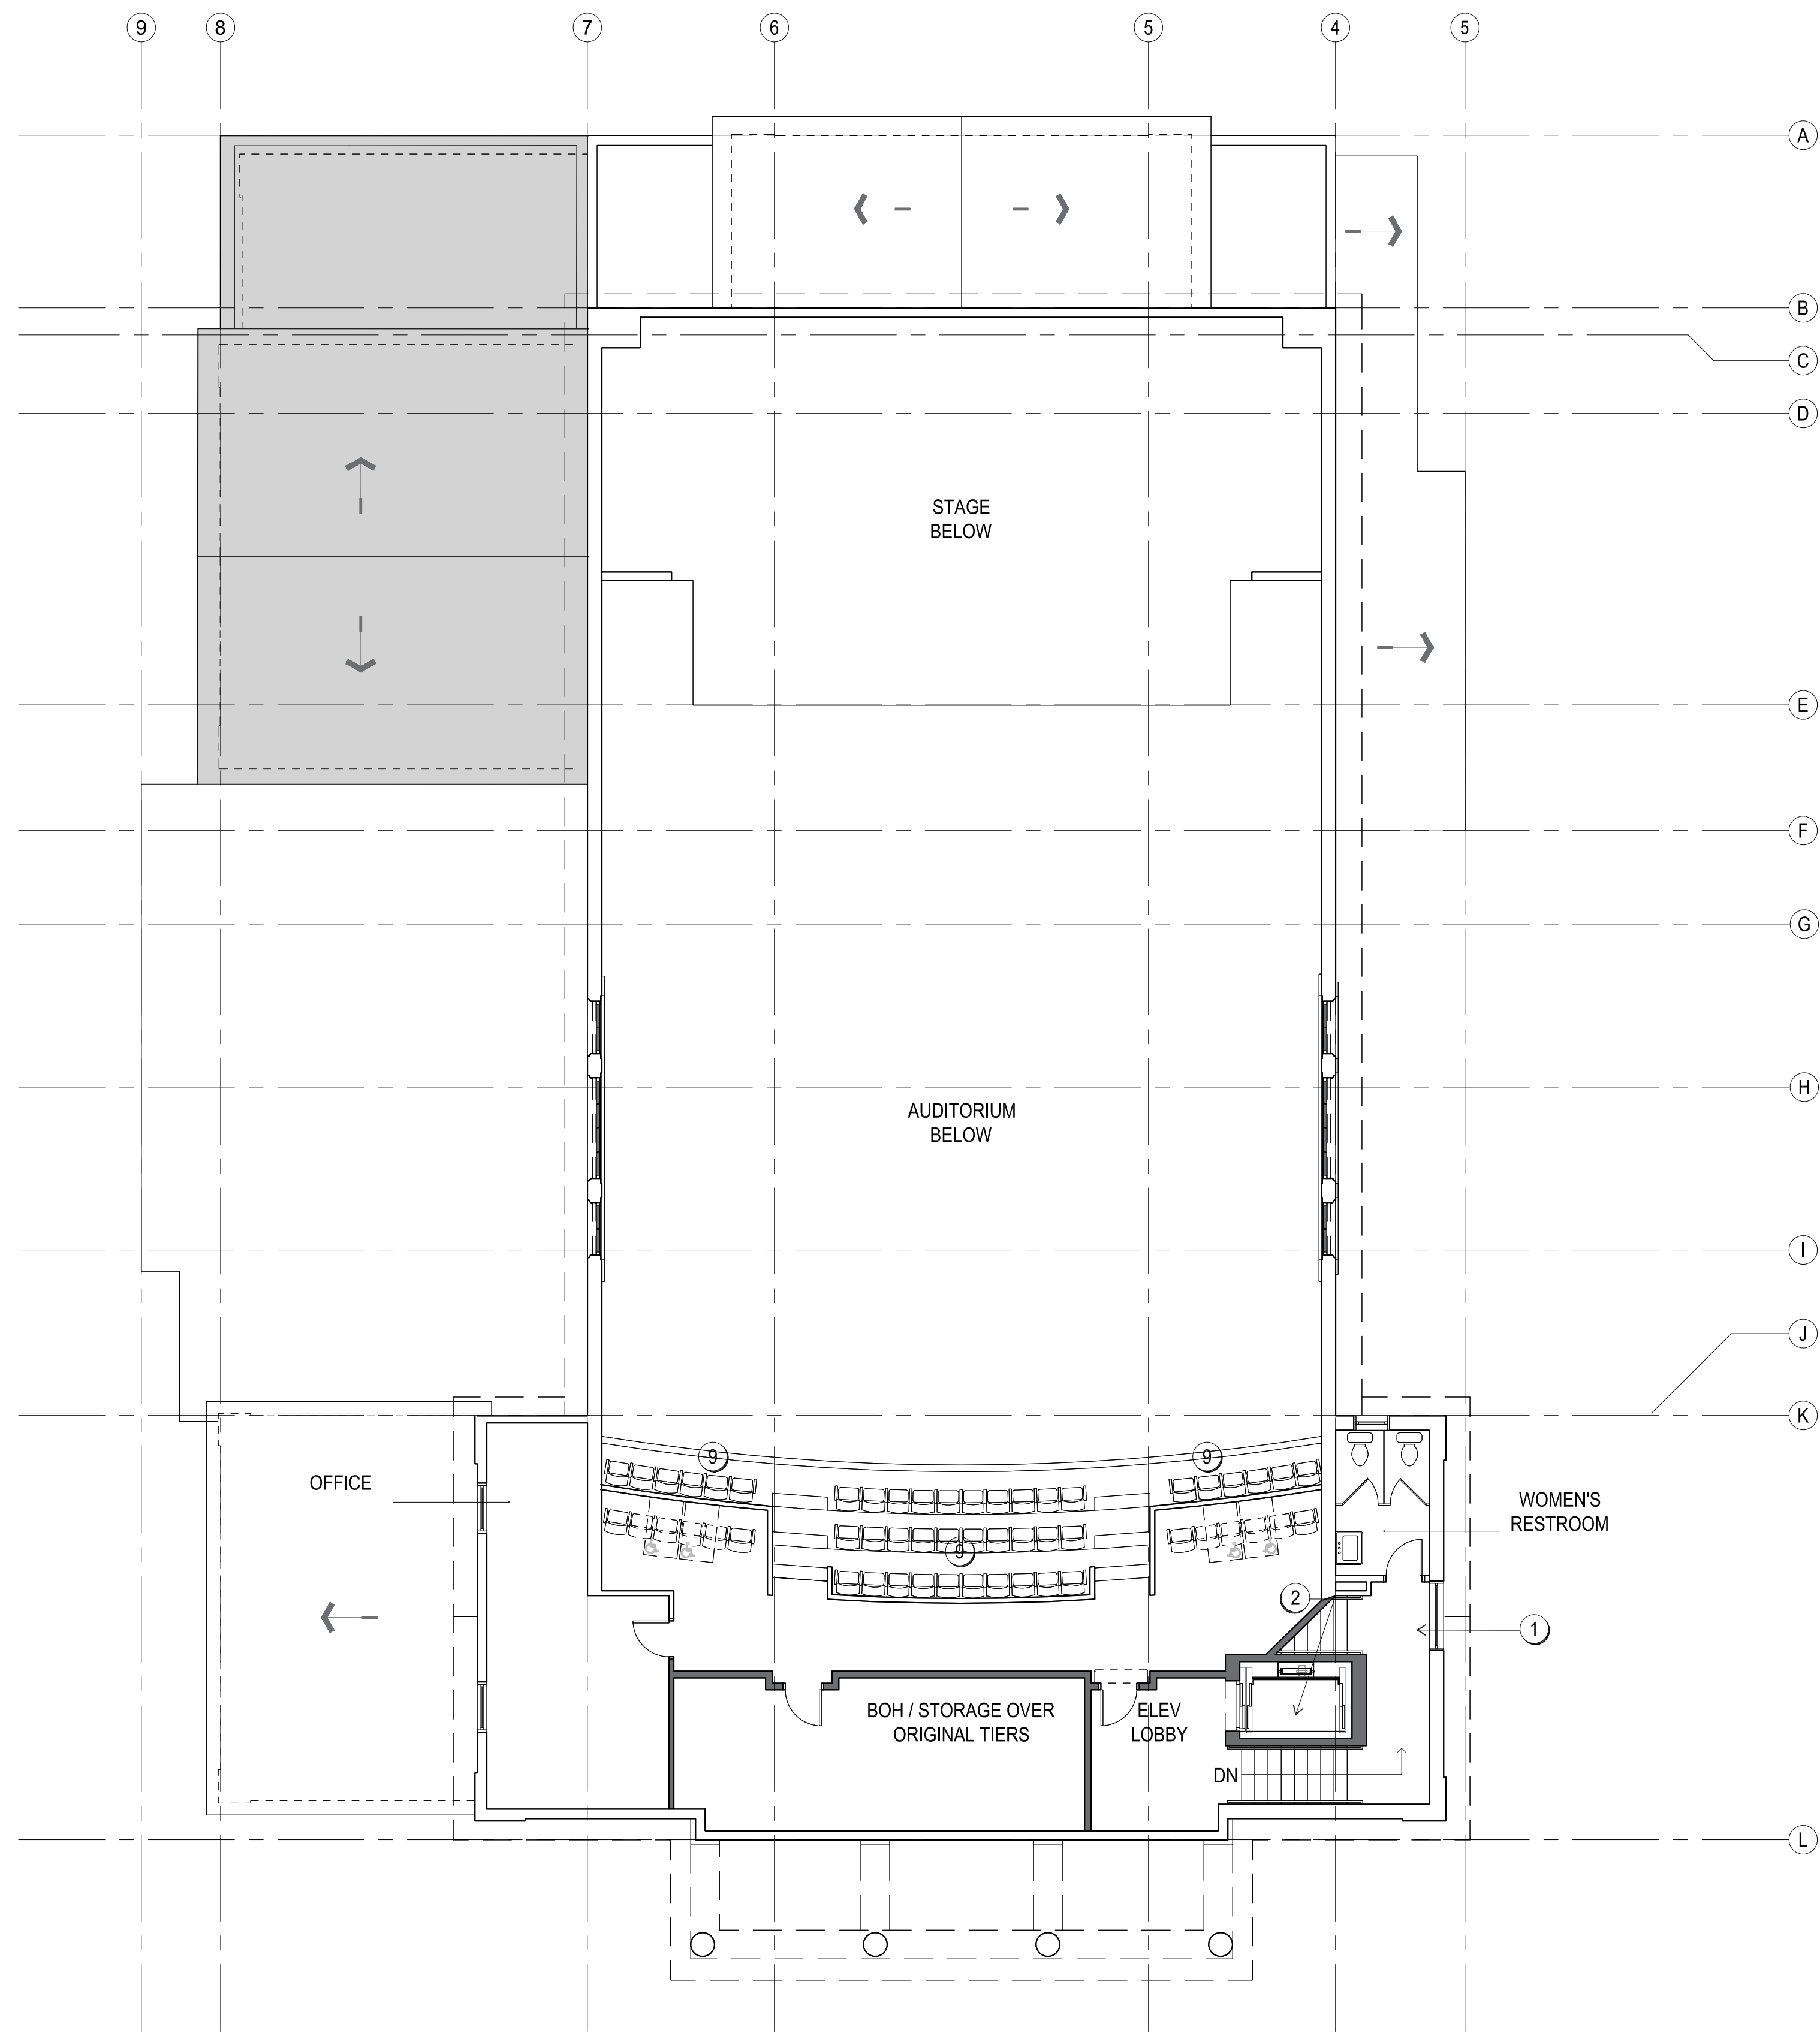
GENERAL FLOOR PLAN NOTES

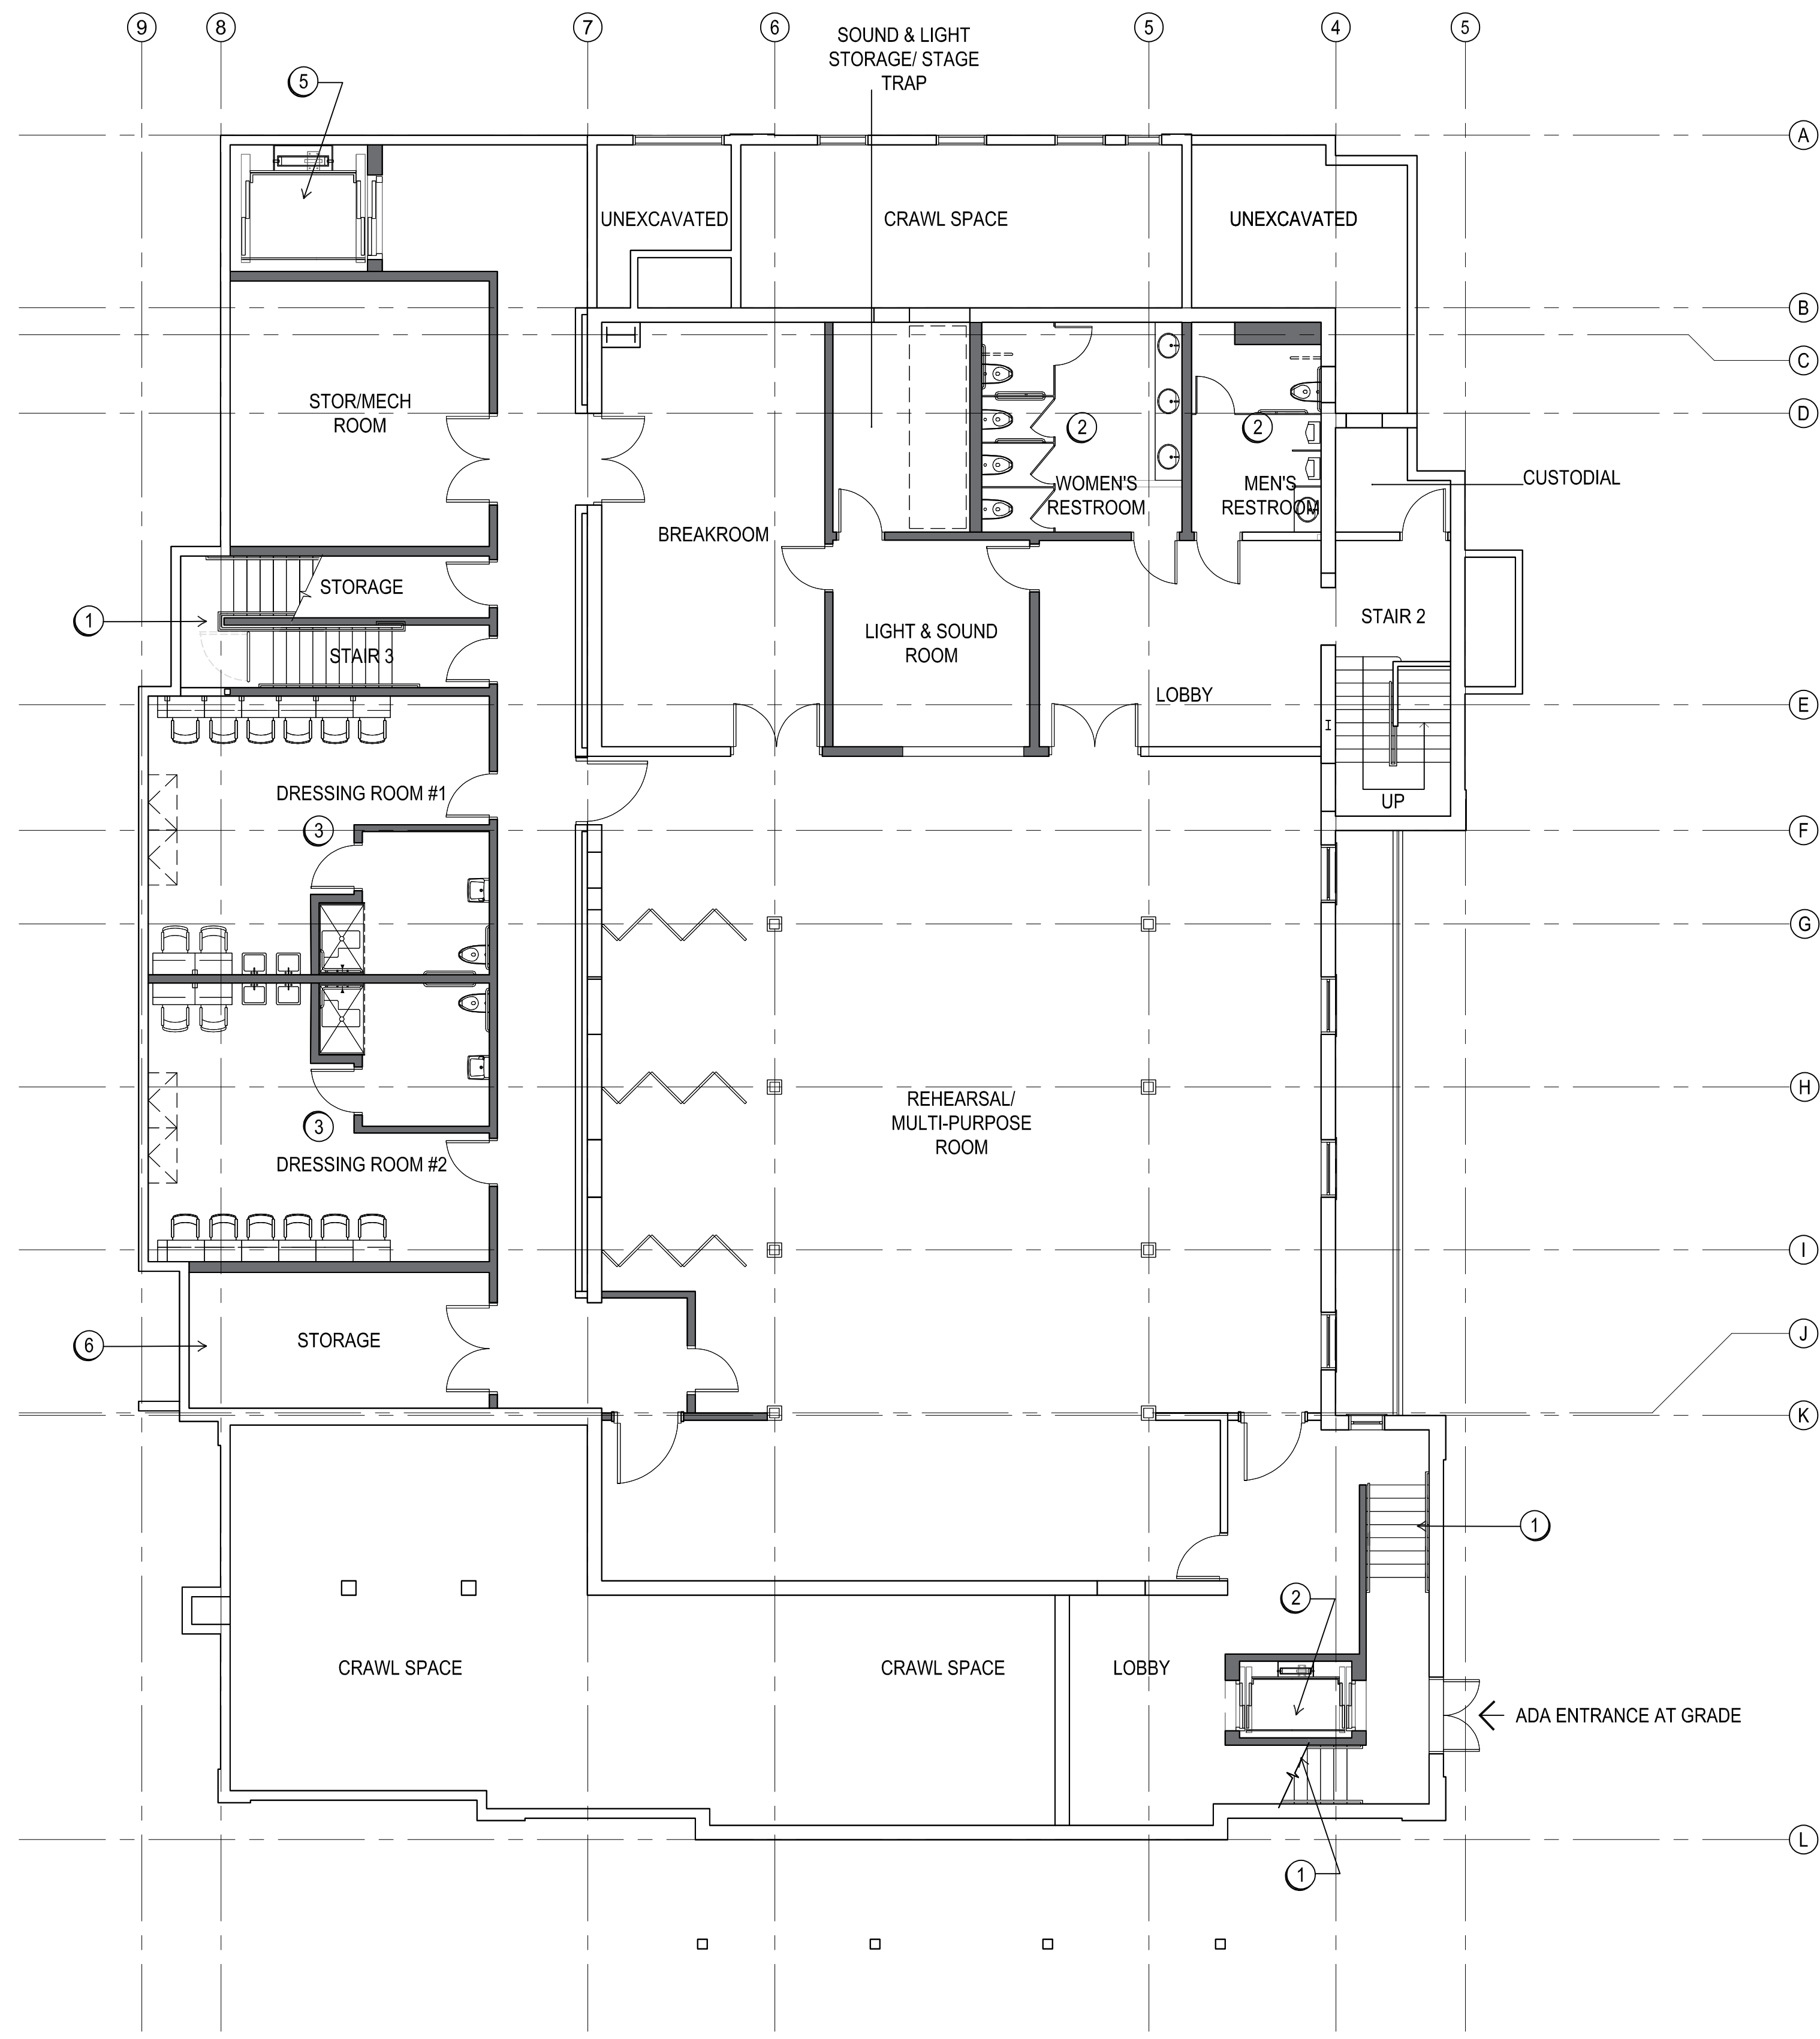
GENERAL FLOOR PLAN NOTES

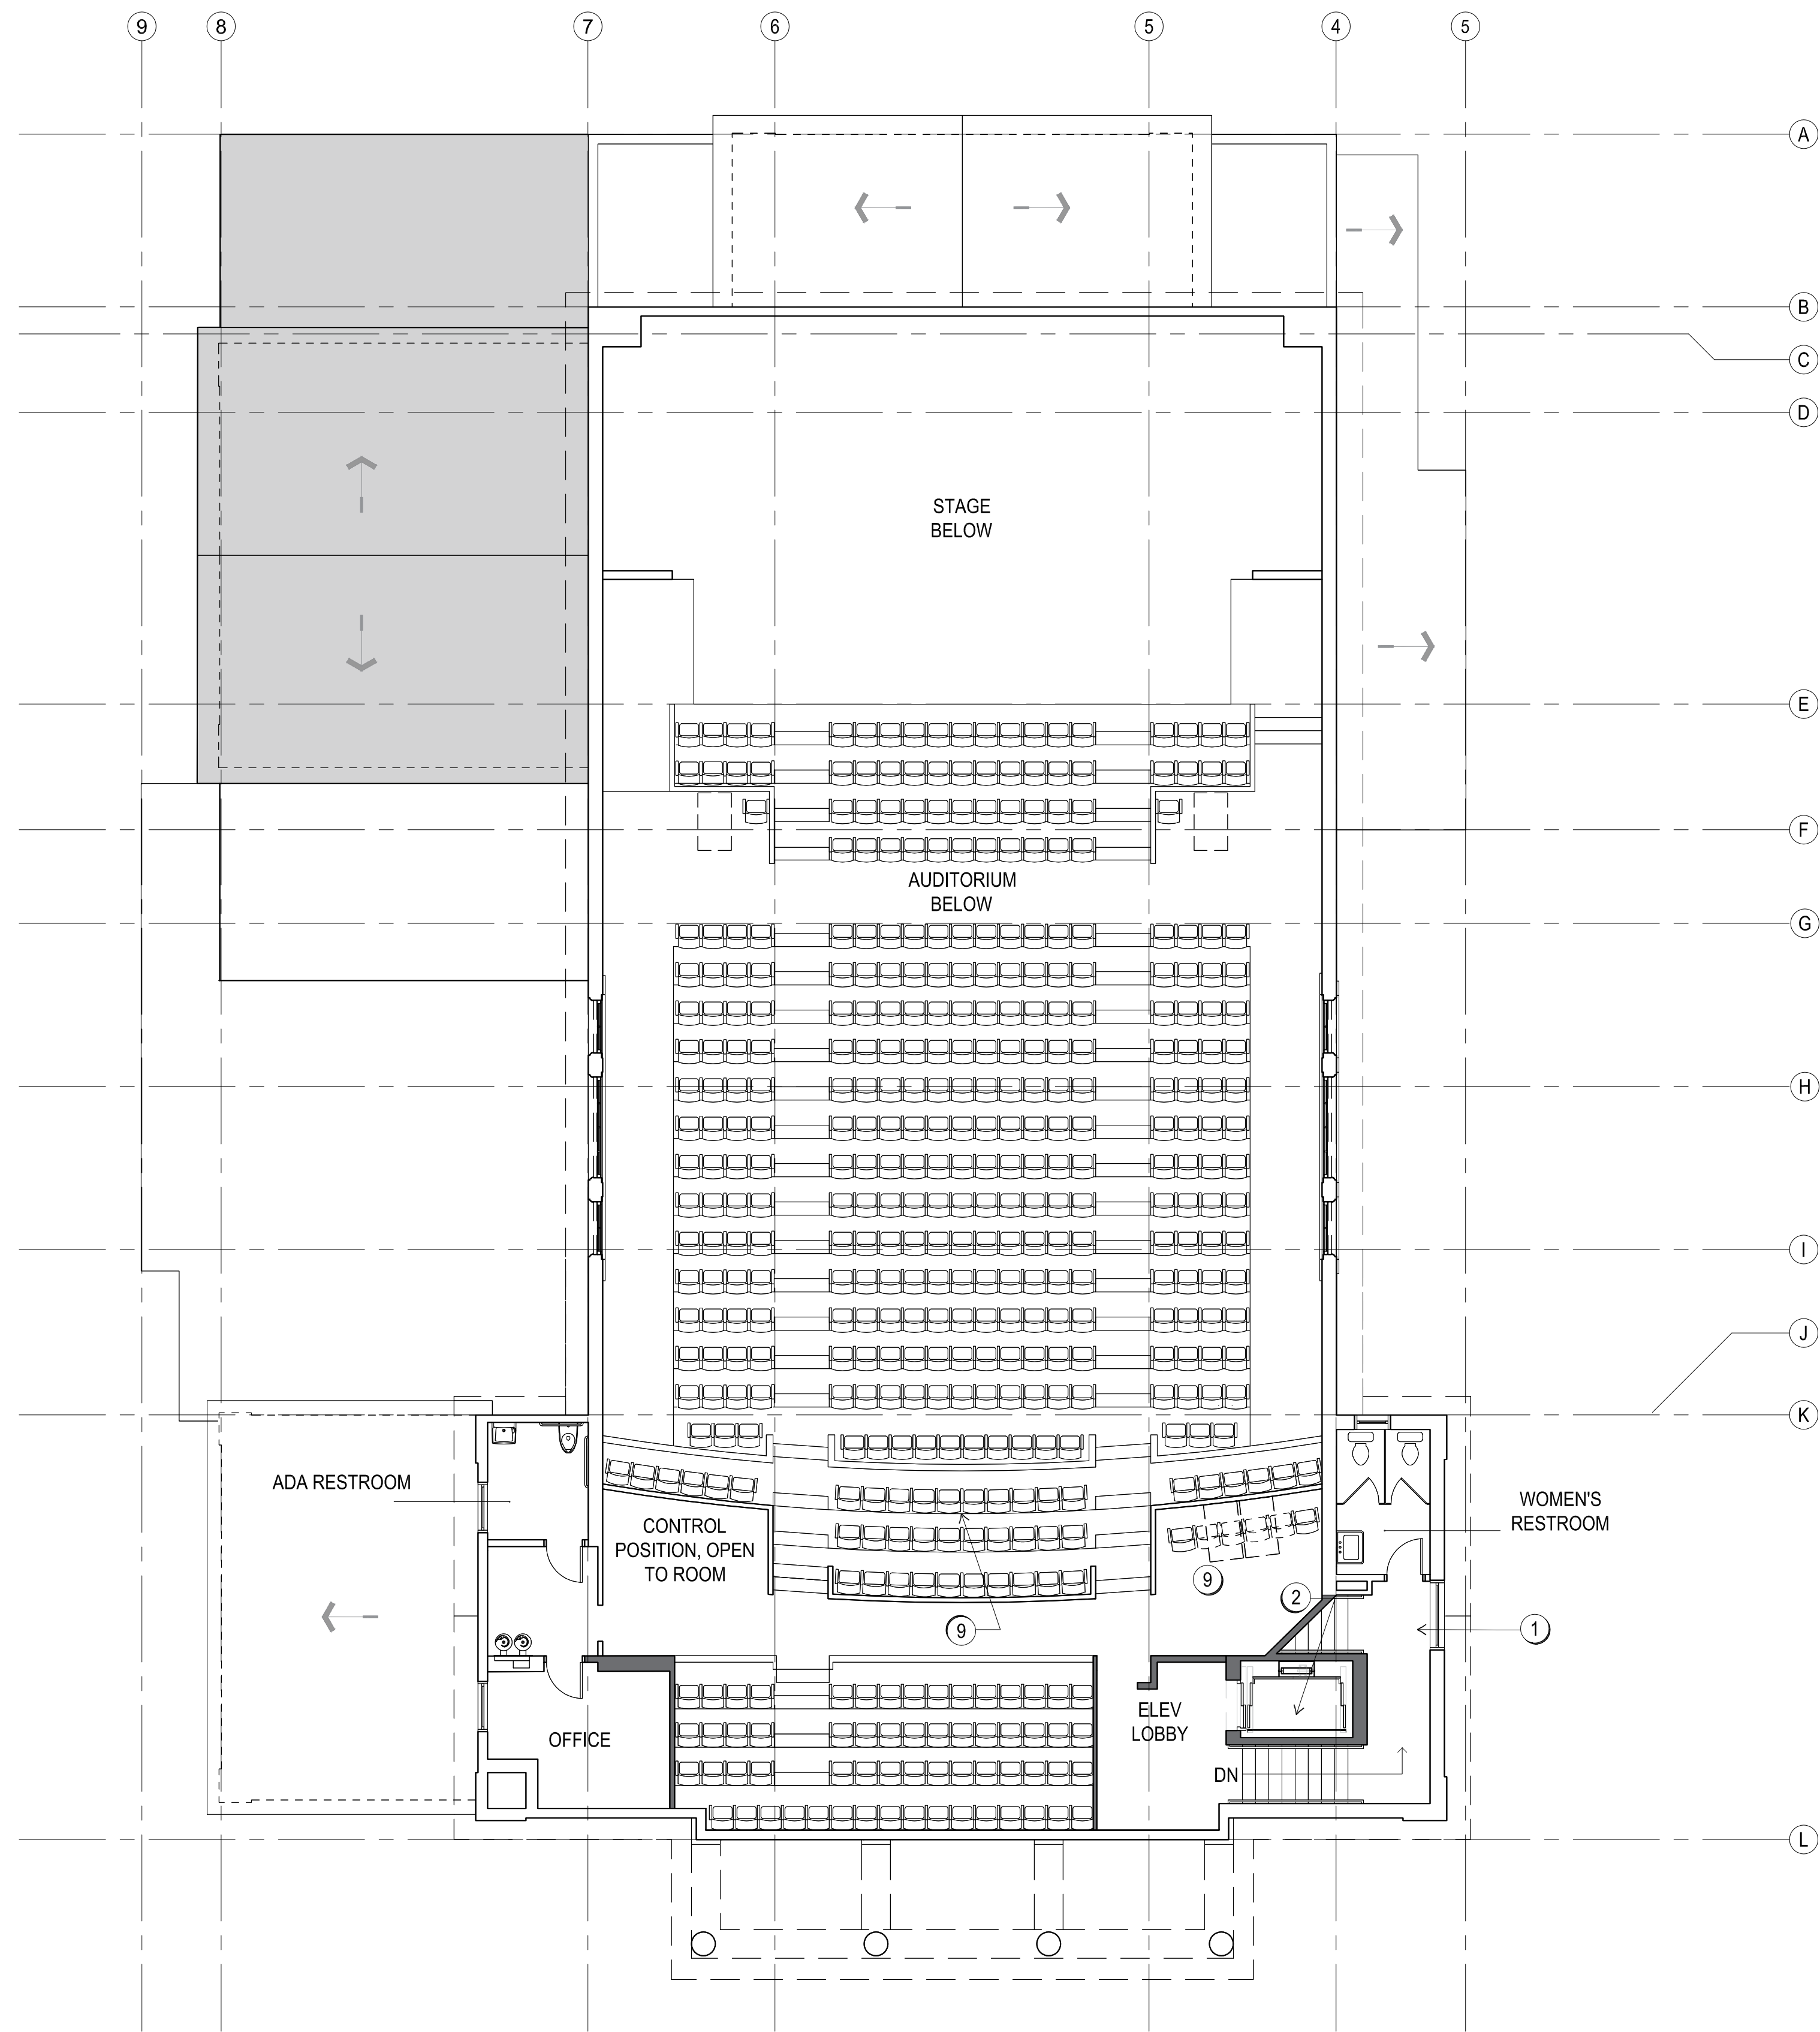
GENERAL FLOOR PLAN NOTES

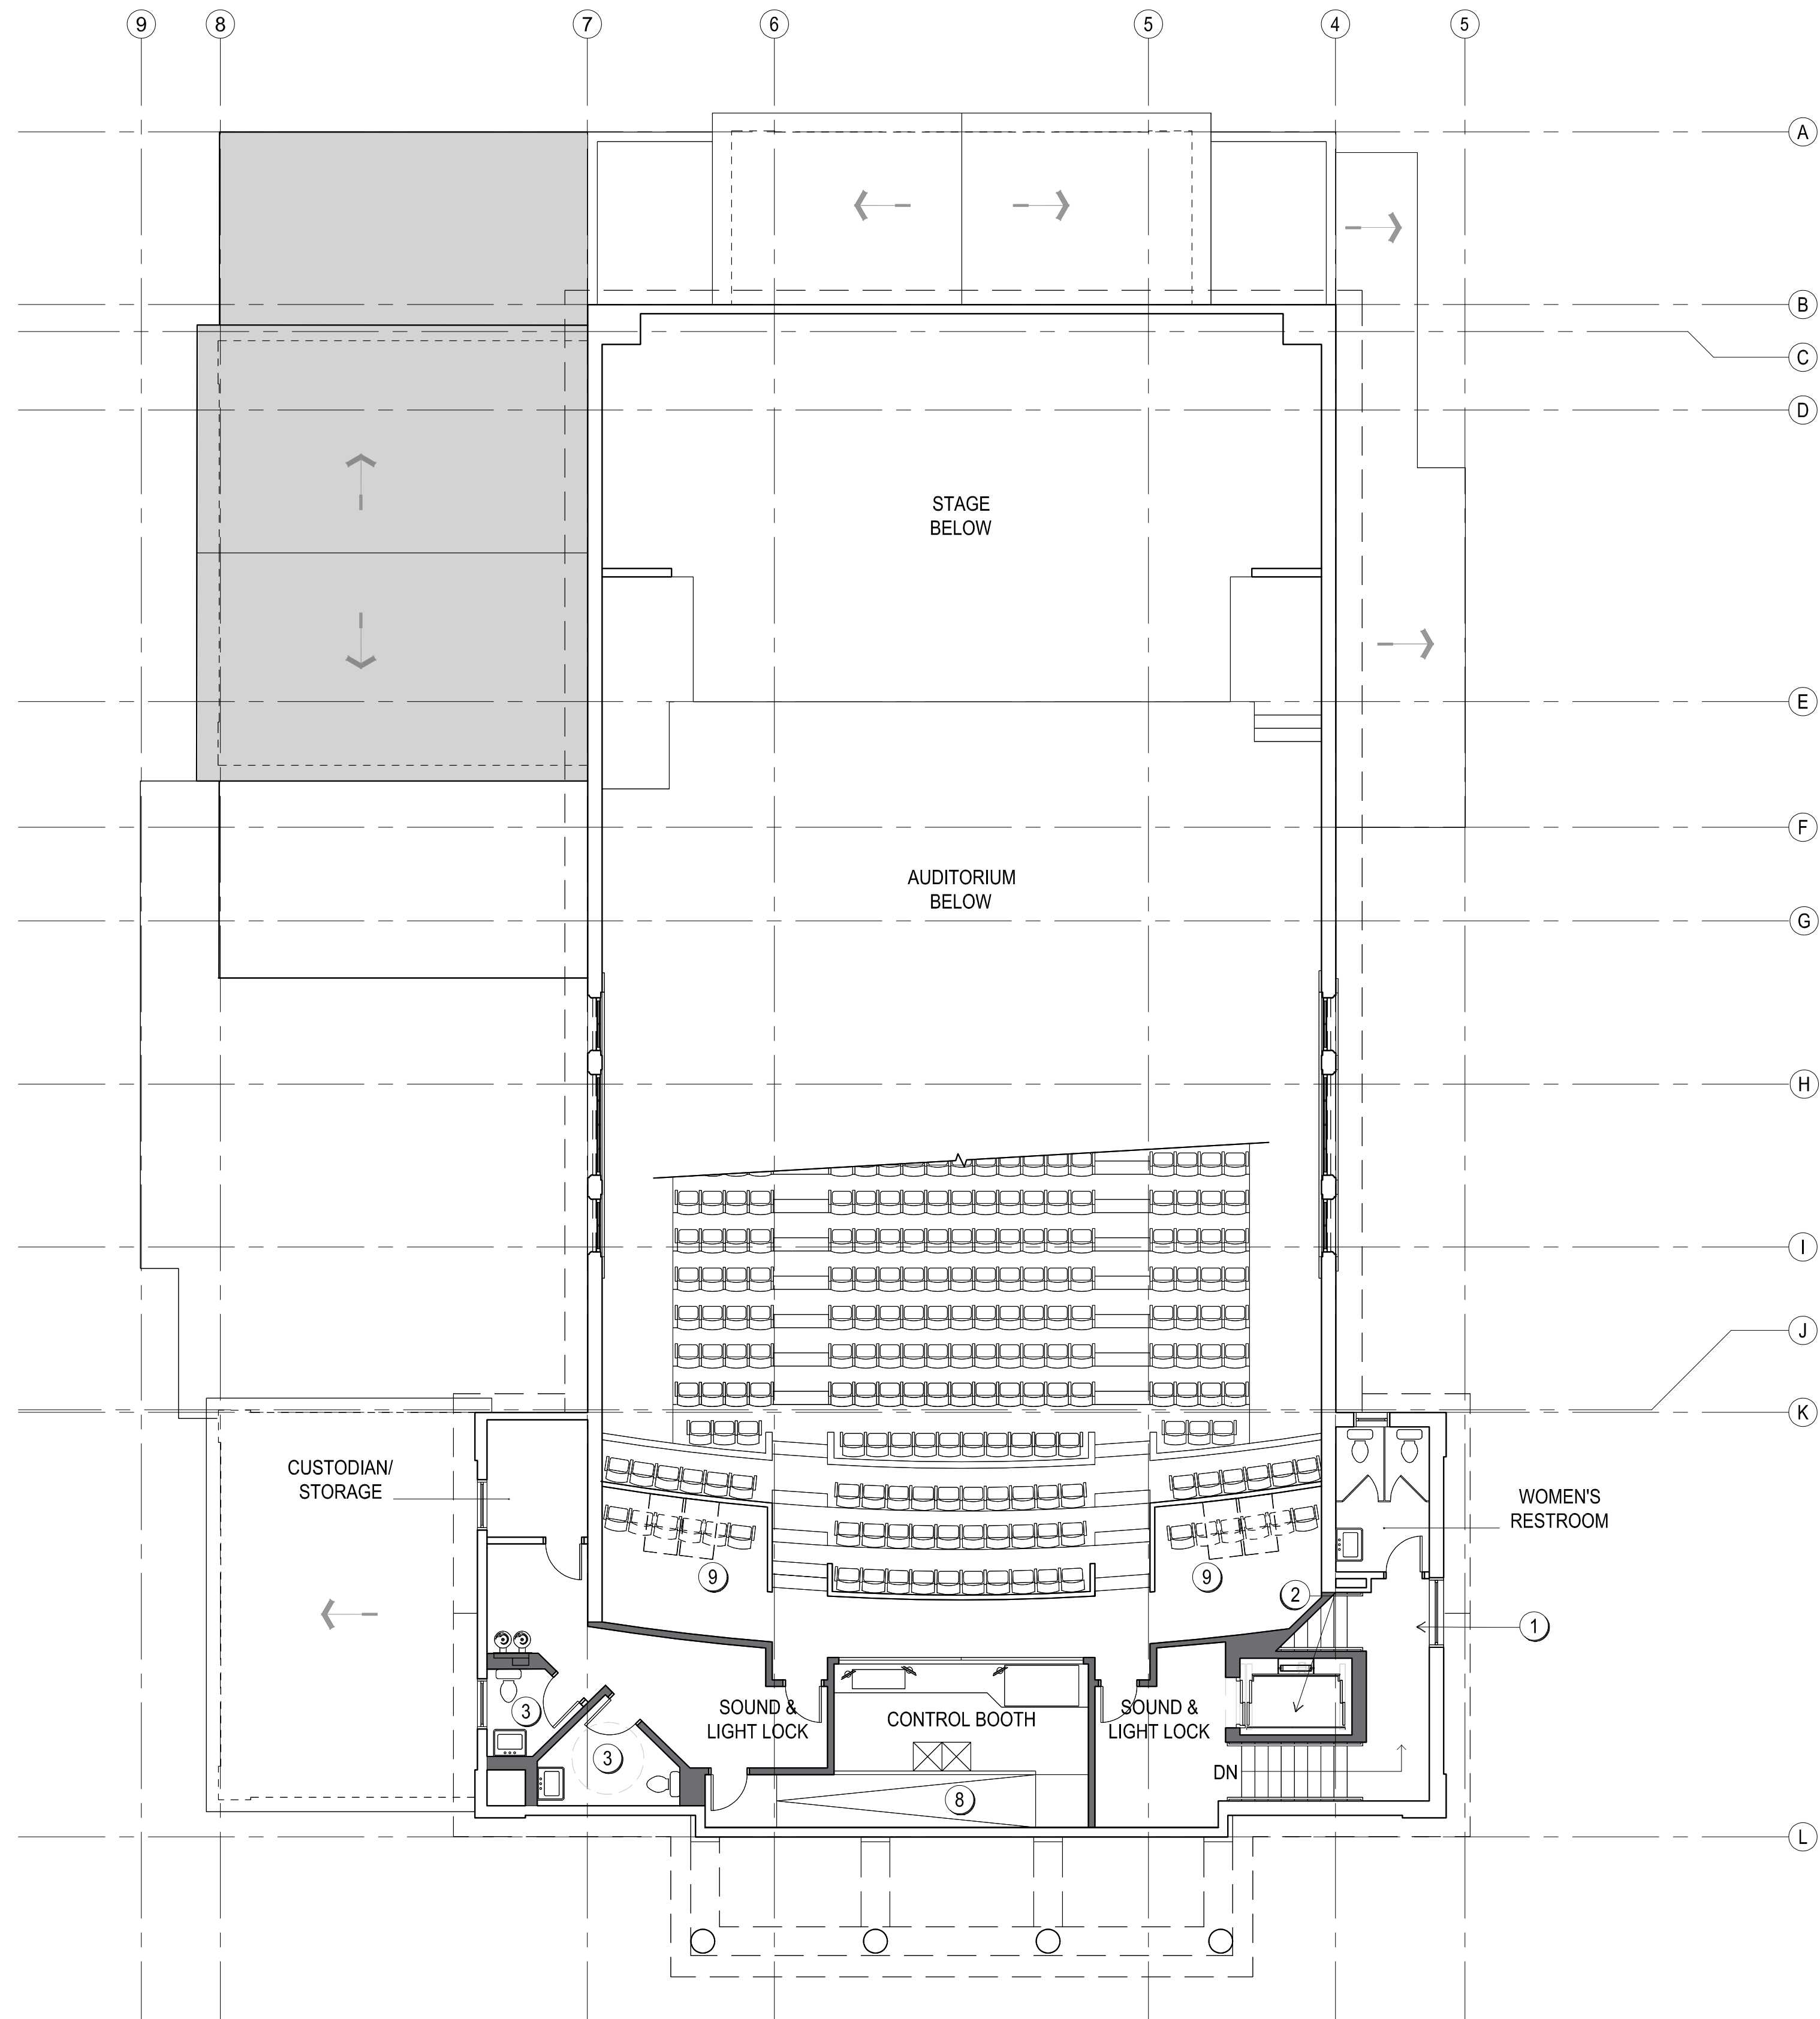
GENERAL FLOOR PLAN NOTES

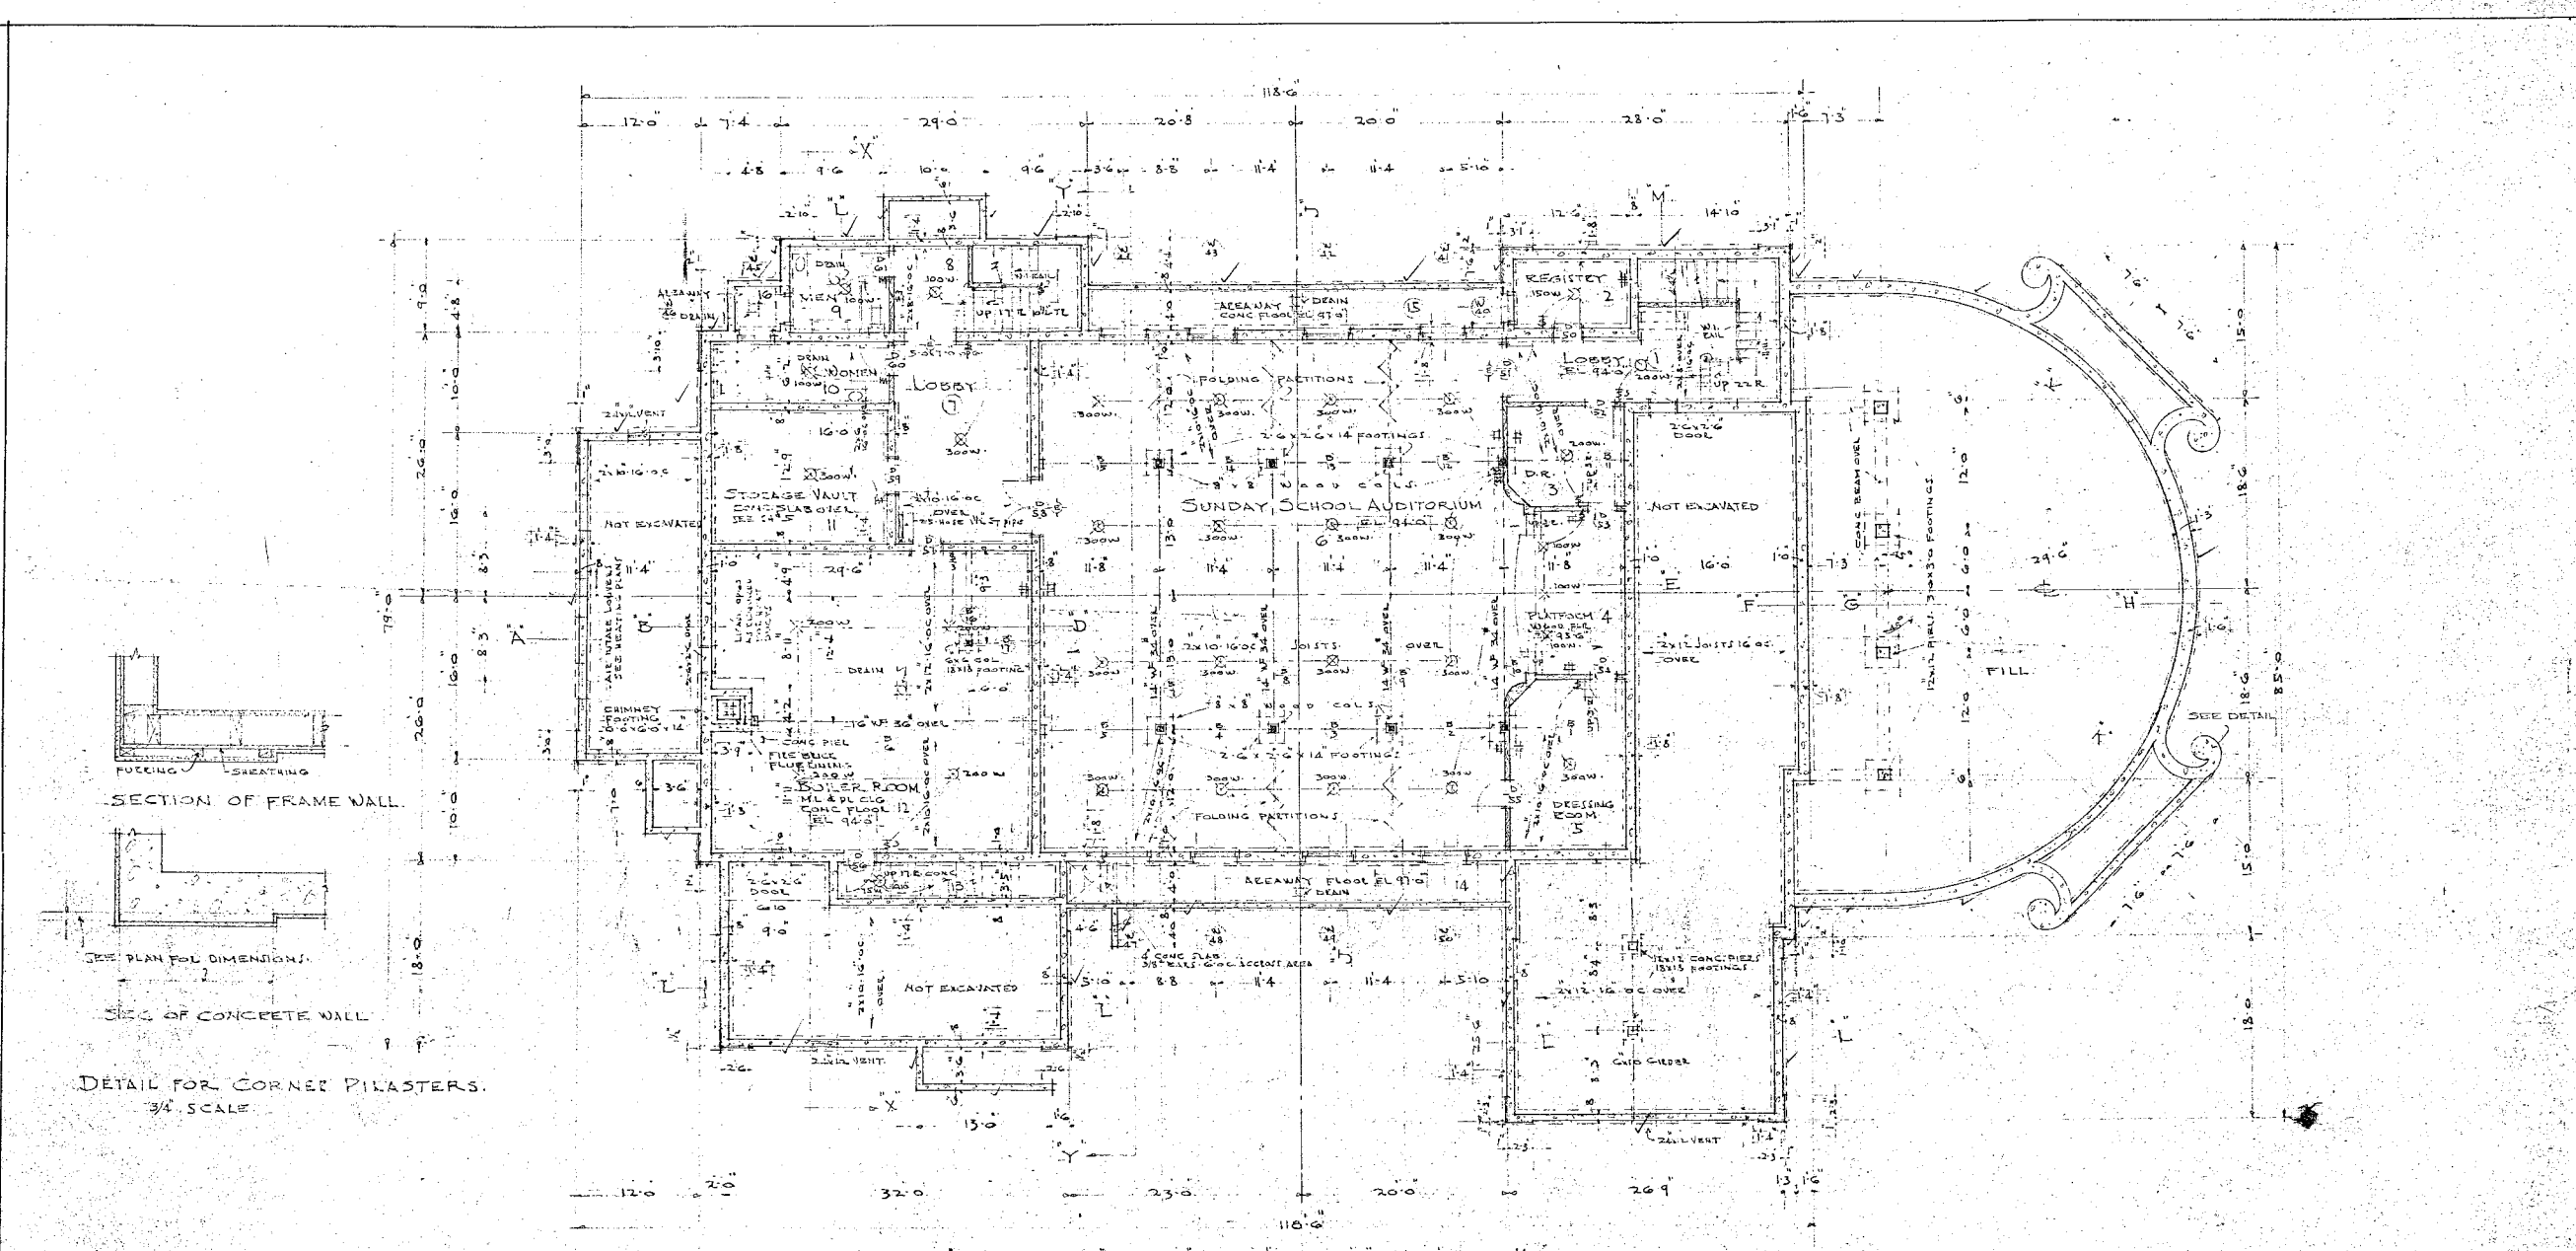
FIRST CHURCH OF CHRIST, SCIENTIST, RENO, NEVADA, 1938.

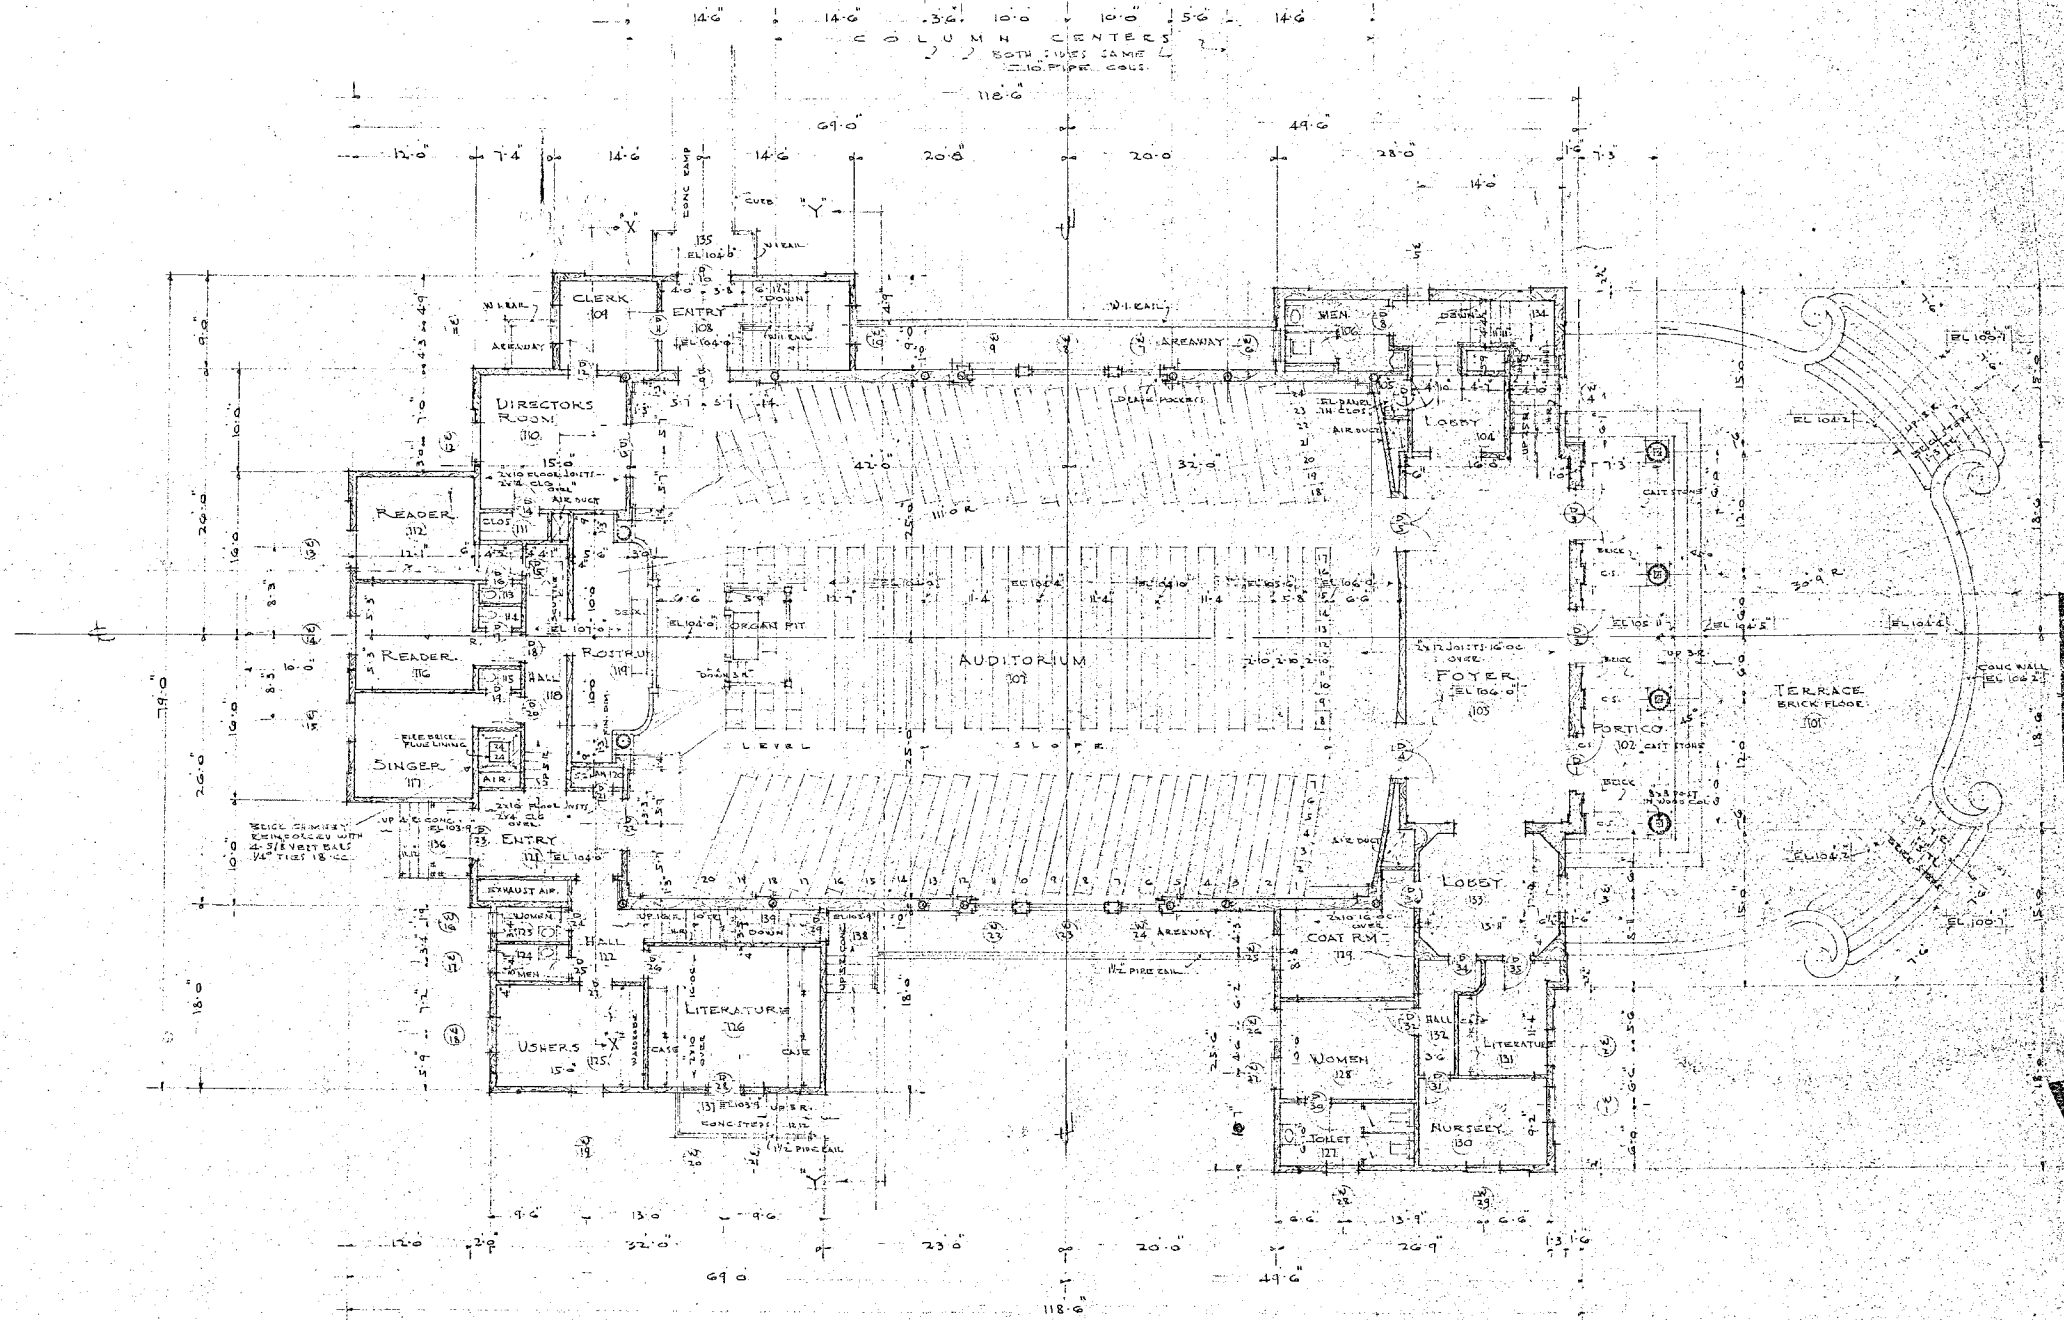
TITLE OF SHEET FOUNDATION PLAN		
DATE 10-16-38	PAUL R. WILLIAMS ARCHITECT	SHEET NUMBER 2
SCALE 1/8" = 1'-0"		
MADE BY E. C. D.	3429 WILSHIRE BOULEVARD LOS ANGELES, CALIF.	
TRACED BY	TITLE OF BLDG. FIRST CHURCH OF CHRIST, SCIENTIST RENO, NEVADA	
CONTRACTORS MUST VERIFY ALL DIMENSIONS BEFORE STARTING WORK

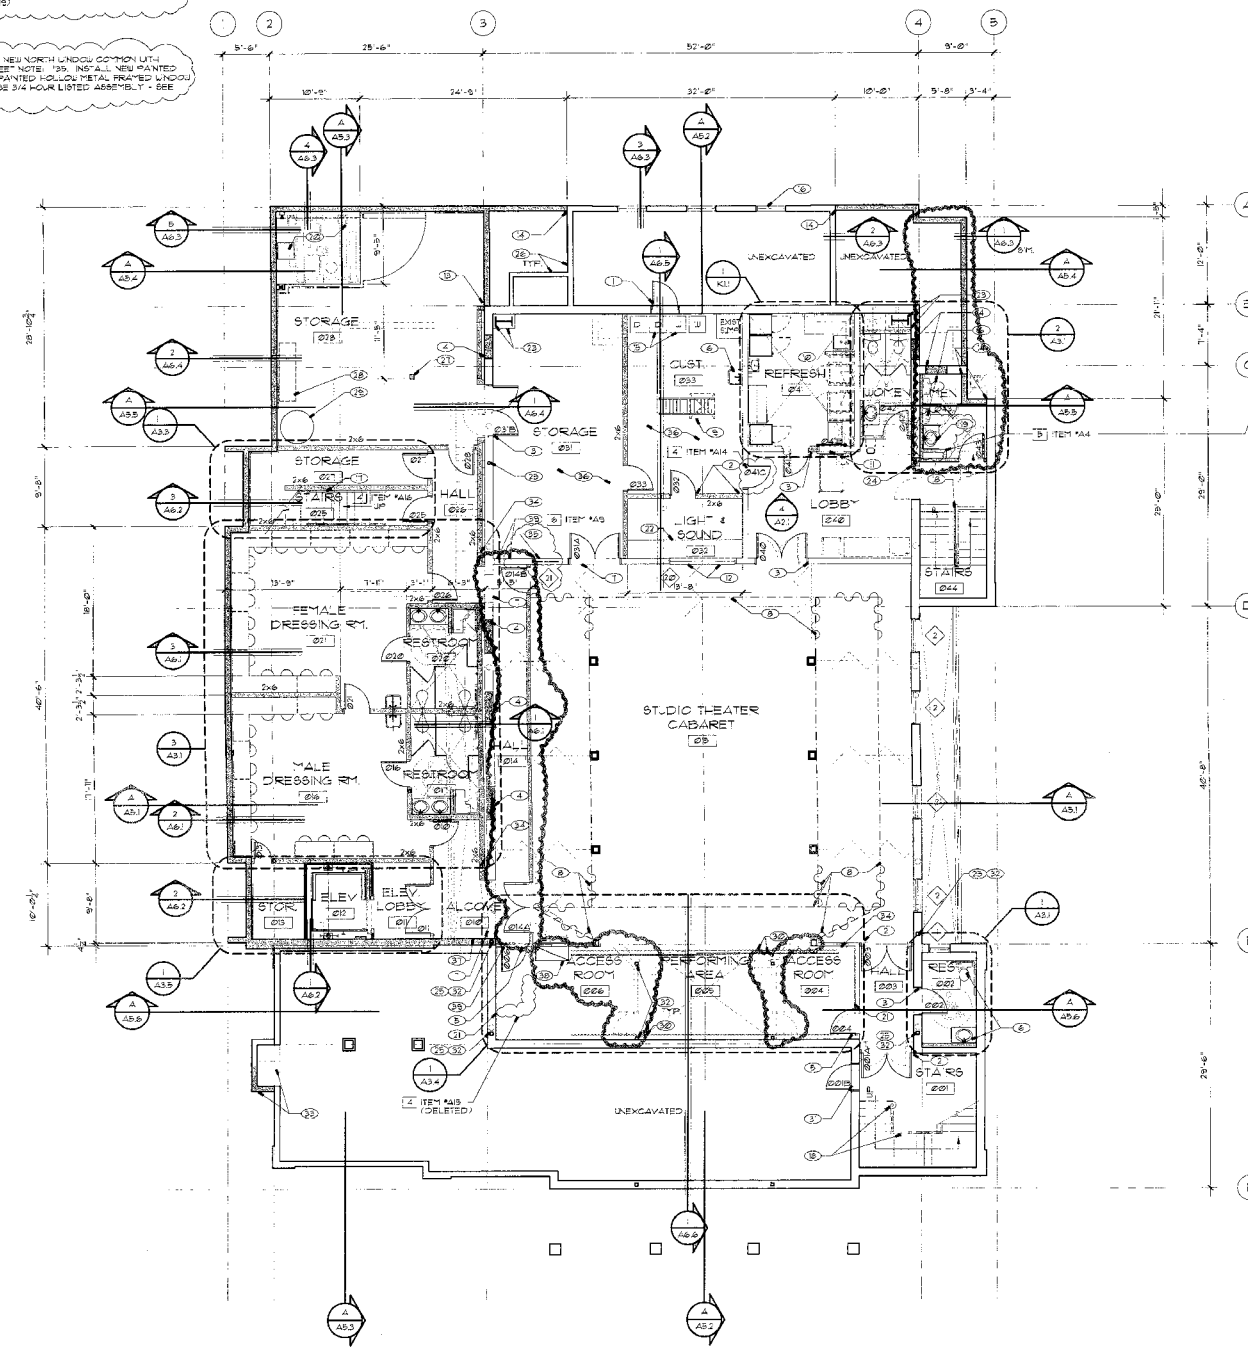
existing/ new basement plan 1/8" x 1'-0" 1
