C I T Y O F
RENO
Memorandum

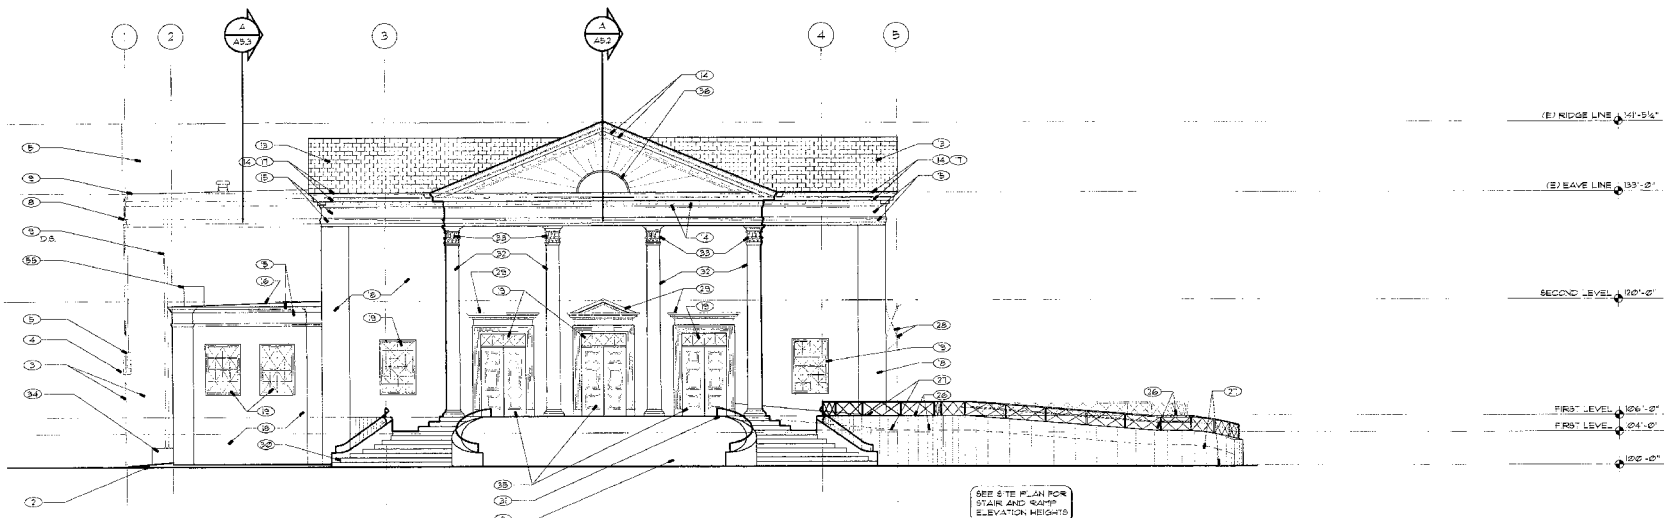
- 5 INSTALL NEW WALL CAP - SEAL PENETRATION LATER TIGHT
- 6 INSTALL NEW HVAC UNIT ON NEW CURB WITH CRICKETS AT OP NEW OR EXISTING ROOF
- 7 INSTALL NEW PAINTED ROOF MOUNTED LEATHER-ROOF WITH CRICKETS

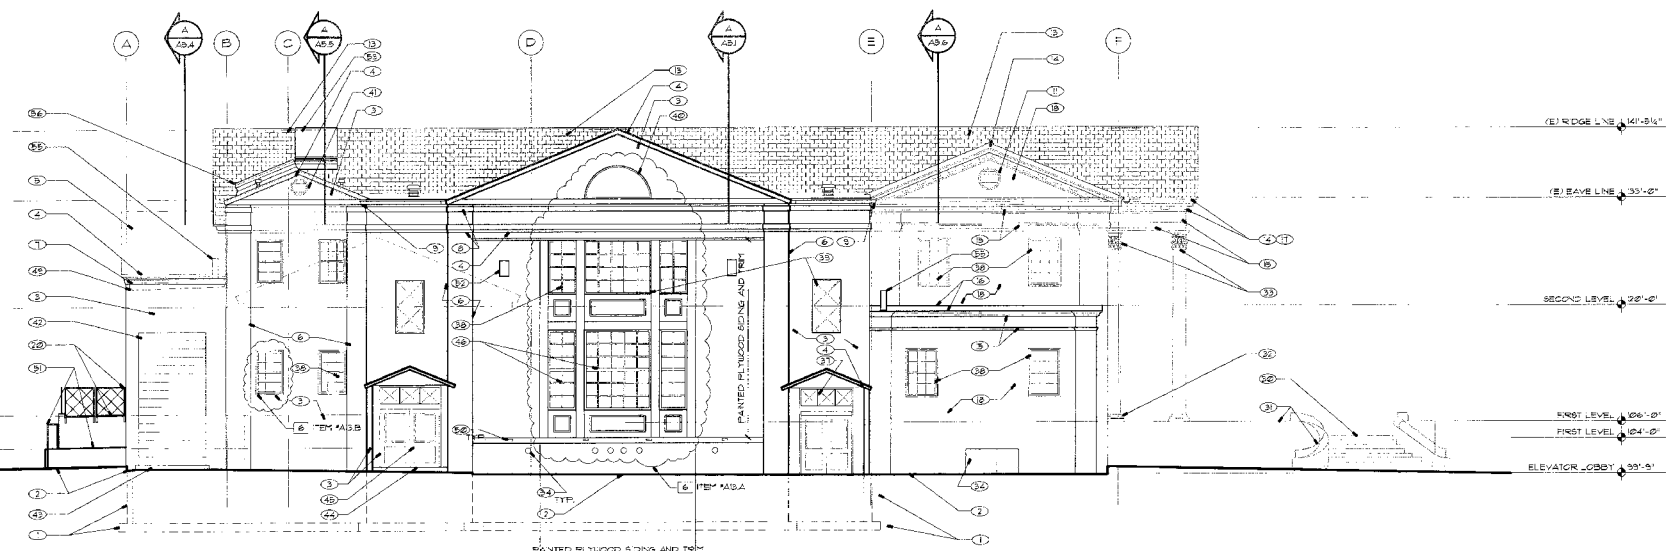
5 | ITEM M25
A. WEST ELEVATION - REVERSE ELEVATION SOUTH OF GRID D. THIS CHANGES TUBE STEEL GRILLEWORK CONFIGURATIONS (ITEM 46) AND FIXED WINDOW CONFIGURATIONS (ITEM 33). THE ABOVE SINGLE HUNG WINDOWS (ITEM 38) AND CHANGES CLERESTORY WINDOWS TO HALF ROUND (ITEM 40). THIS ALSO CHANGES CEMENT PLASTER FINISHES TO PAINTED PLYWOOD SIDING WITH PAINTED TRIM WORK - SEE 3/16/16.
B. WEST ELEVATION - REVERSE ELEVATION NORTH OF GRID C. ADD HALF WINDOWS TO EMULATE SINGLE HUNG WINDOW (ITEM 38).

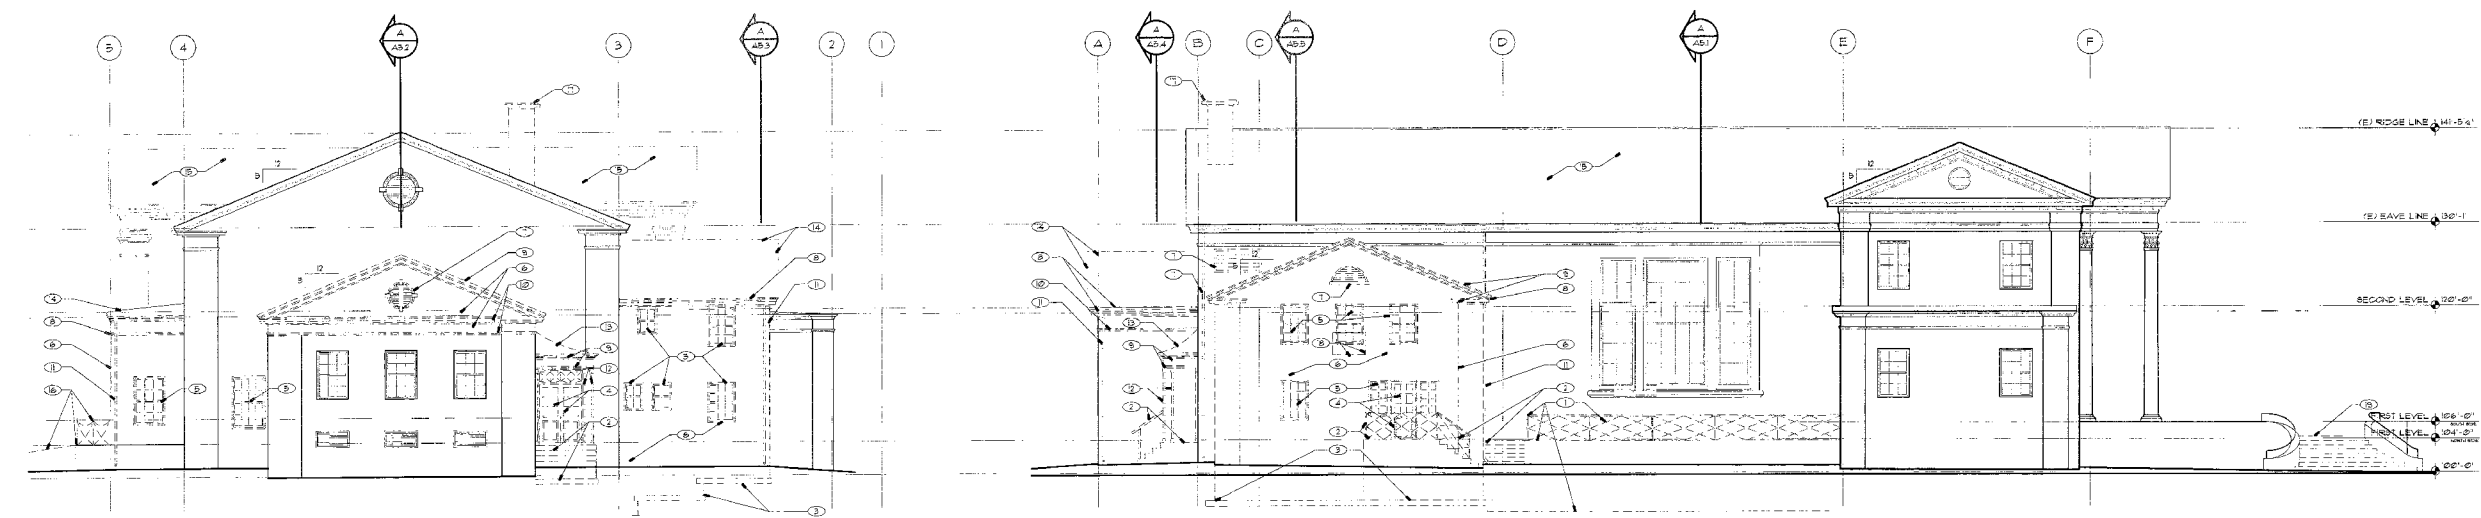
- ⑱ DASHED LINES INDICATE (E) STEEL FIRE ESCAPE LADDER TO BE REMOVED IN ITS ENTIRETY.
- ⑳ DASHED LINES INDICATE (E) CONCRETE STAIRS AND TERRACE TO BE REMOVED AND REPLACED IN THEIR ENTIRETY. - SEE 8/12/02.

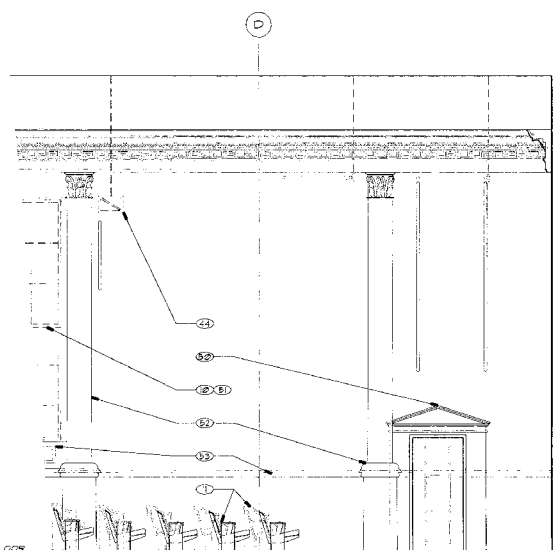
partial west interior elevation - auditorium 1010 1/4" = 1'-0" 1

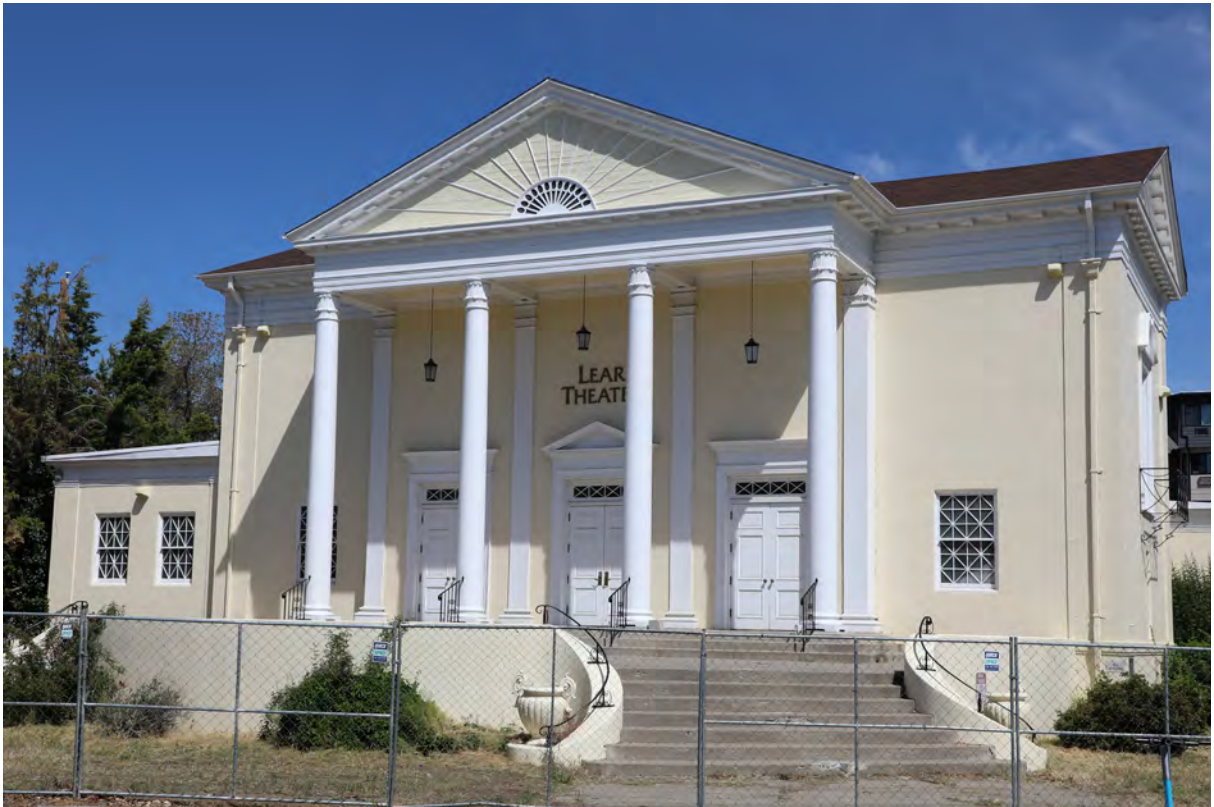
Figure 01 - Lear Theater, primary (south) façade, view north (ARG, 2024)

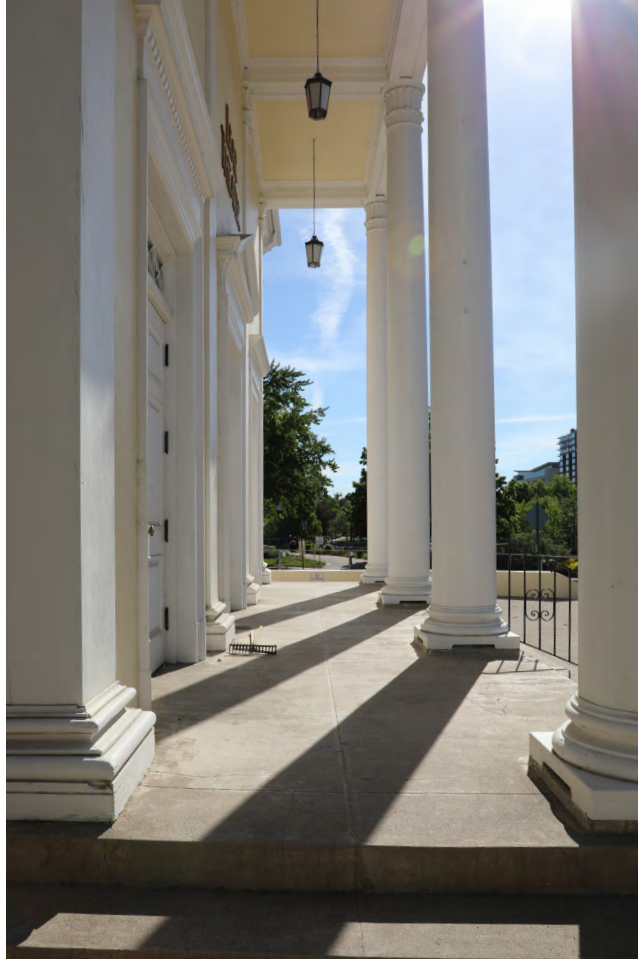
Figure 02 - Porch at primary (south) façade, view east (ARG, 2024)

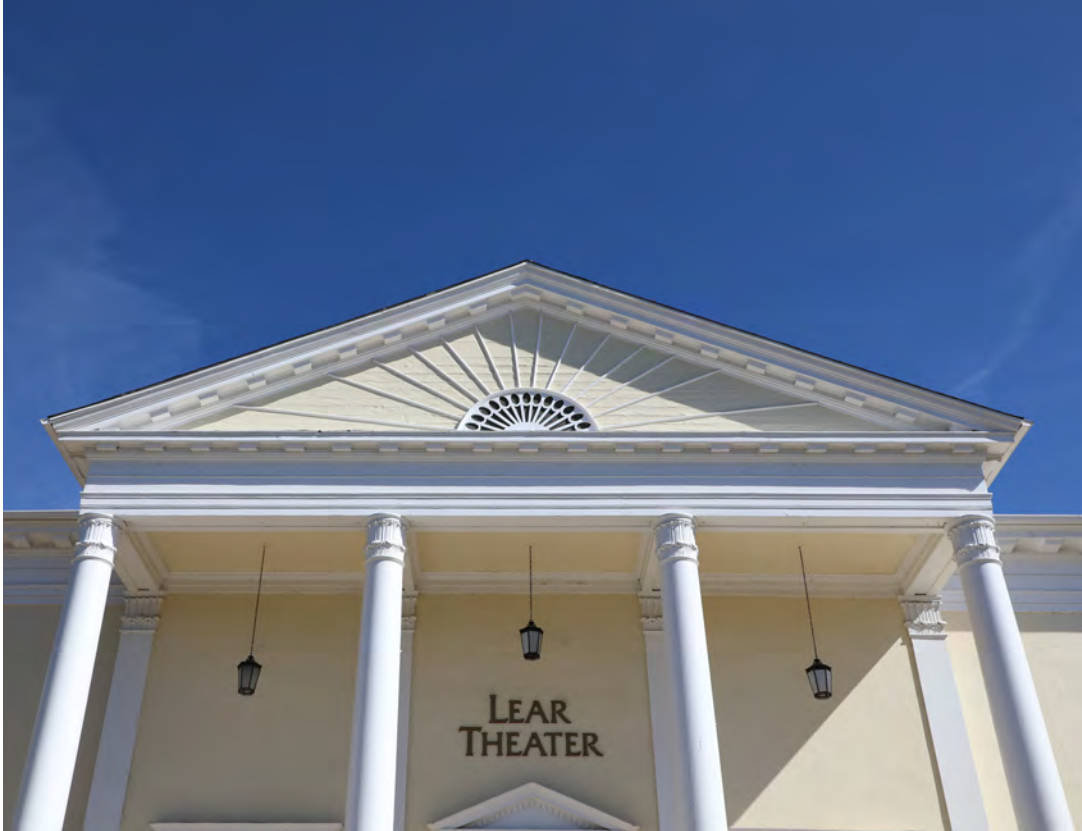
Figure 03 - Gable end at primary (south) façade, view north(ARG, 2024)

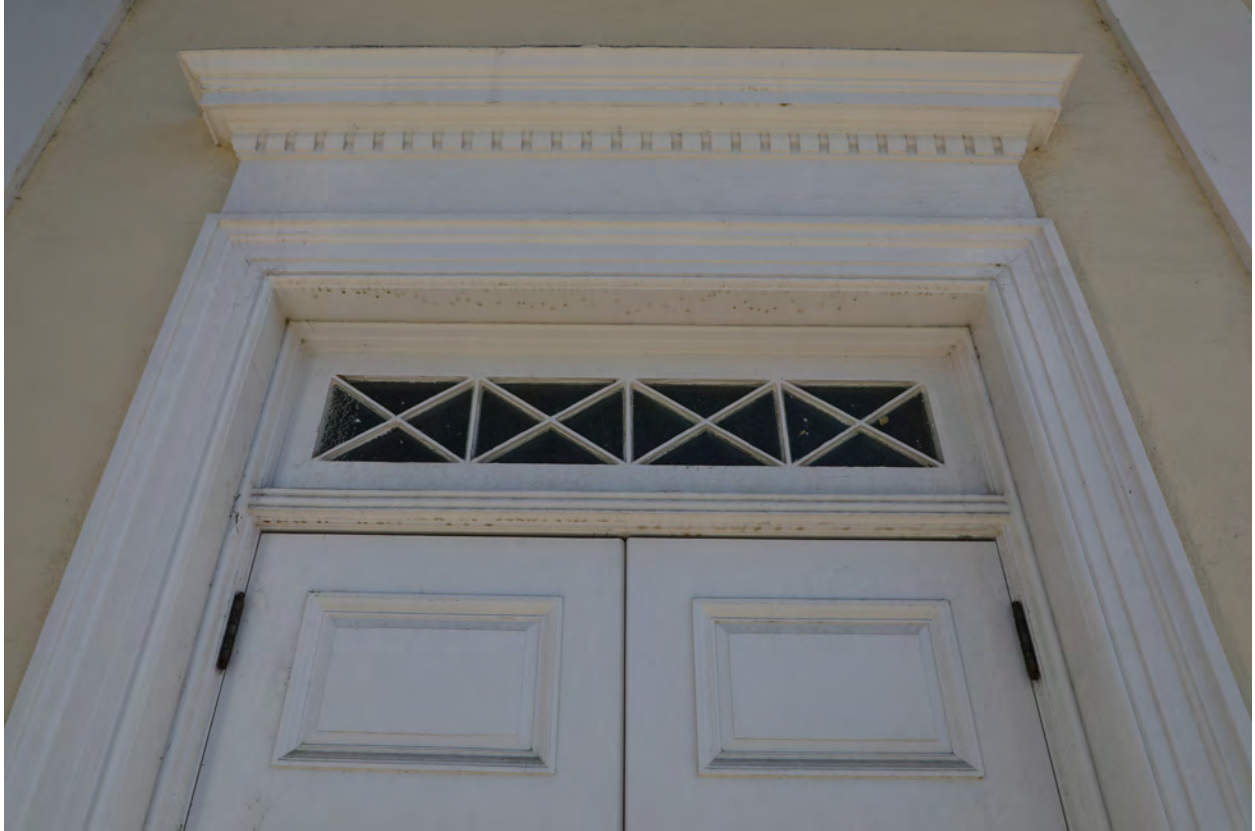
Figure 04 - Detail of entry at primary (south) façade, view north (ARG, 2024)

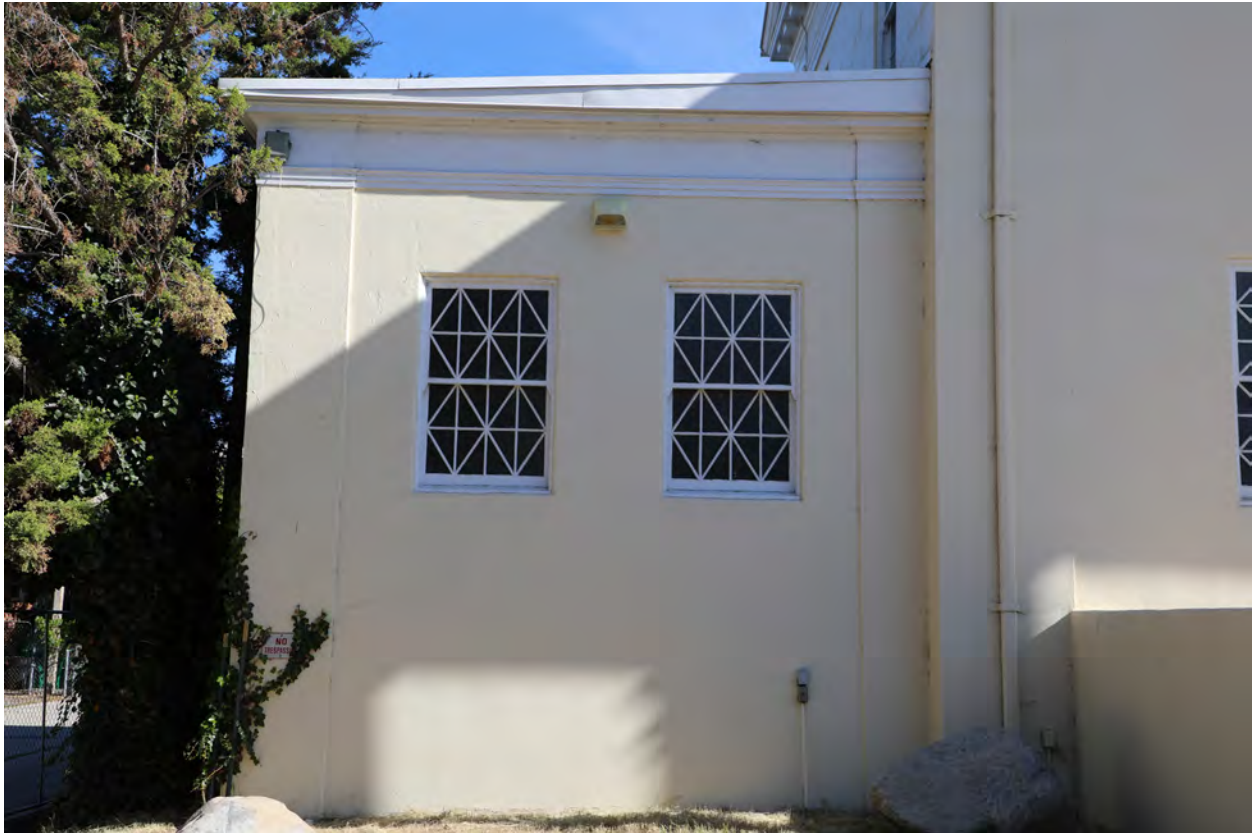
Figure 05 - West portion of primary (south) façade, view north (ARG, 2024)

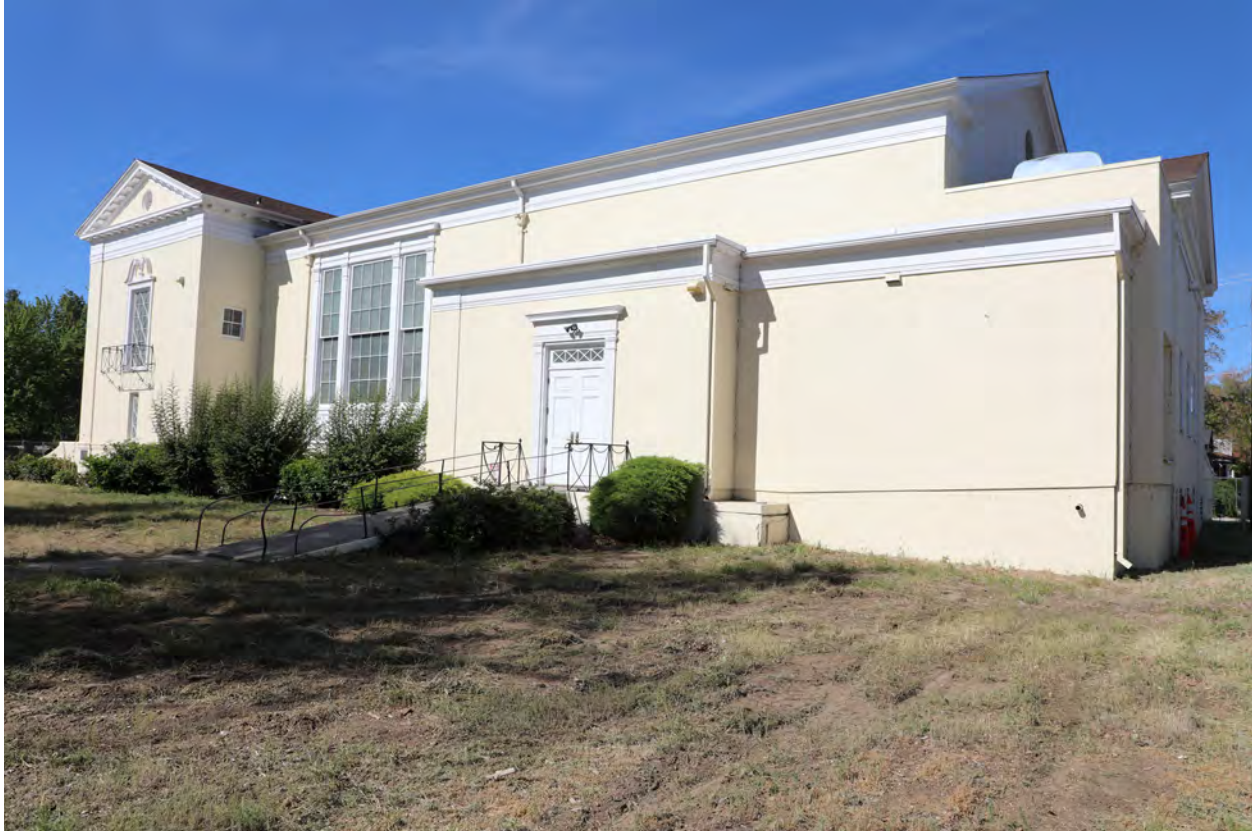
Figure 06 - East façade, view southwest (ARG, 2024)

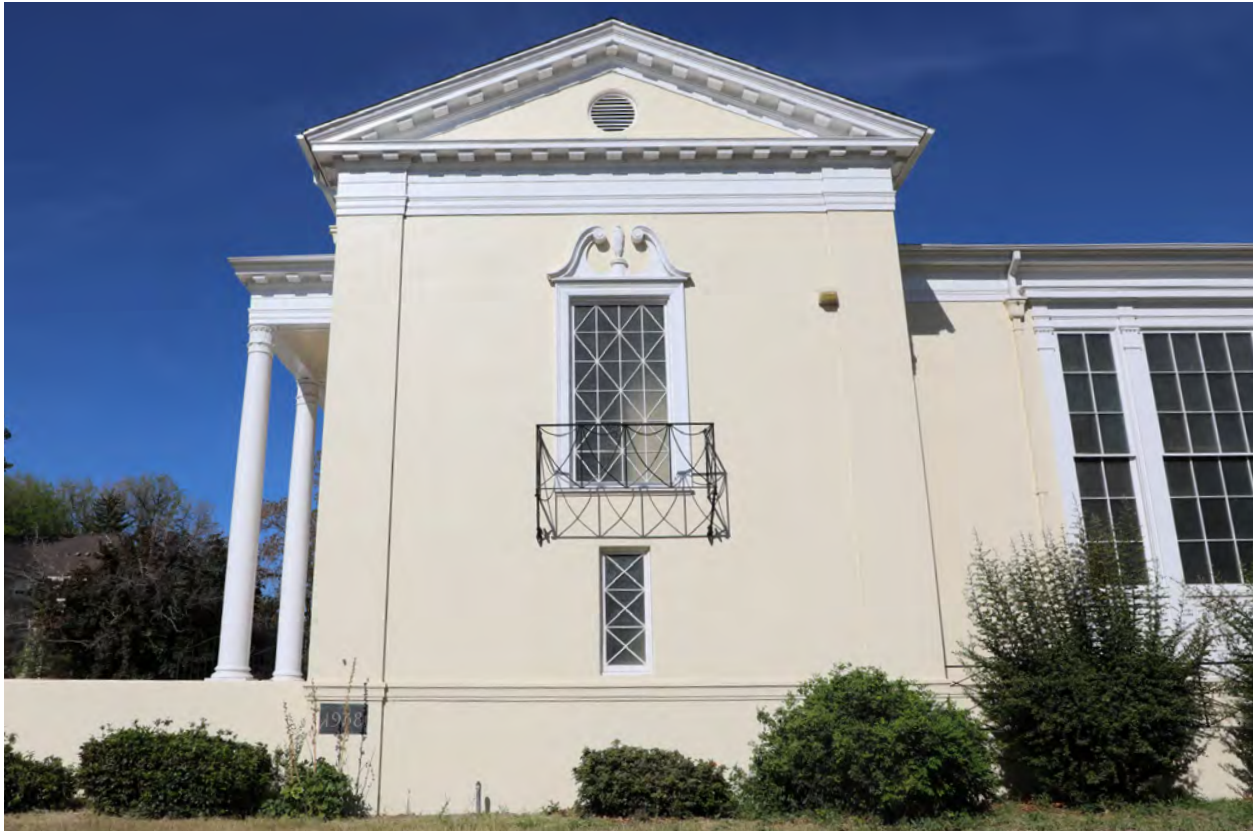
Figure 07 - Southern portion of east façade, view west (ARG, 2024)

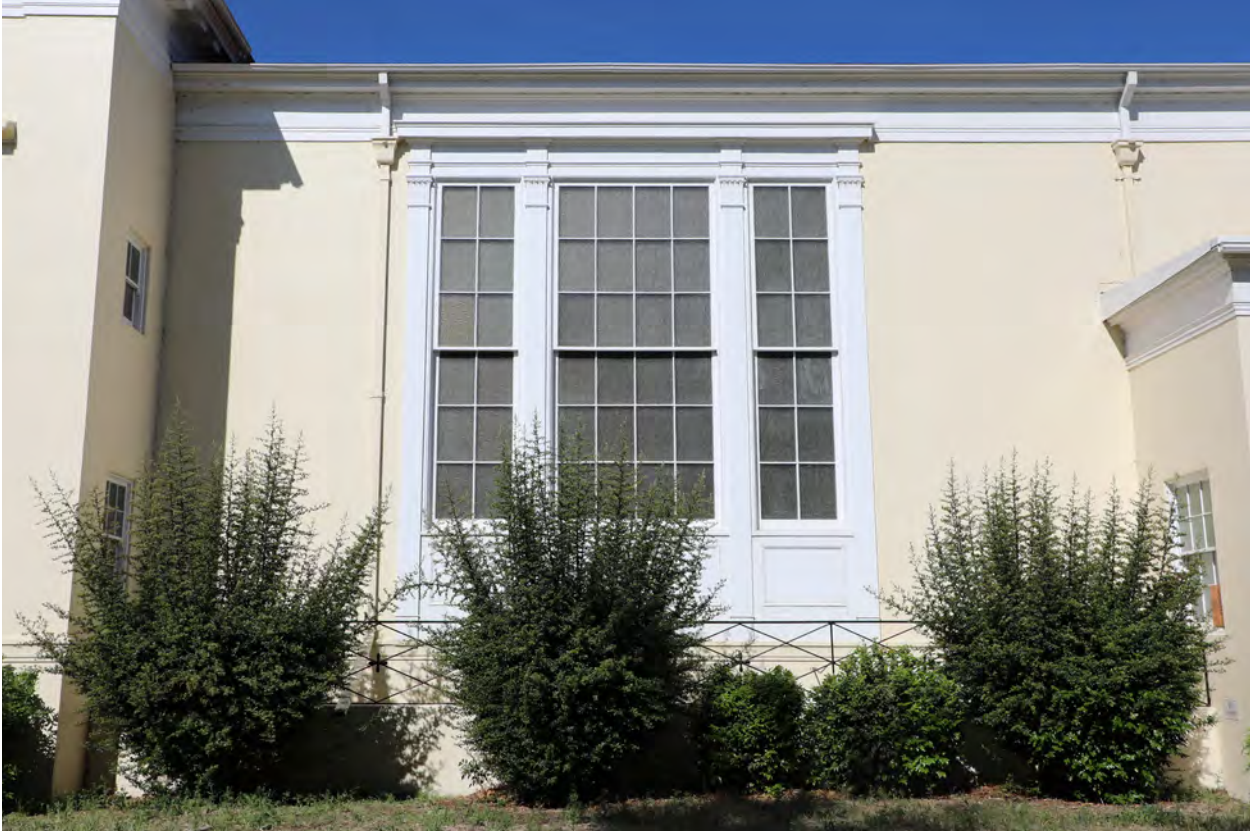
Figure 08 - Central portion of east façade, view west (ARG, 2024)

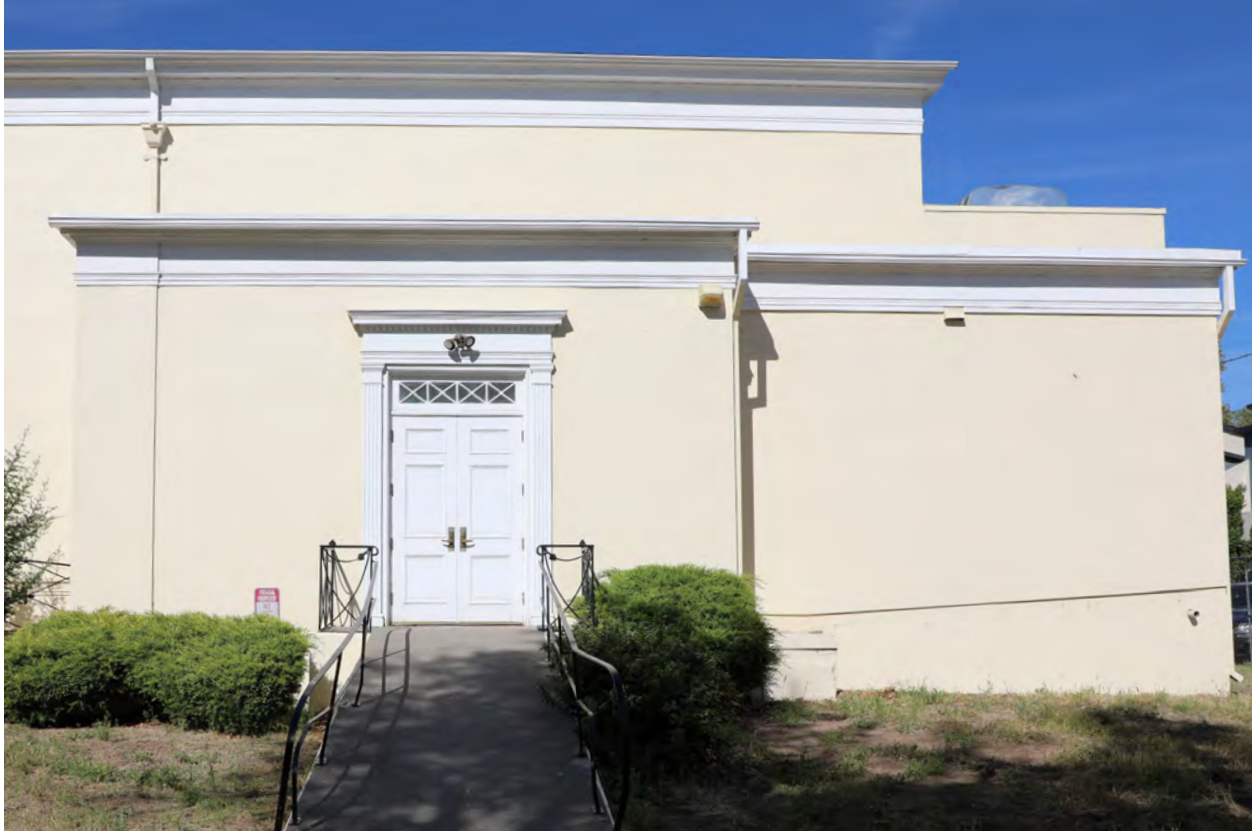
Figure 09 - Northern portion of east façade showing 2002 addition on the right, view west (ARG, 2024)

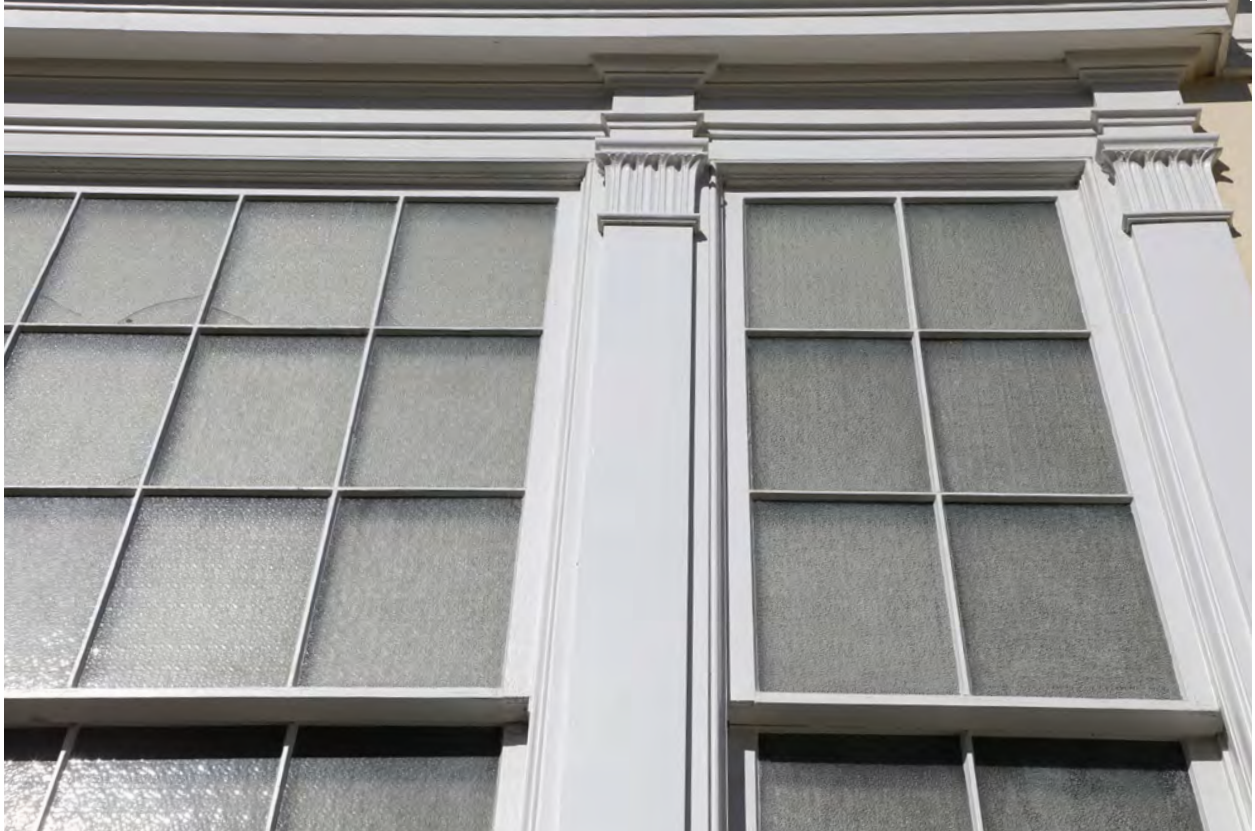
Figure 10 - Detail of large central window at east facade, view west. (ARG, 2024)

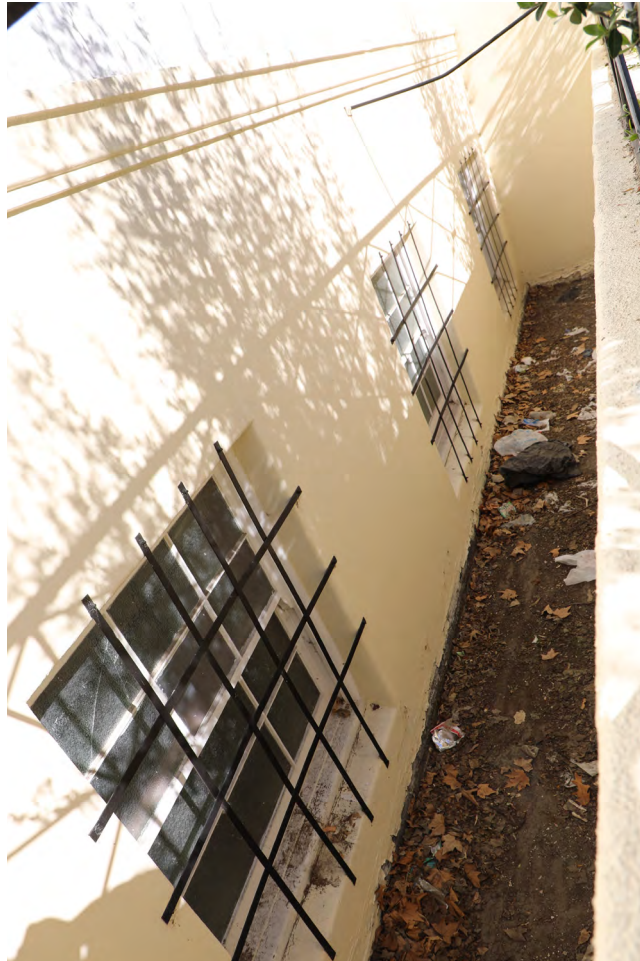
Figure 11 - View into areaway at basement windows along the east facade, view north (ARG, 2024)

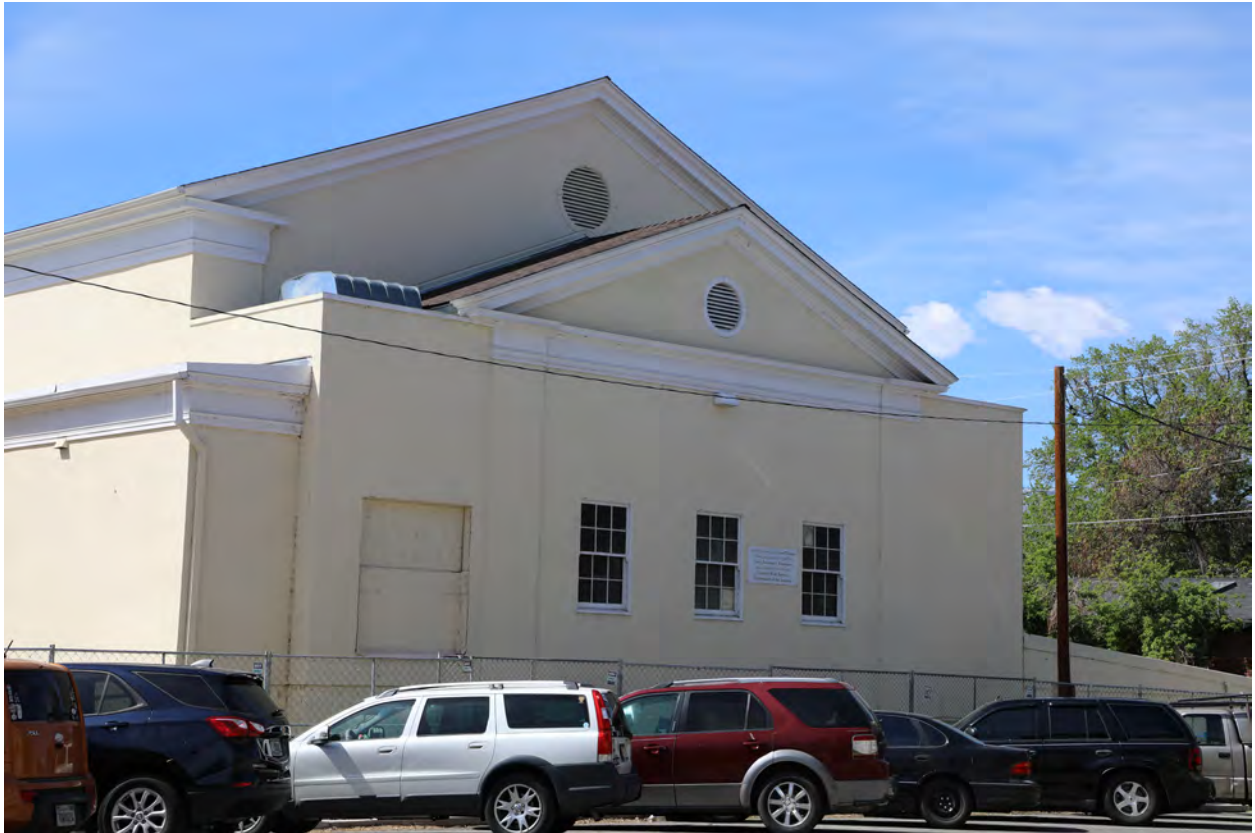
Figure 12 - Rear (north) façade, view southwest (ARG, 2024)

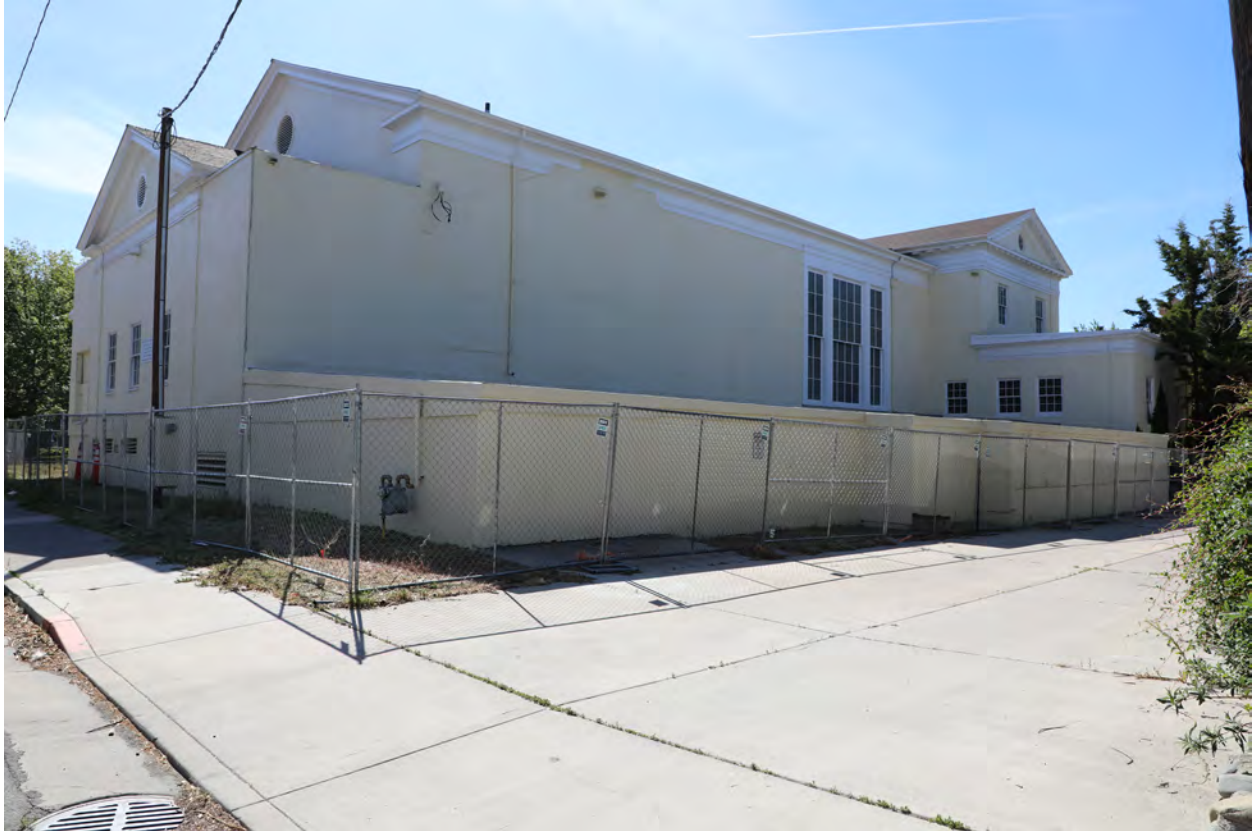
Figure 13 - West facade showing incomplete 2002 addition, view southeast (ARG, 2024)

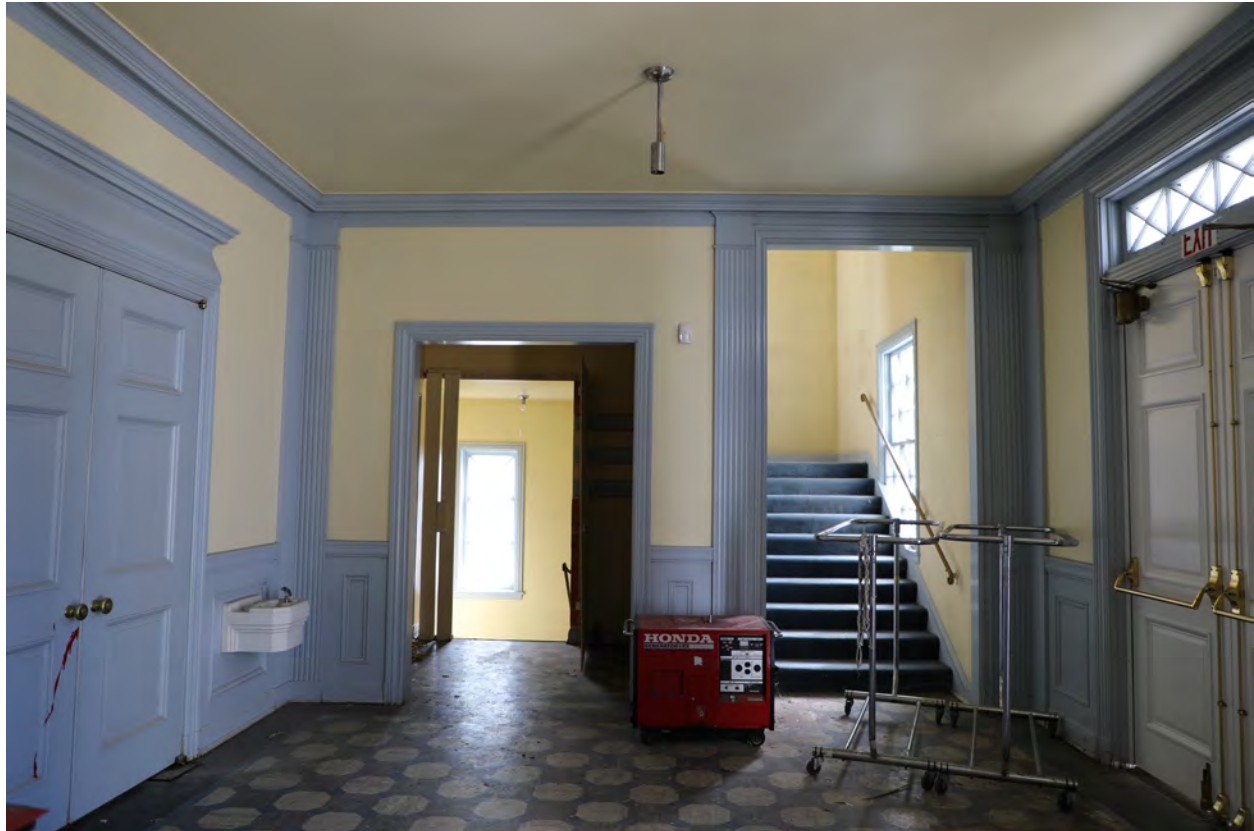
Figure 15 - Foyer, view east (ARG, 2024)

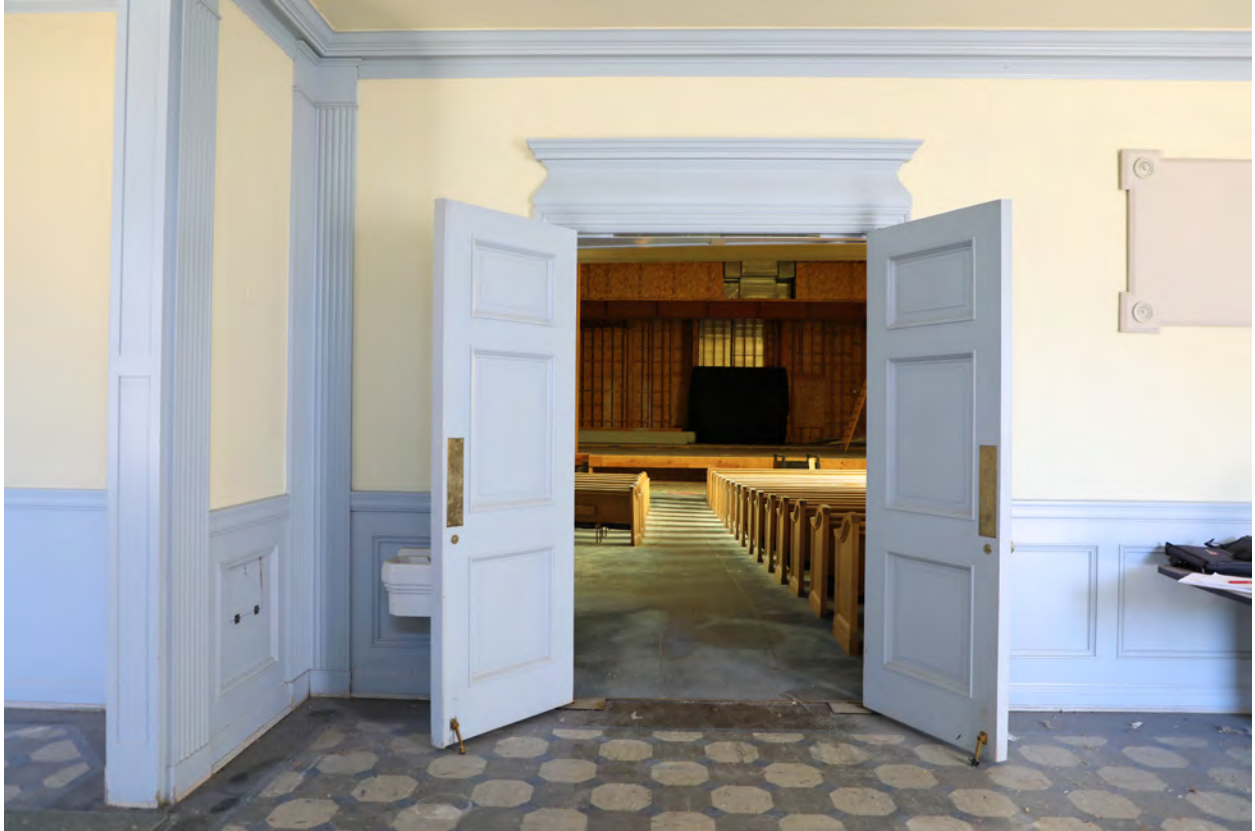
Figure 16 - Foyer, looking into theater, view north (ARG, 2024)

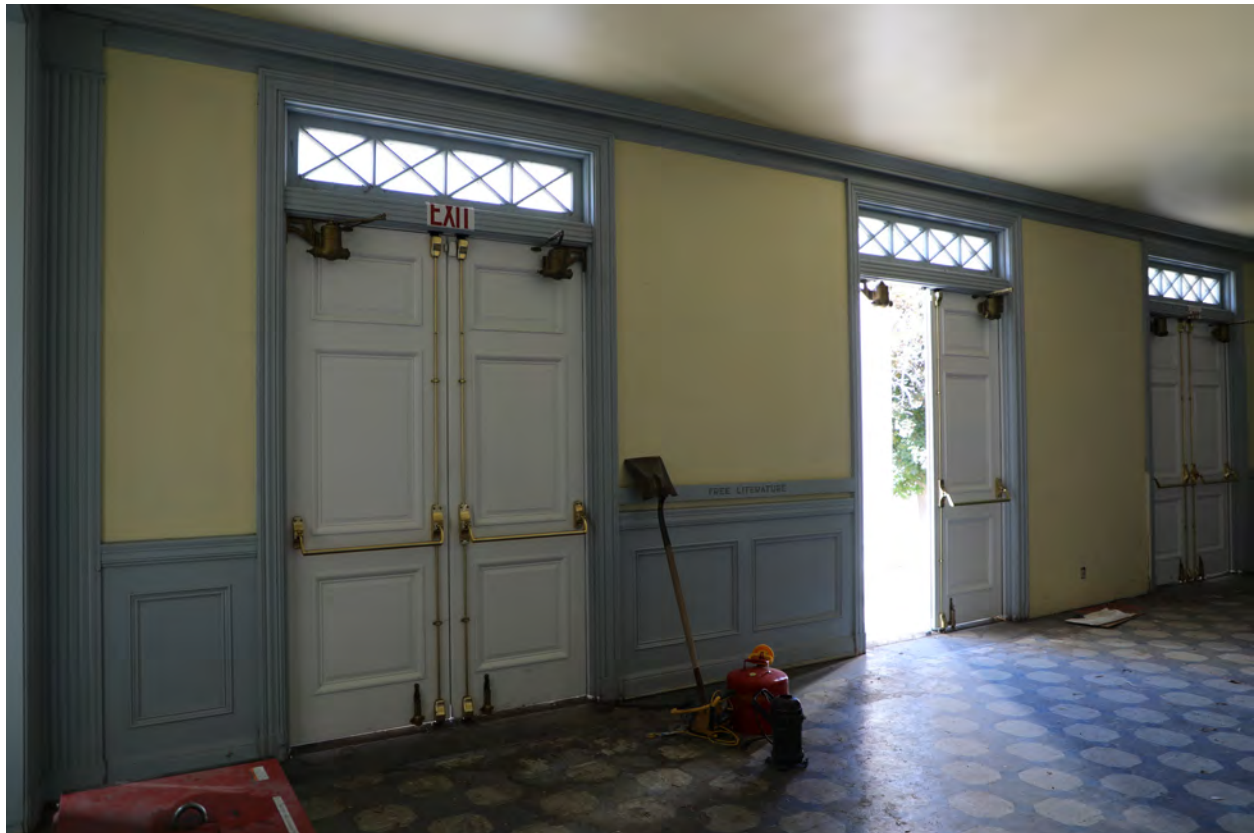
Figure 17 - Foyer, looking toward entry doors, view southwest (ARG, 2024)

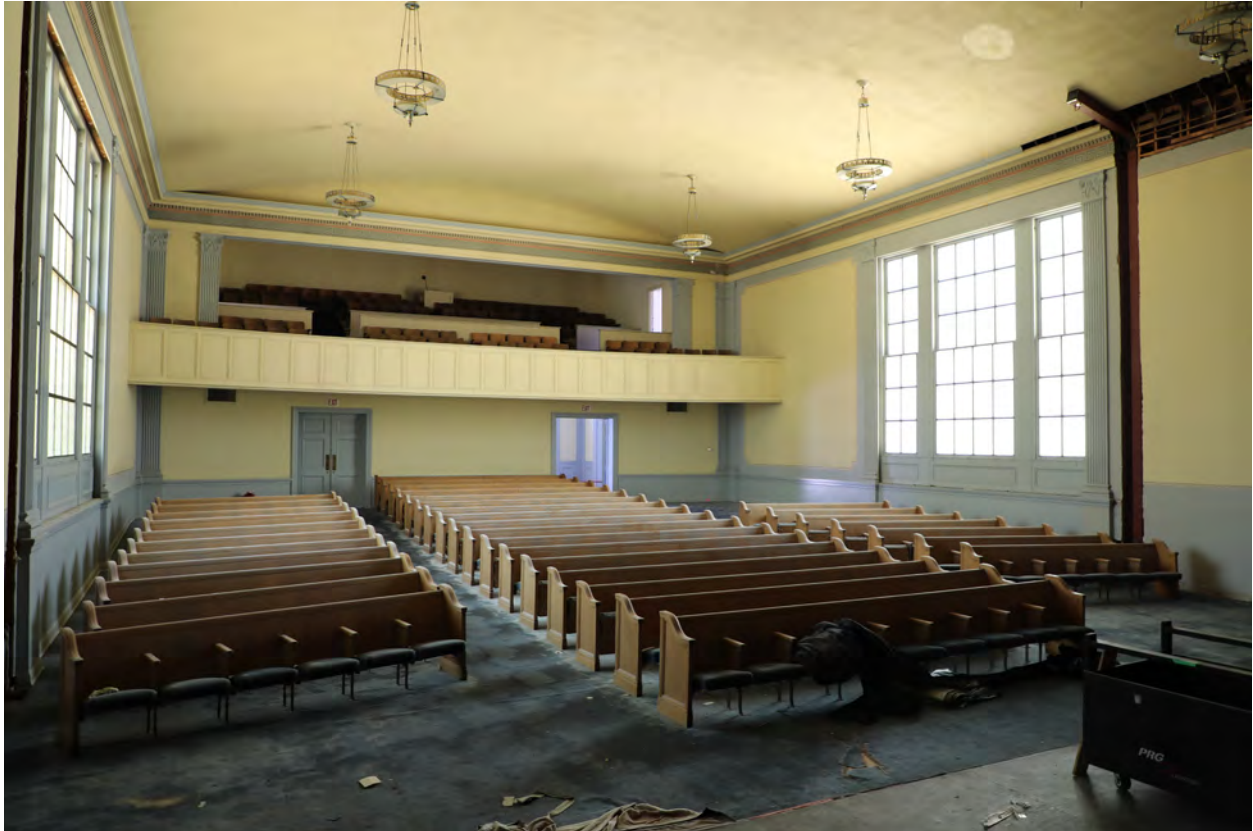
Figure 18 - Auditorium, from the stage, view southwest (ARG, 2024)

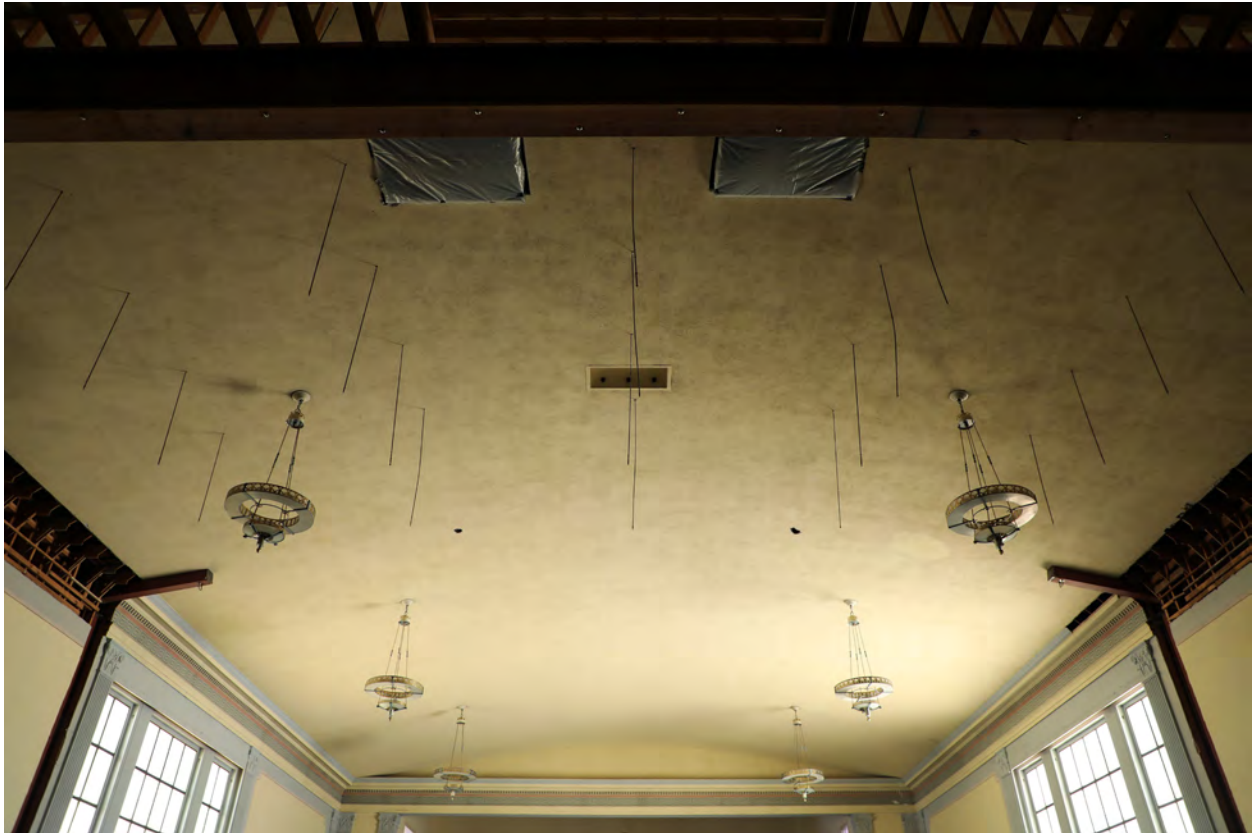
Figure 19 - Auditorium ceiling, view south (ARG, 2021)

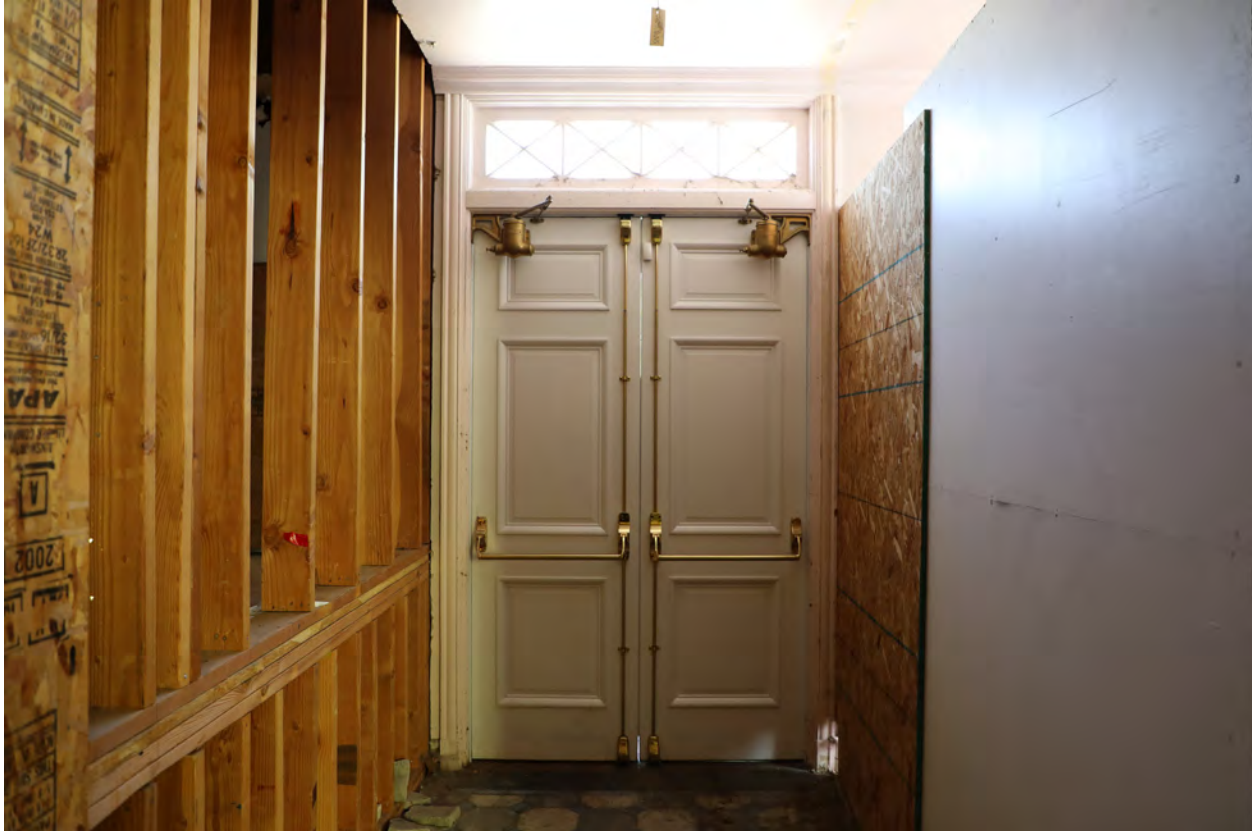
Figure 20 - East entryway, view east (ARG, 2024)
