C I T Y O F
RENO
Memorandum

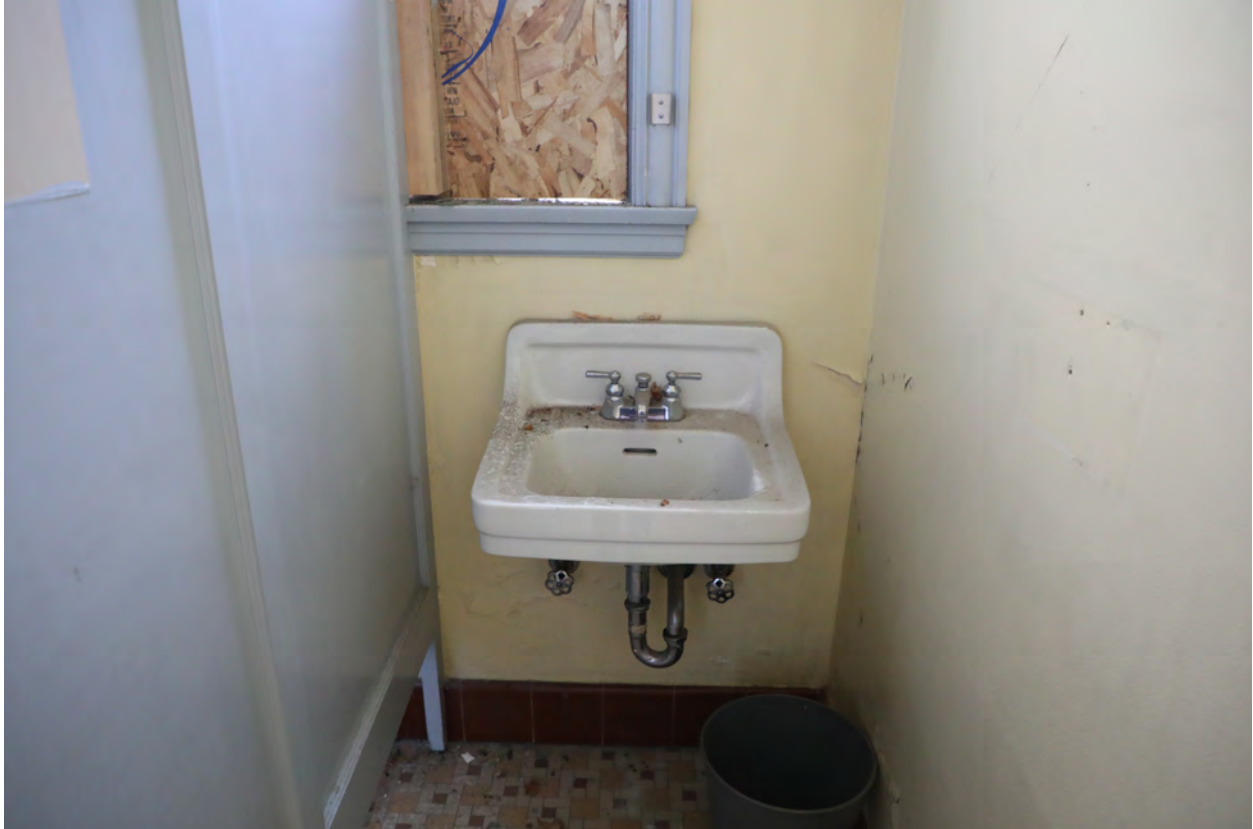
Figure 21 - 1st floor mens restroom, looking at window and sink, view north (ARG, 2024)

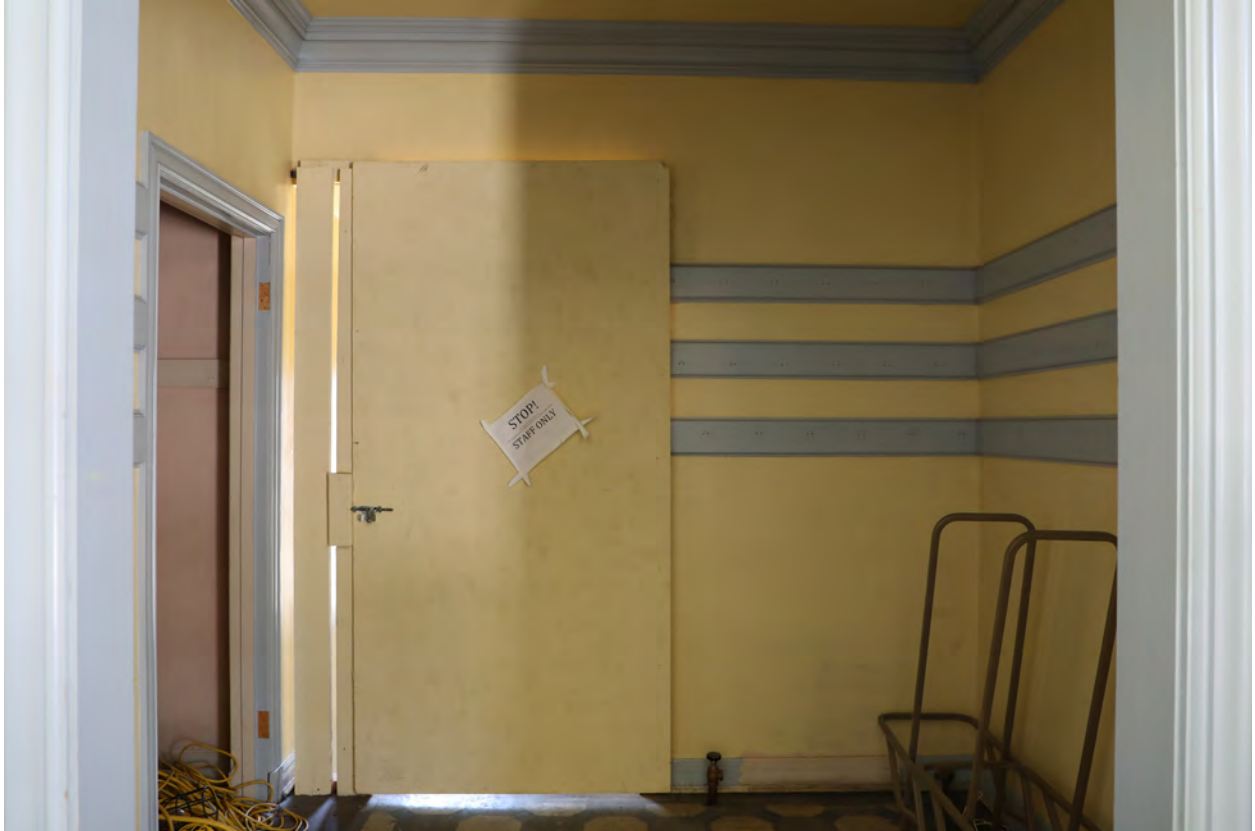
Figure 22 - Looking from foyer at temporary door in east lobby, view east (ARG, 2024)

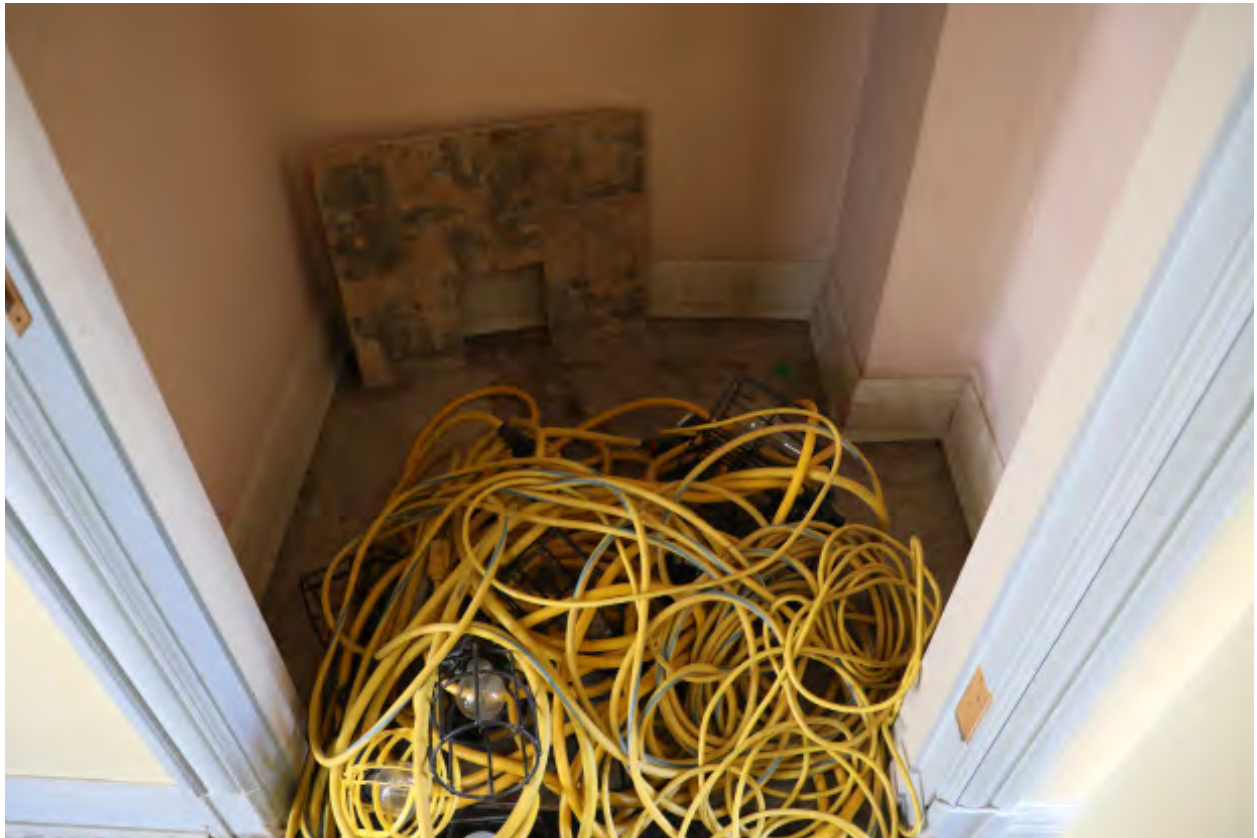
Figure 23 - Closet off of east lobby, view north (ARG, 2024)

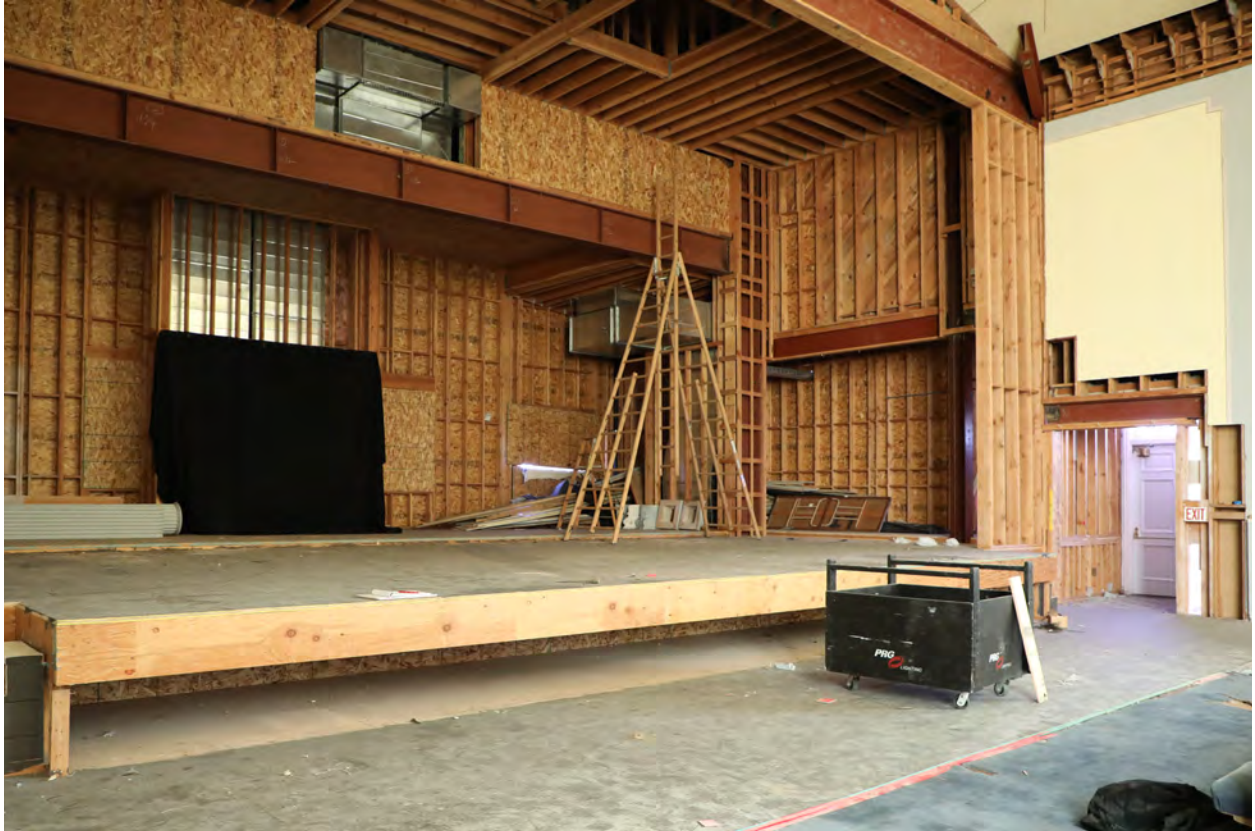
Figure 24 - Looking at stage from auditorium floor, view northeast (ARG, 2024)

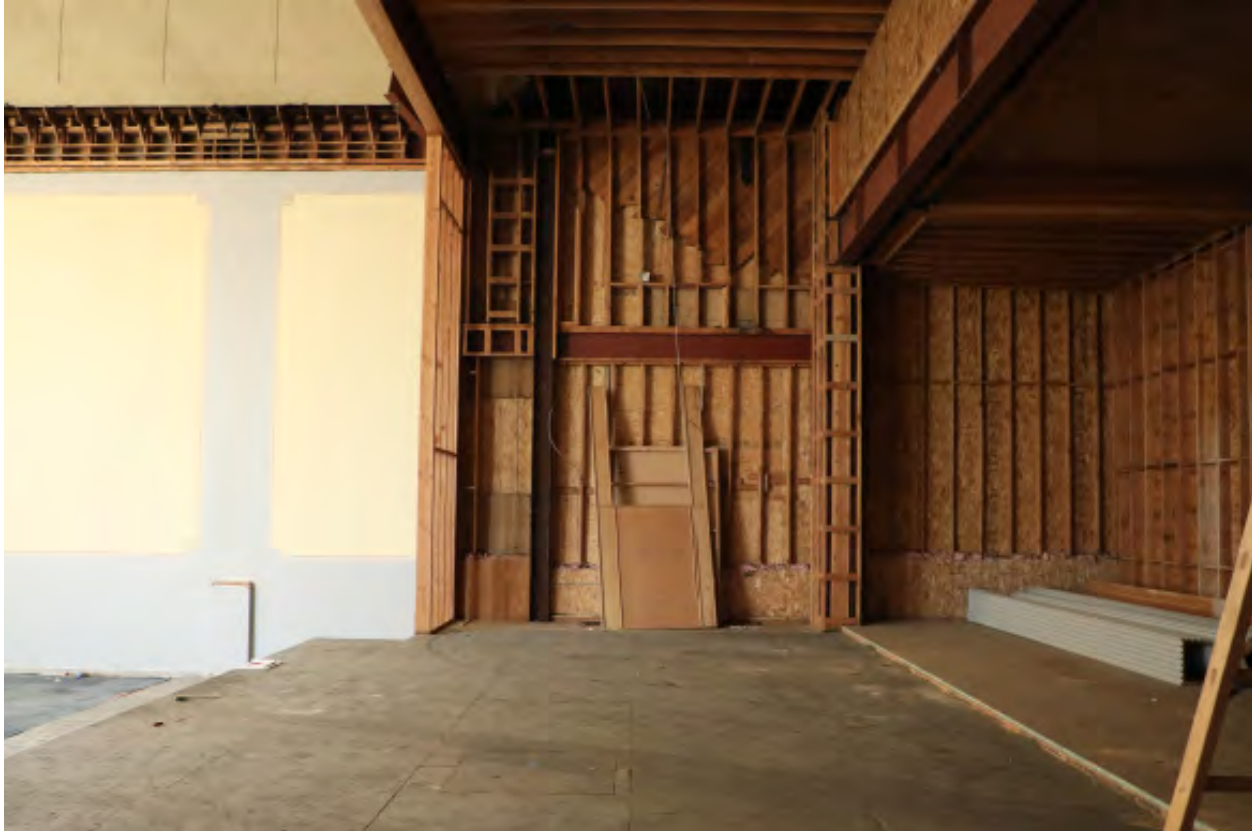
Figure 25 - looking west from east end of stage (ARG, 2024)

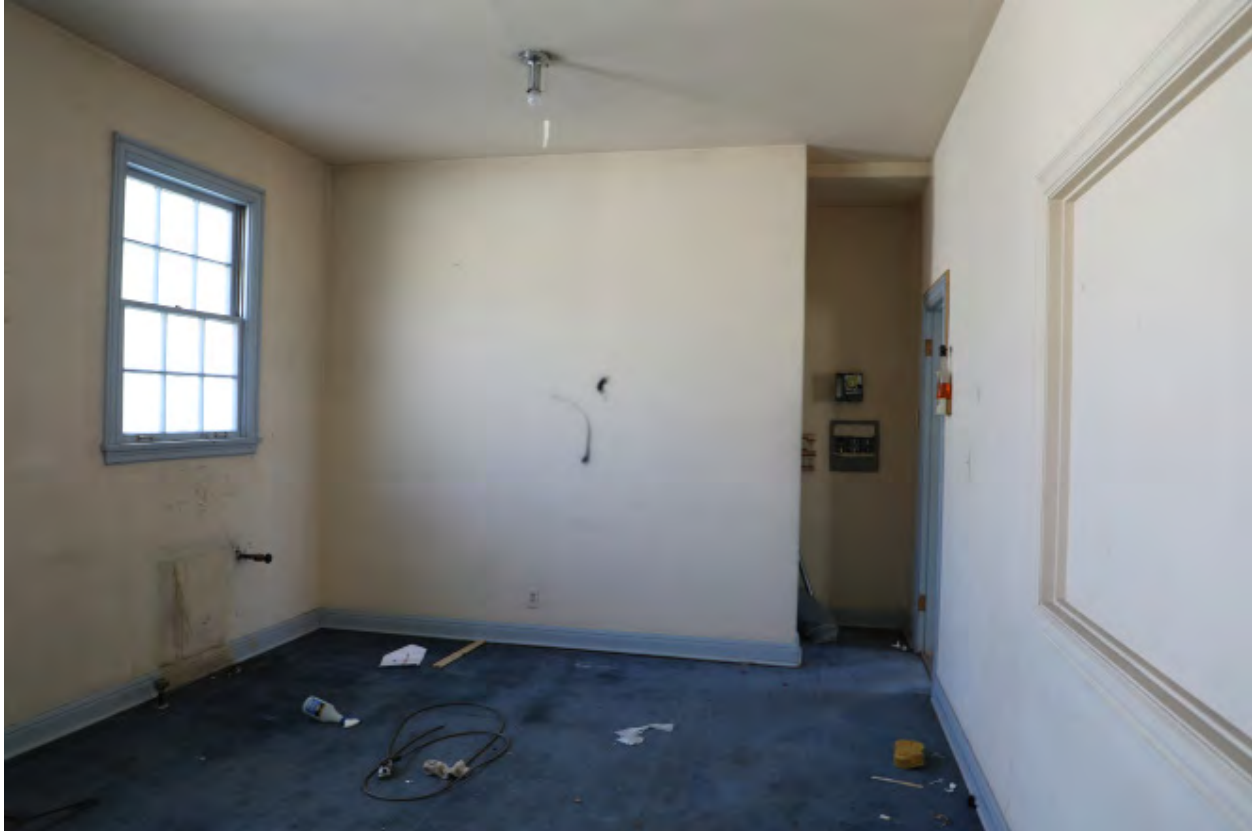
Figure 27 - Coat Room, view east (ARG 2024)

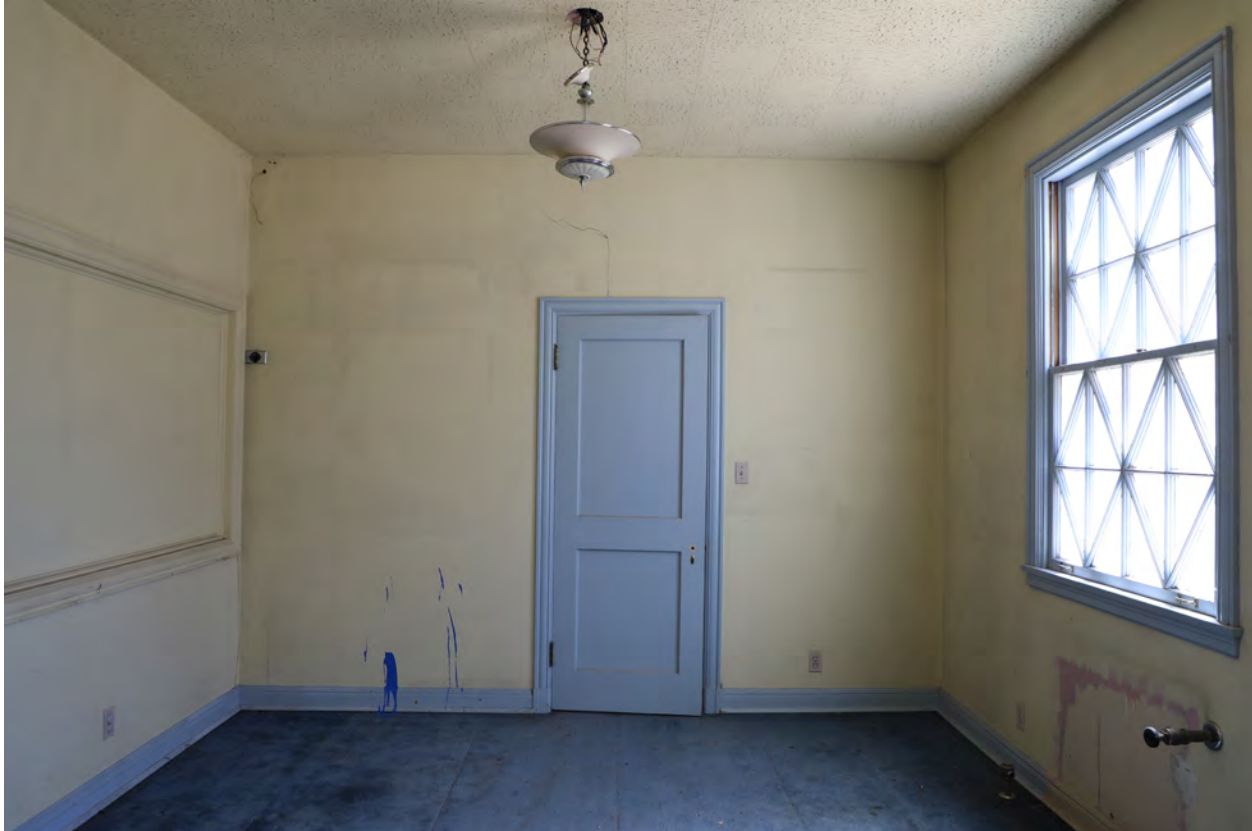
Figure 28 - Literature Room, view east (ARG, 2024)

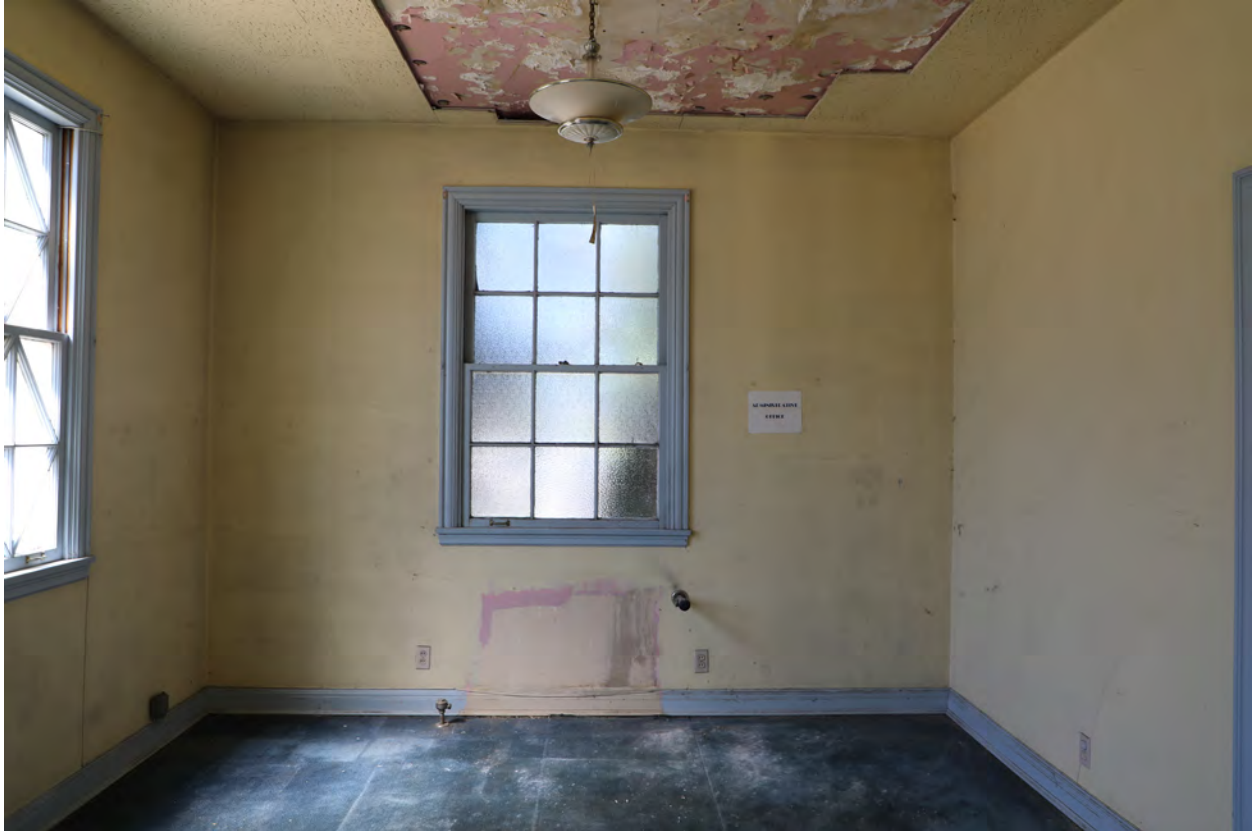
Figure 29 - Literature Room, view west (ARG, 2021)

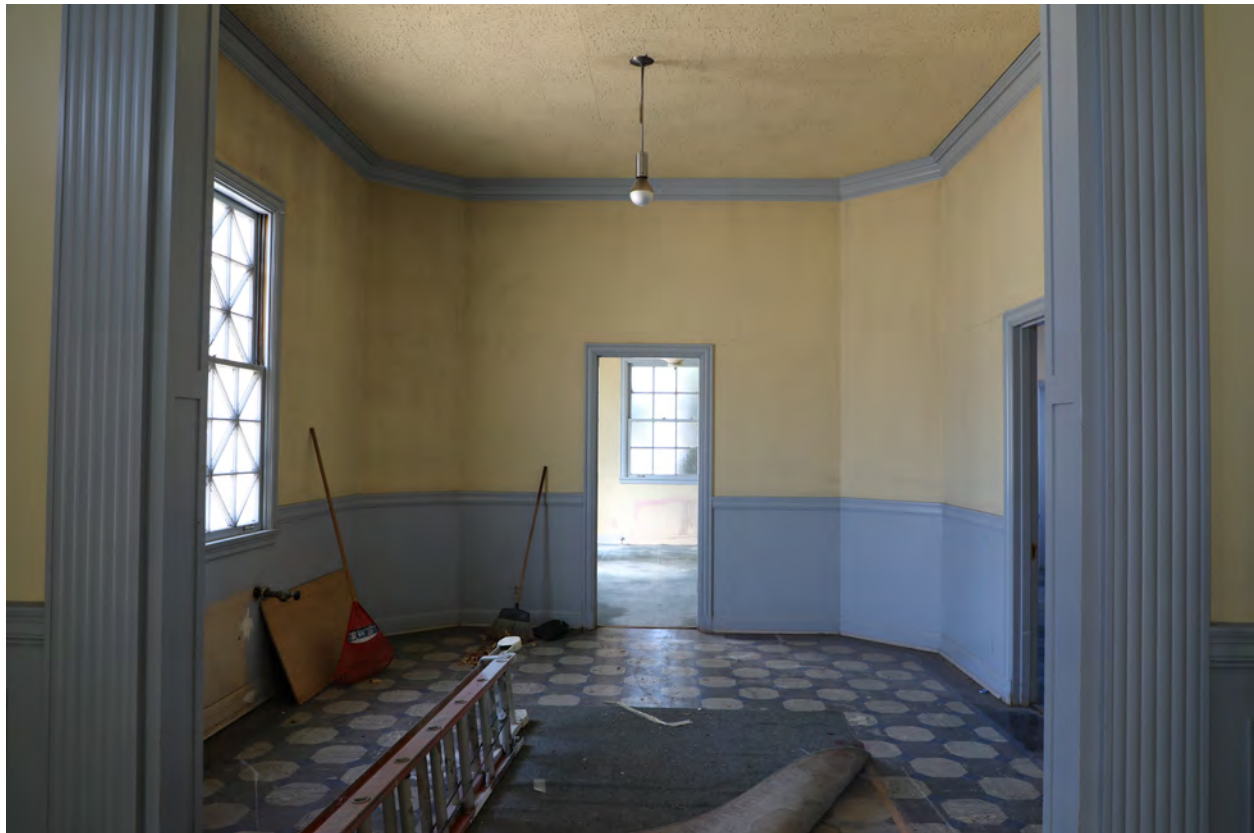
Figure 30 - West Lobby, viewed from the foyer, view west (ARG, 2024)

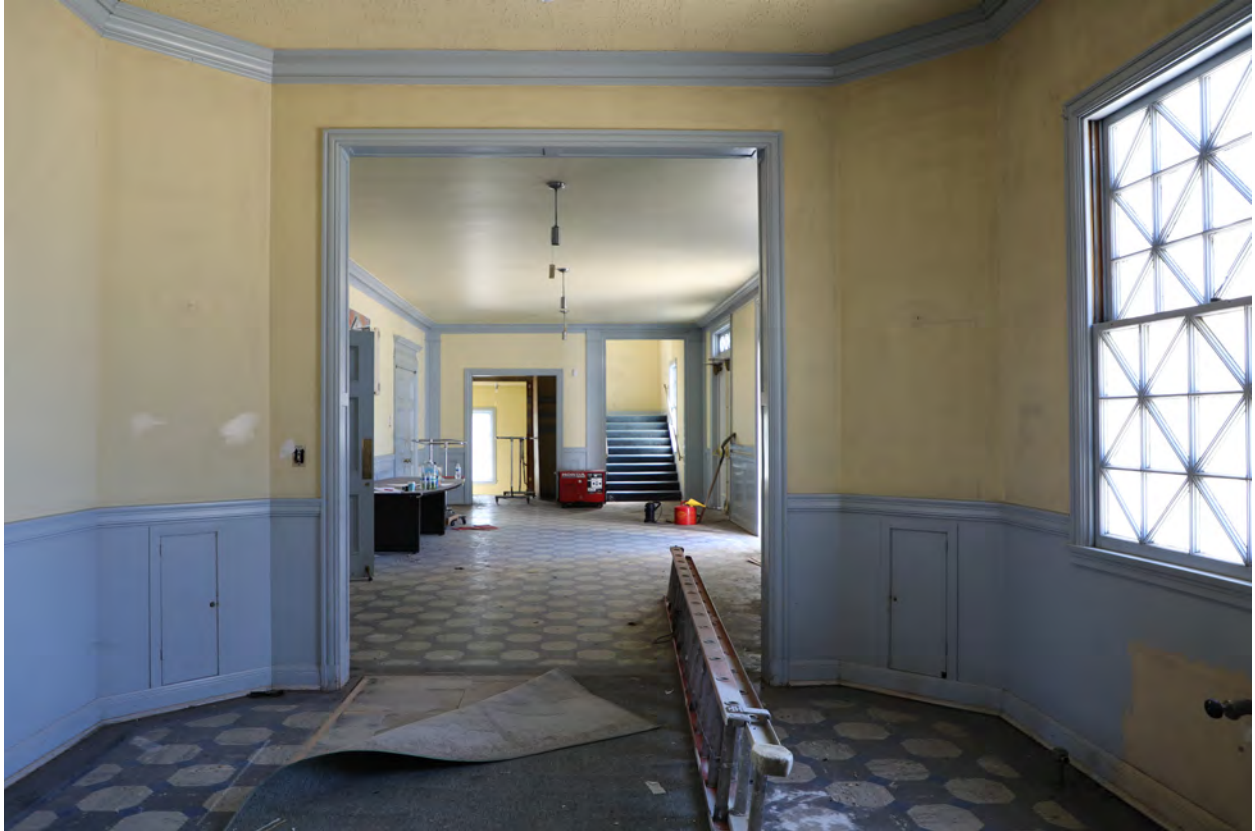
Figure 31 - West Lobby, looking into foyer, view east (ARG, 2024)

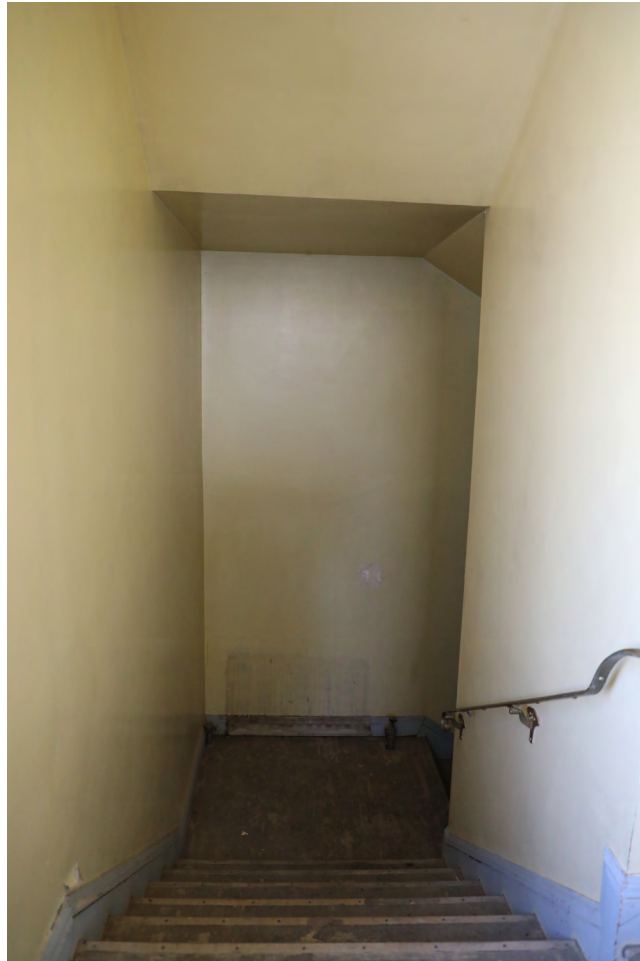
Figure 32 - Southern stairs to basement, view west (ARG, 2024)

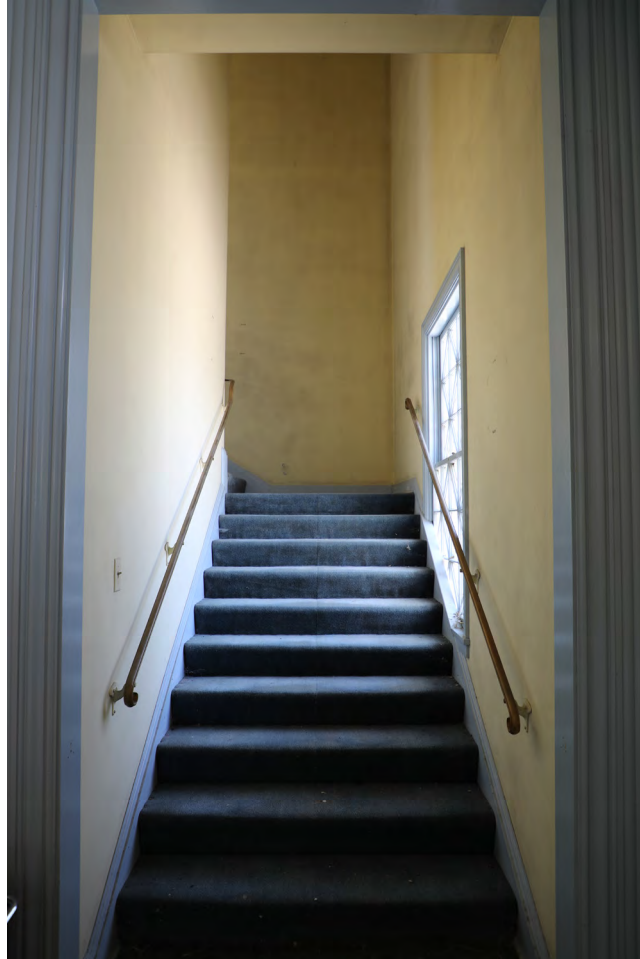
Figure 33 - Stairs to Balcony, from foyer, view east (ARG, 2024)

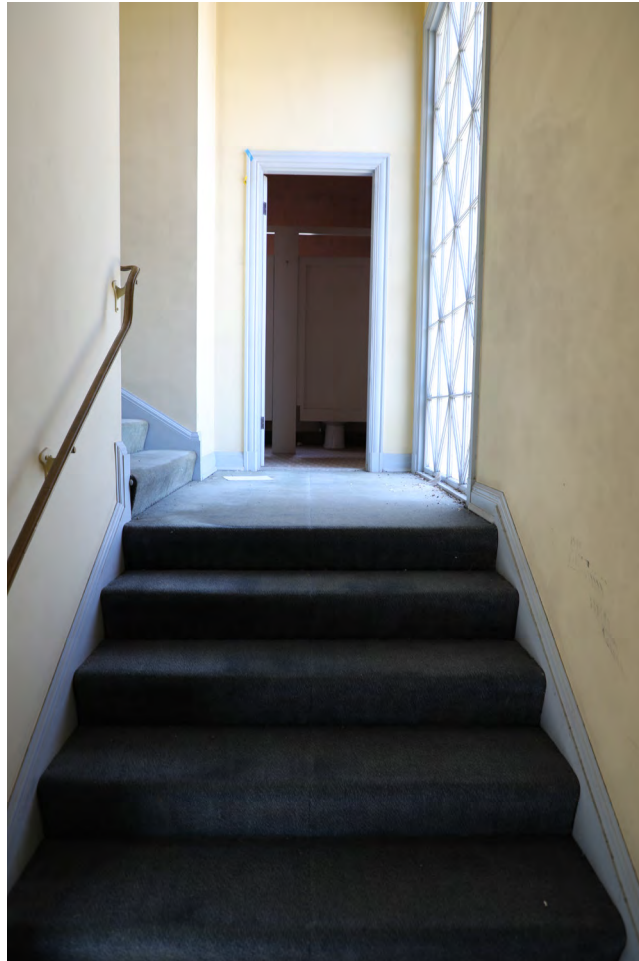
Figure 34 - Stairs to balcony looking from first landing, toward women's restroom, view north (ARG, 2024)

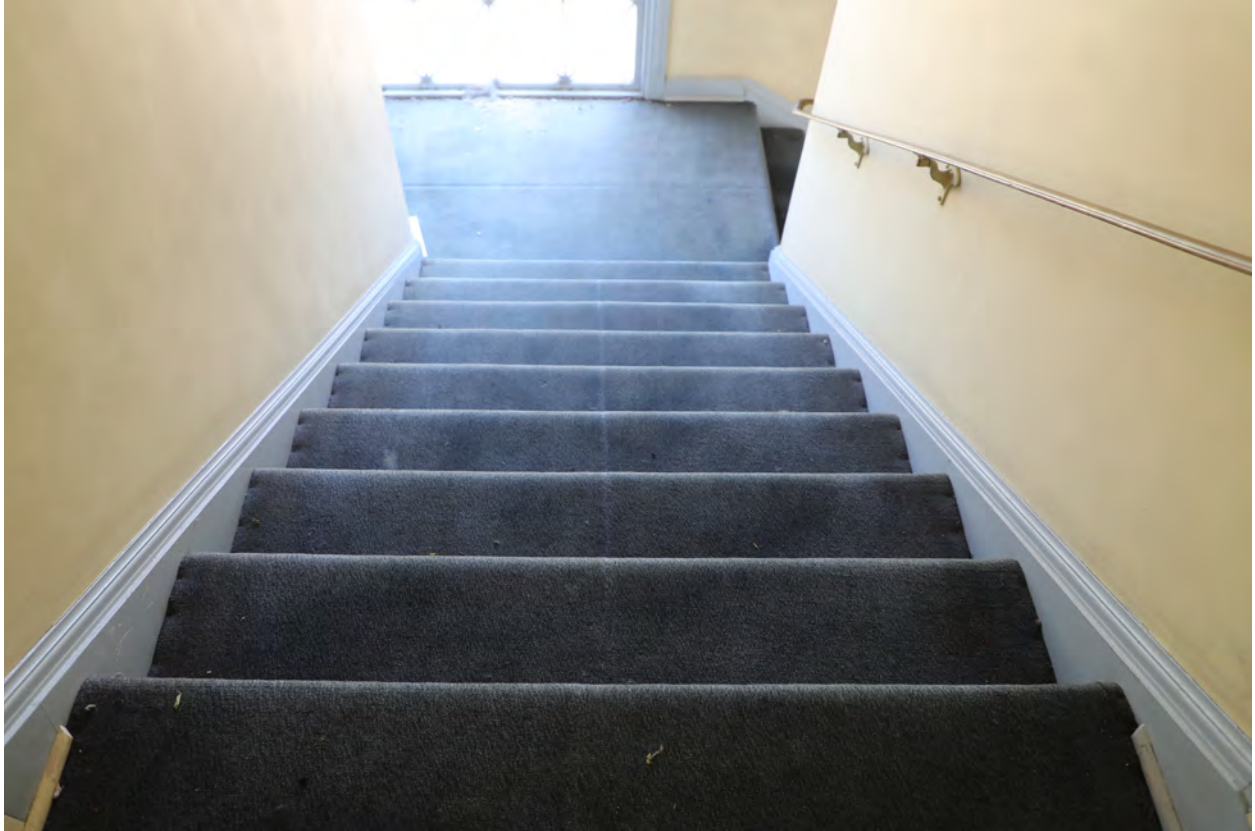
Figure 35 - Stairs to Balcony looking from balcony level, view east (ARG, 2024)

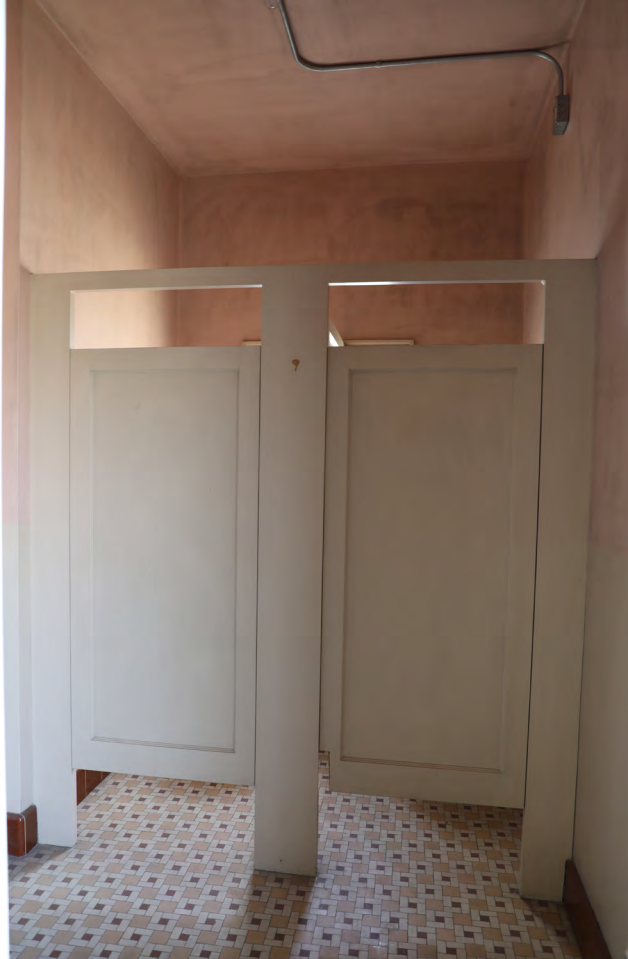
Figure 36 - Women's Restroom, view north (ARG, 2024)

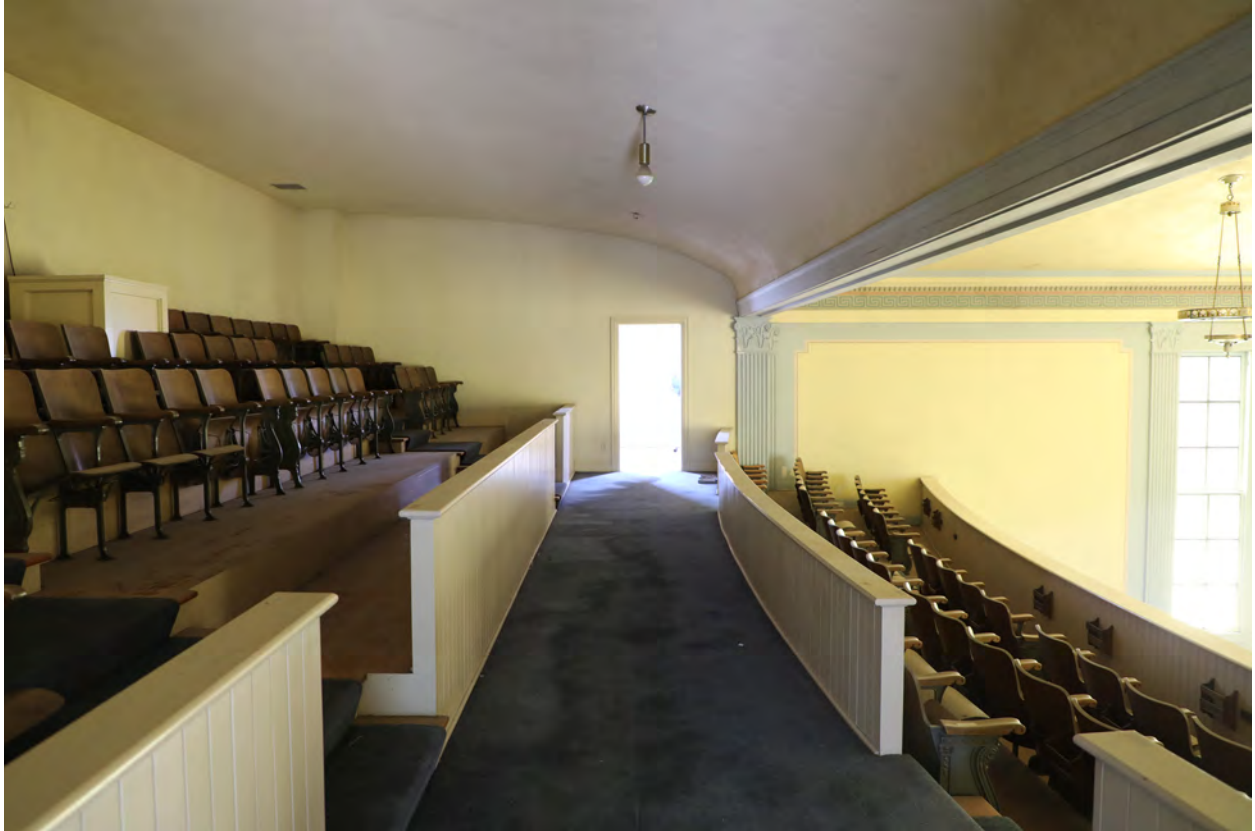
Figure 37 - Balcony, view west (ARG, 2024)

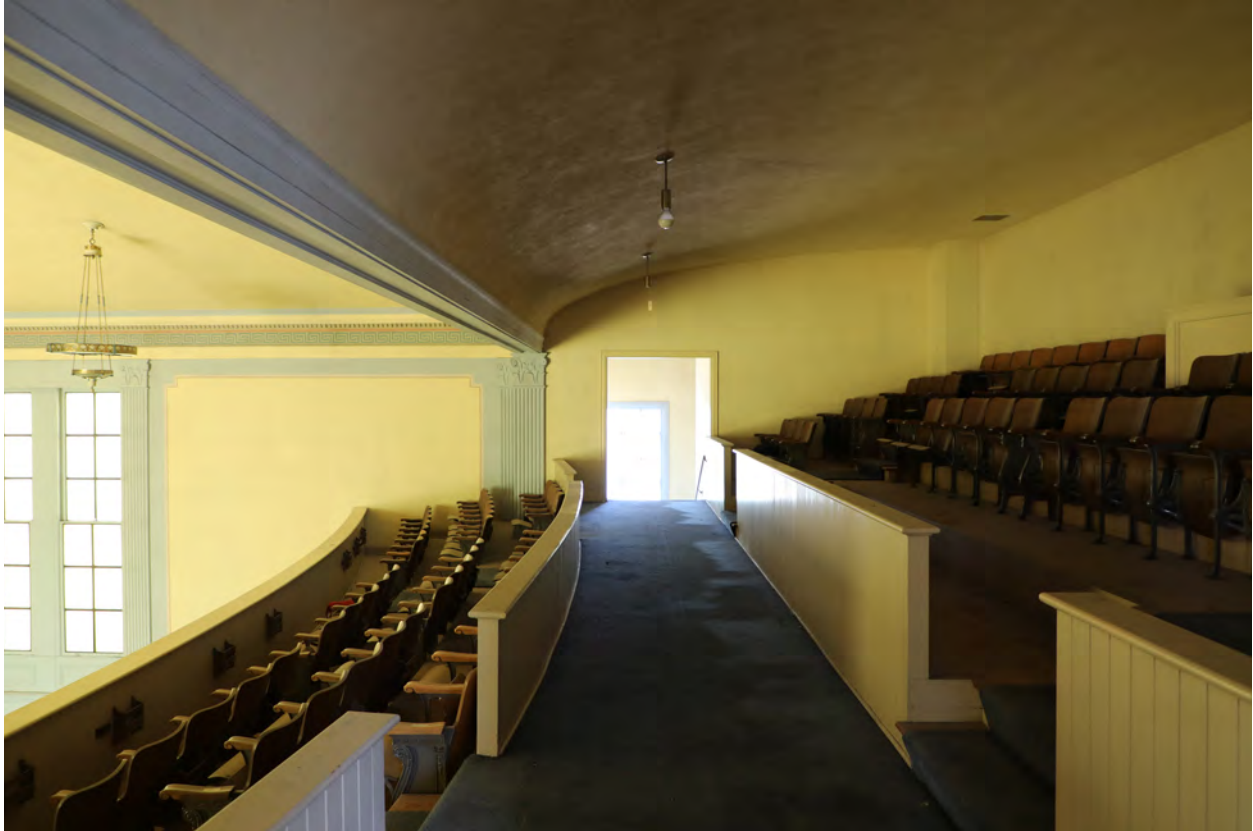
Figure 38 - Balcony, view east (ARG, 2024)

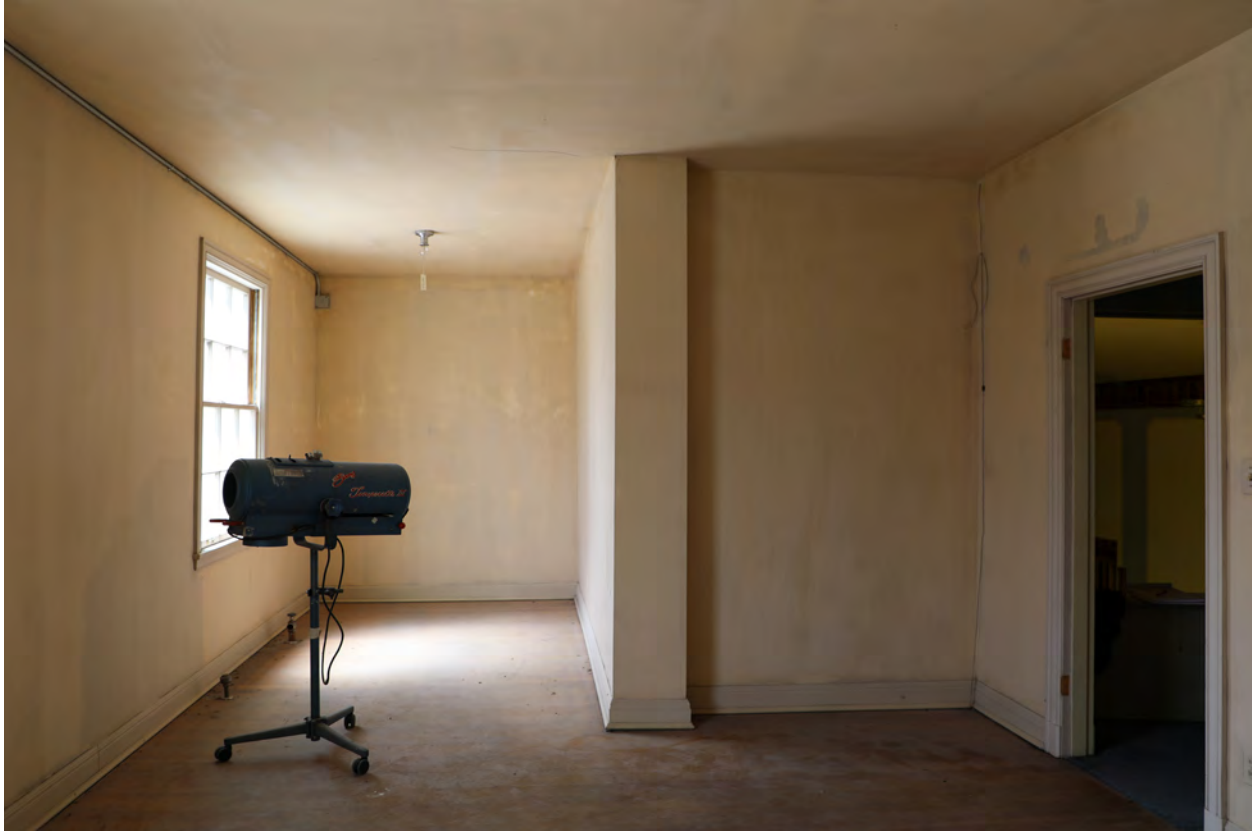
Figure 39 - Committee Room, view north (ARG, 2024)

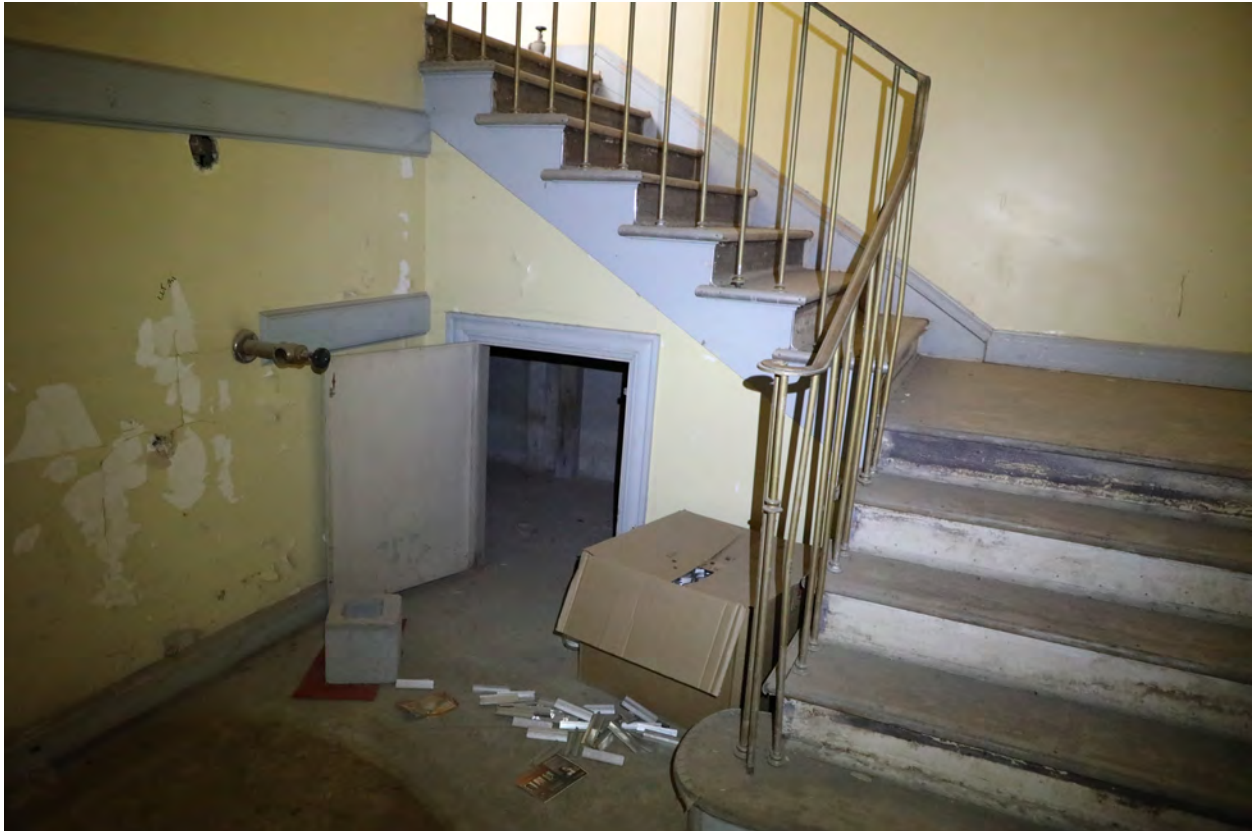
Figure 40 - Basement at base of southern stairs, view southeast (ARG, 2024)

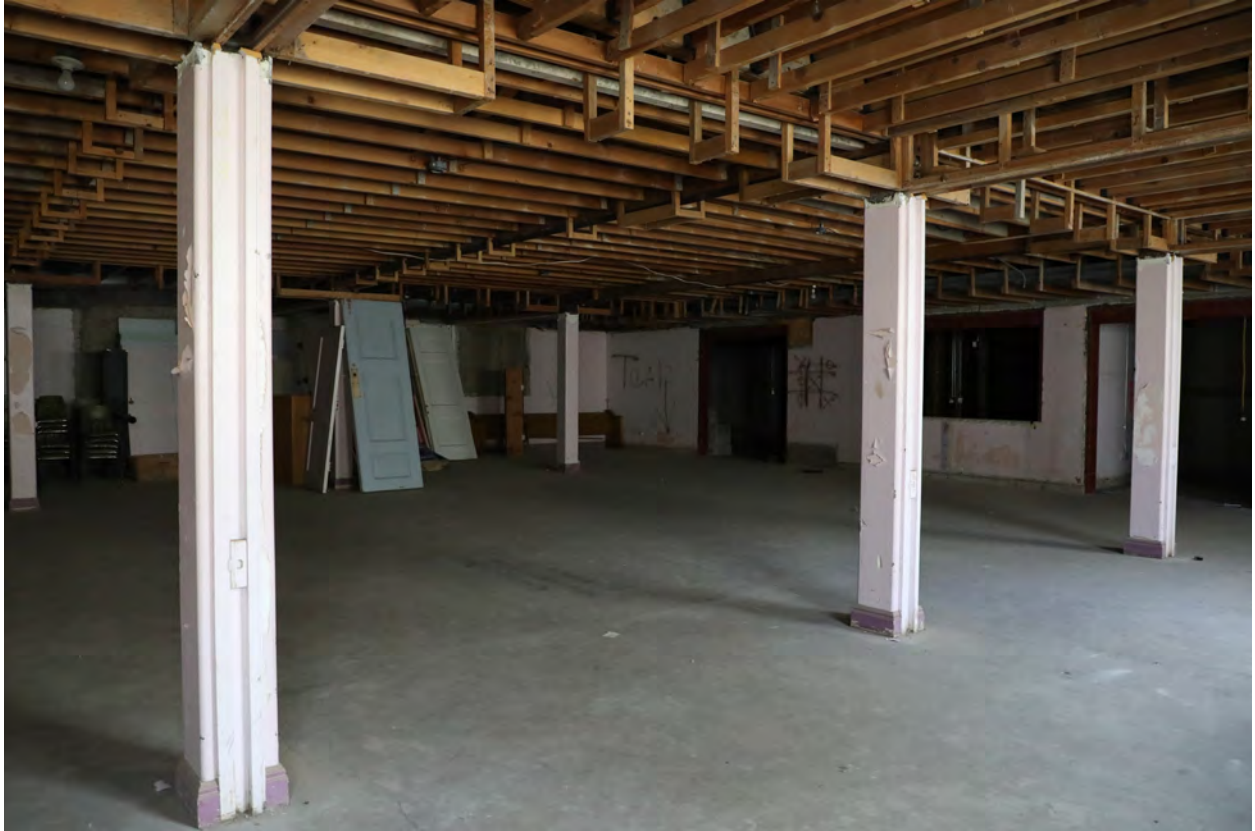
Figure 41 - Basement, cabaret theater space, view northwest (ARG, 2024)

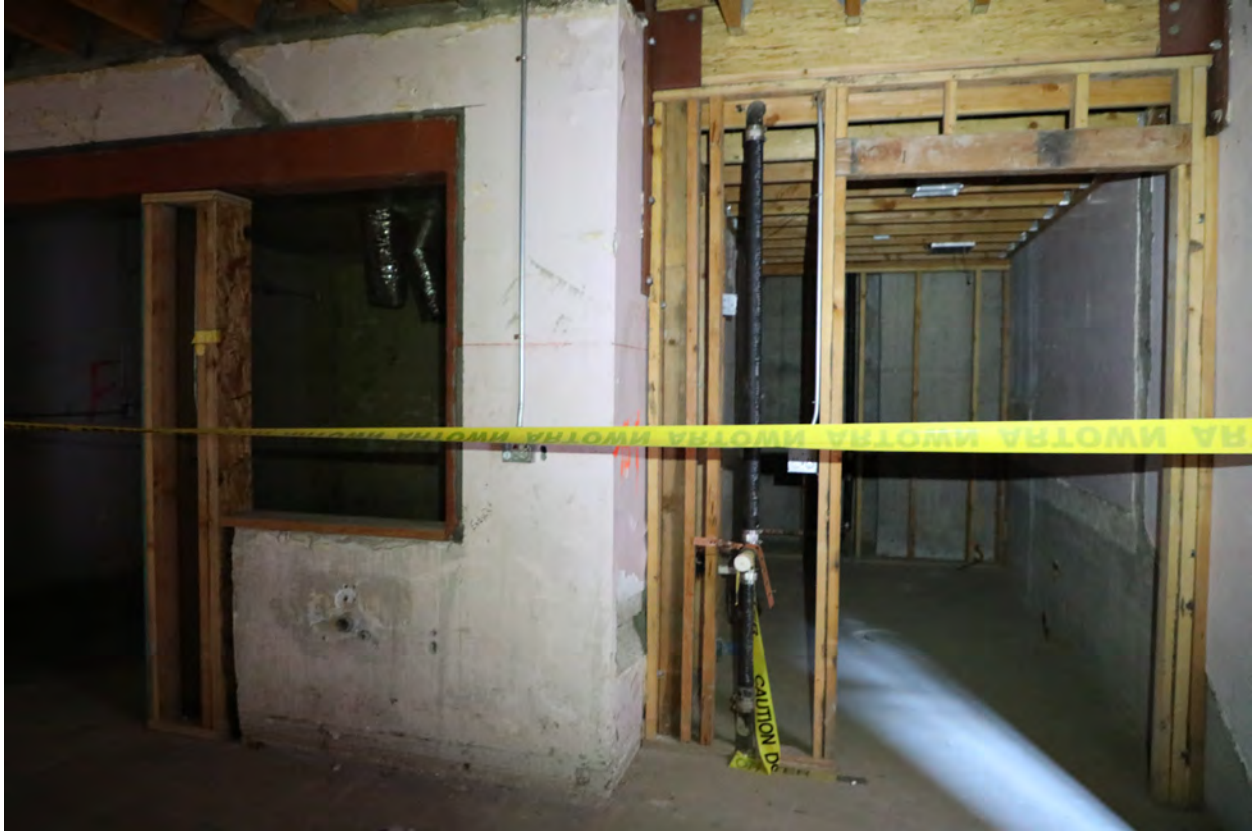
Figure 42 - Basement, northern unfinished spaces, view north (ARG, 2024)

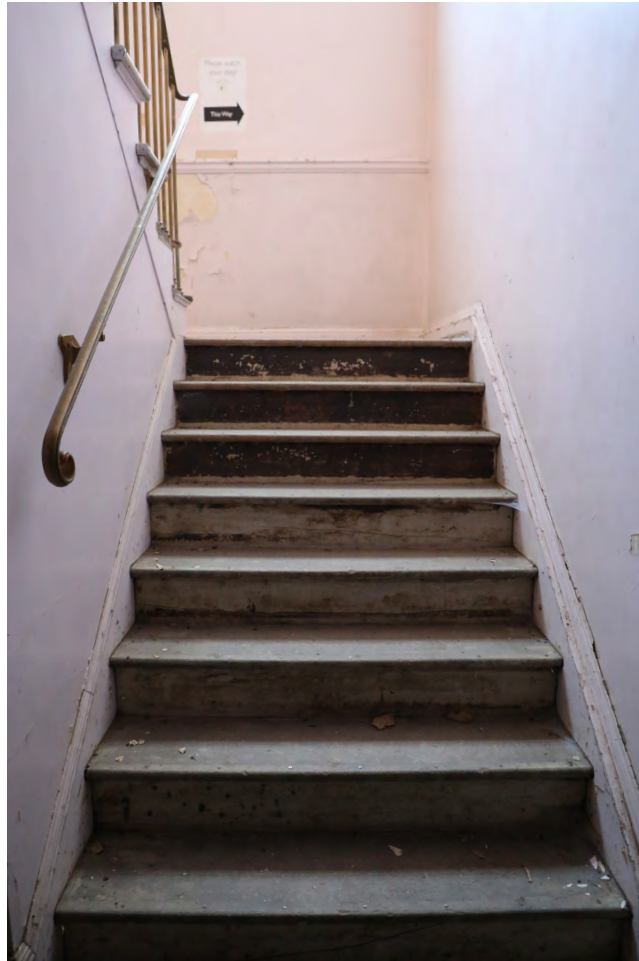
Figure 43 - North stairs from basement, view south (ARG, 2024)

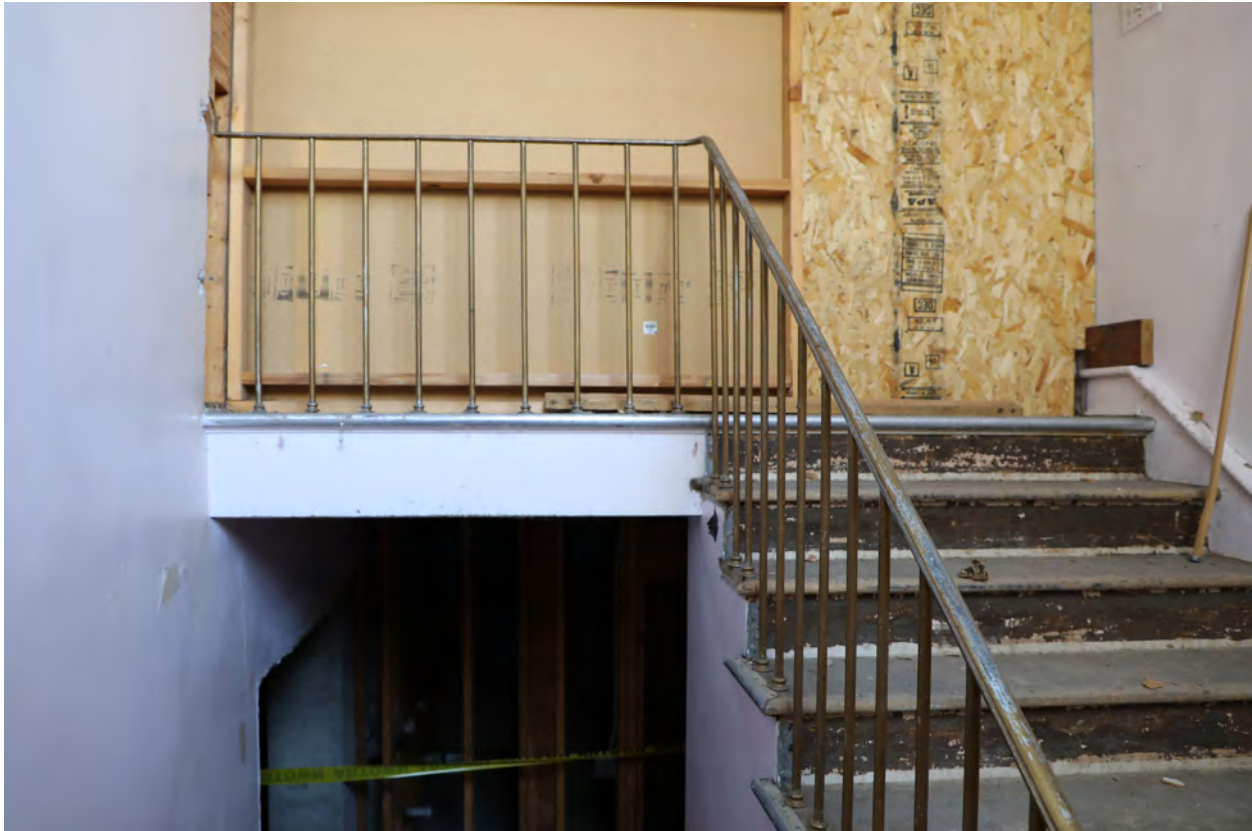
Figure 44 - North stairs from basement, looking at temporary wall, view north (ARG, 2024)

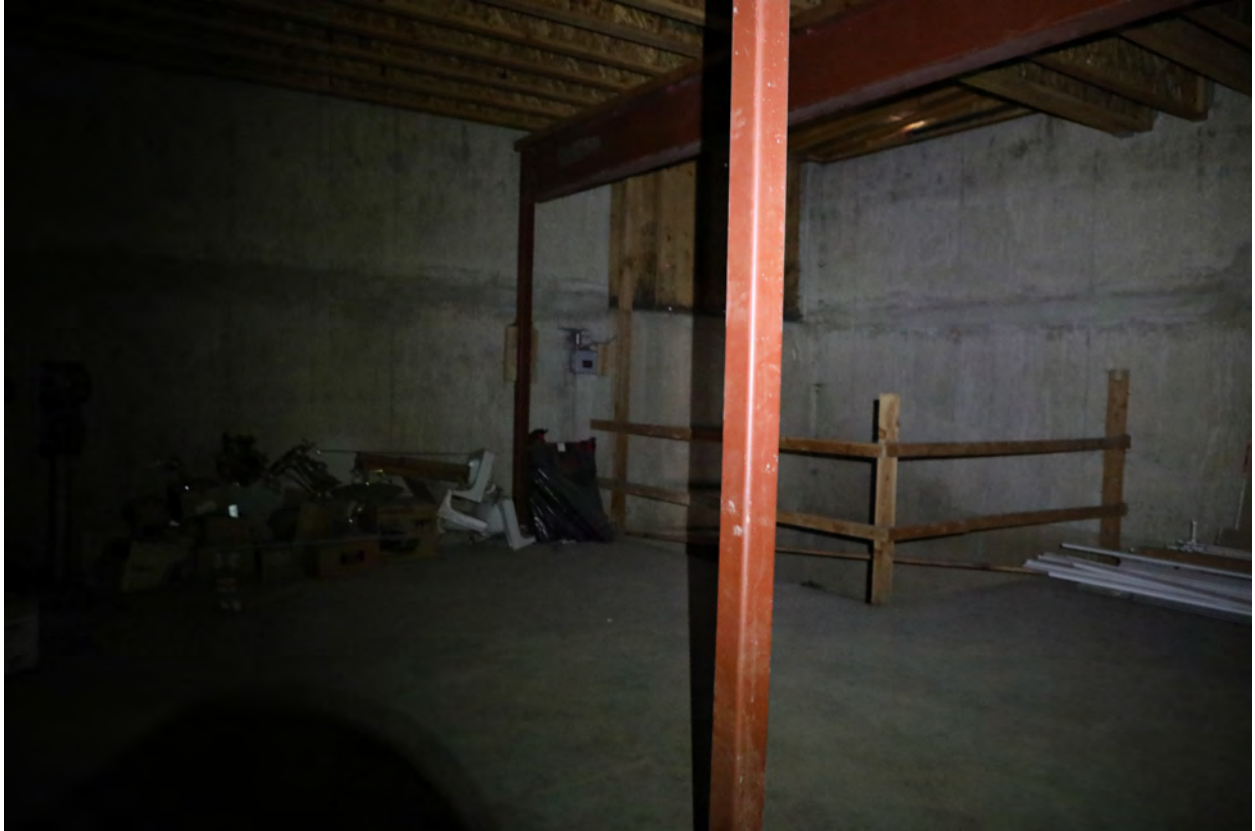
Figure 45 - Basement, looking into unfinished mechanical room with north elevator pit, view northwest (ARG, 2024)
