C I T Y O F
RENO
Memorandum

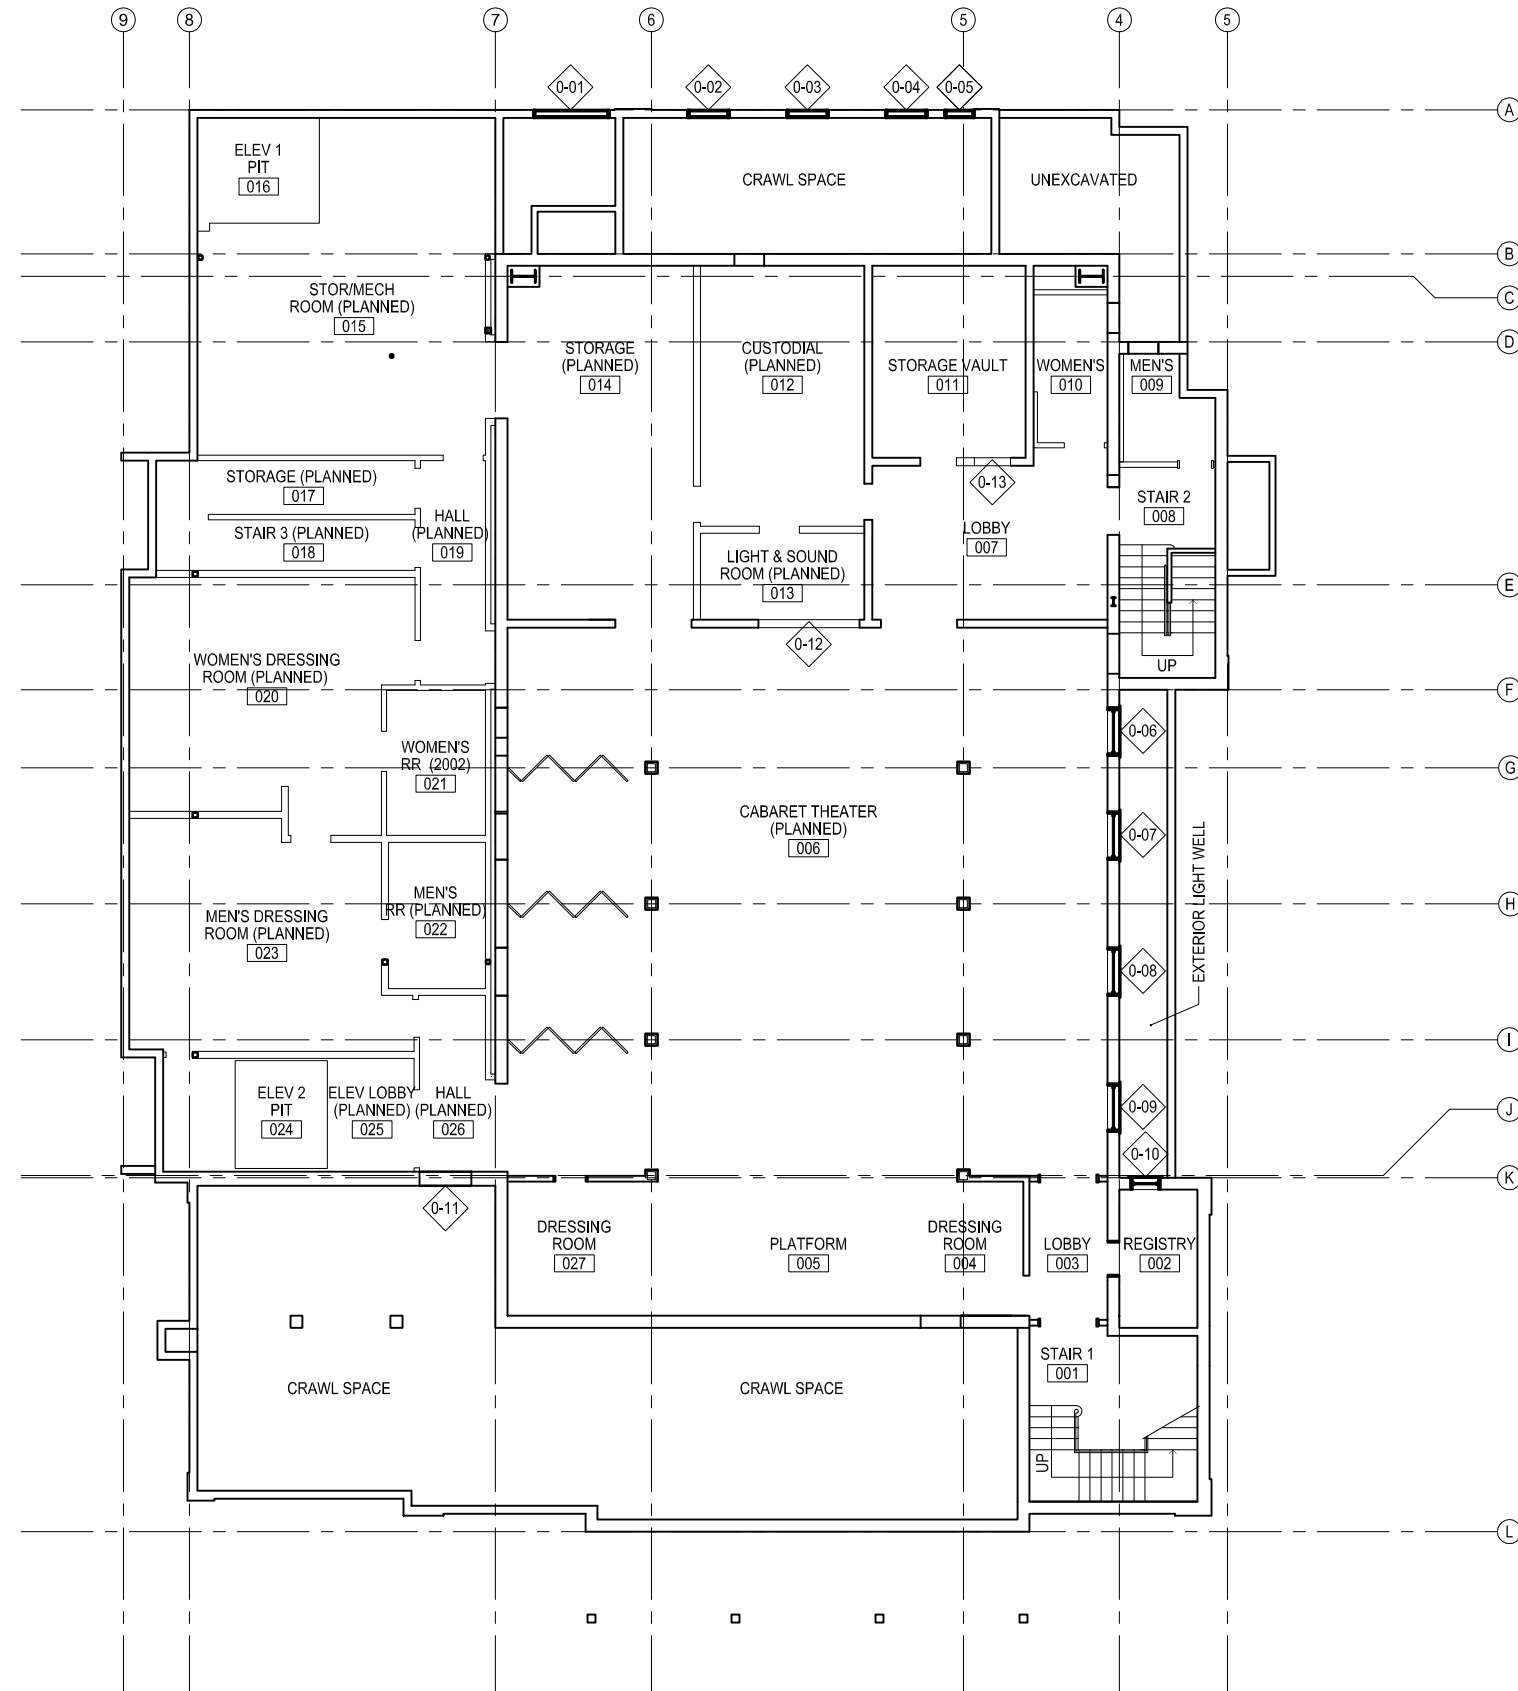
1 EXISTING PLAN - BASEMENT
 AE1.00 SCALE: 1/8" = 1'-0"

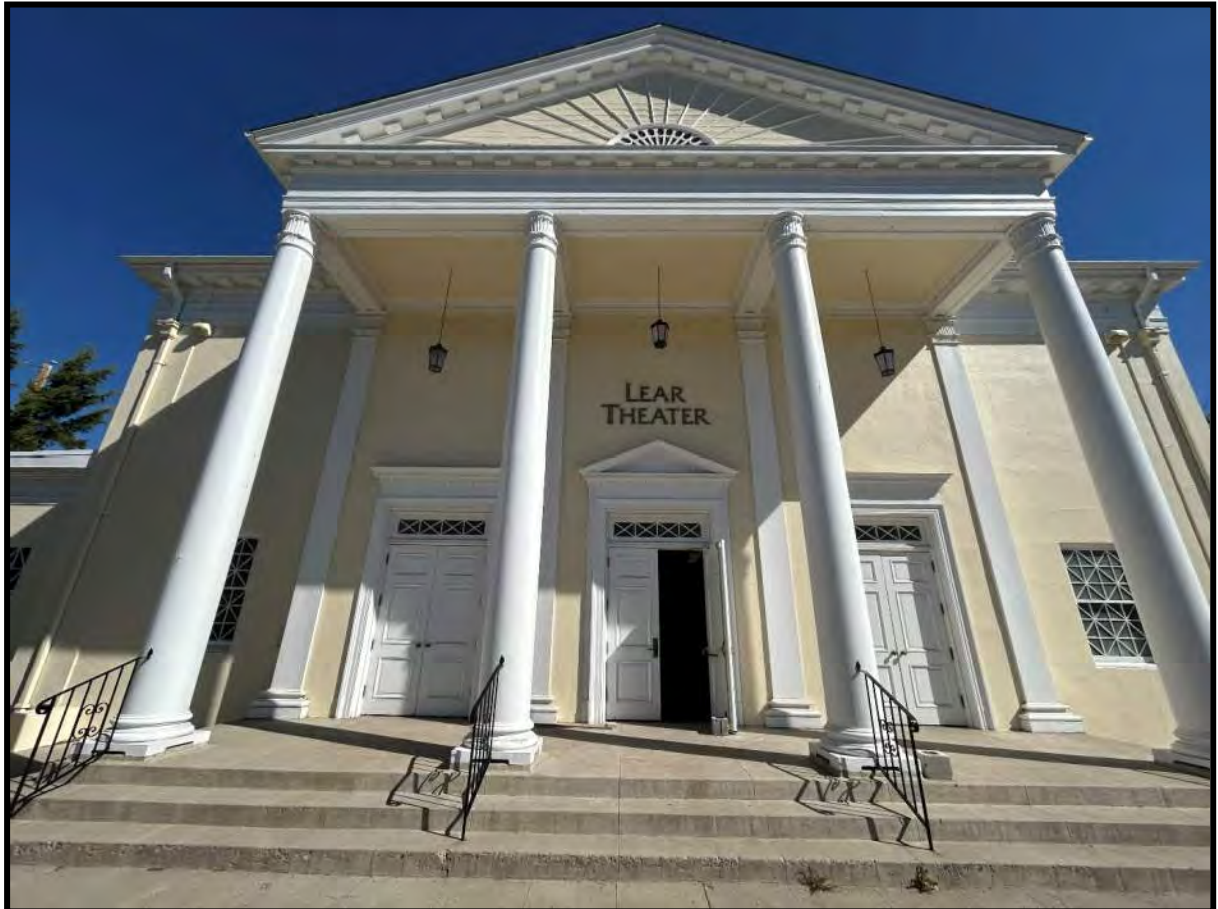
Lear Theater Structural Condition Assessment

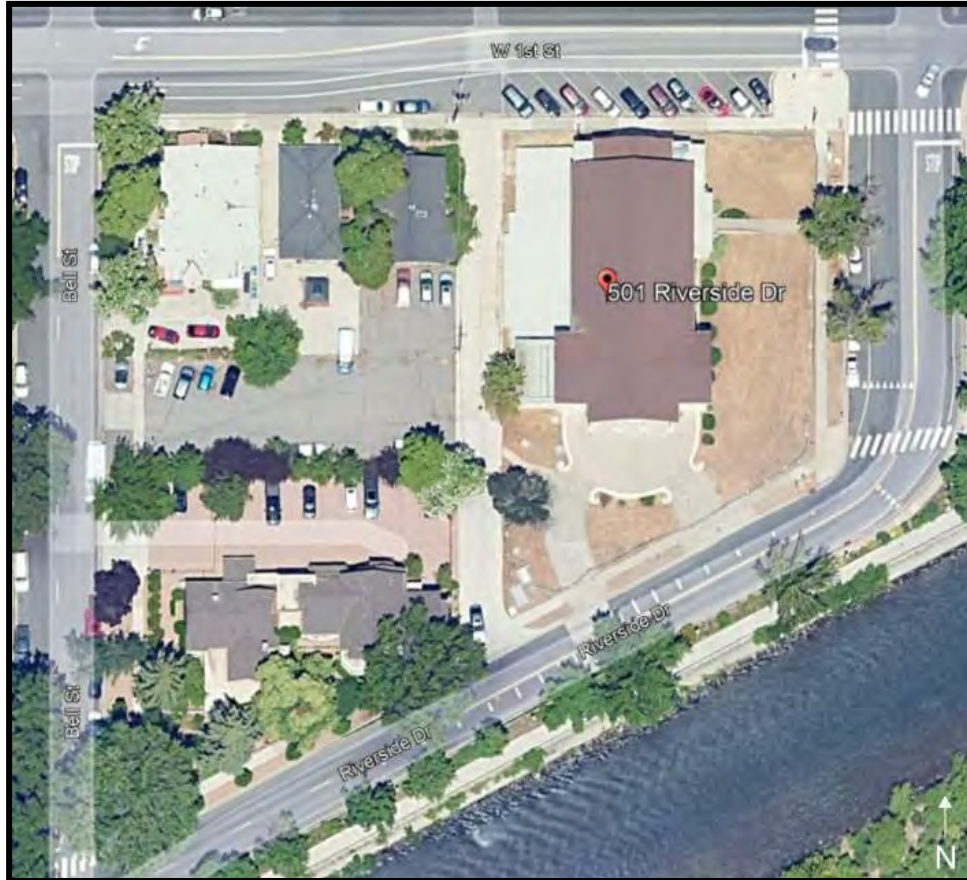
Figure 1 Map illustrating the location of Lear Theater (*Google Earth*).

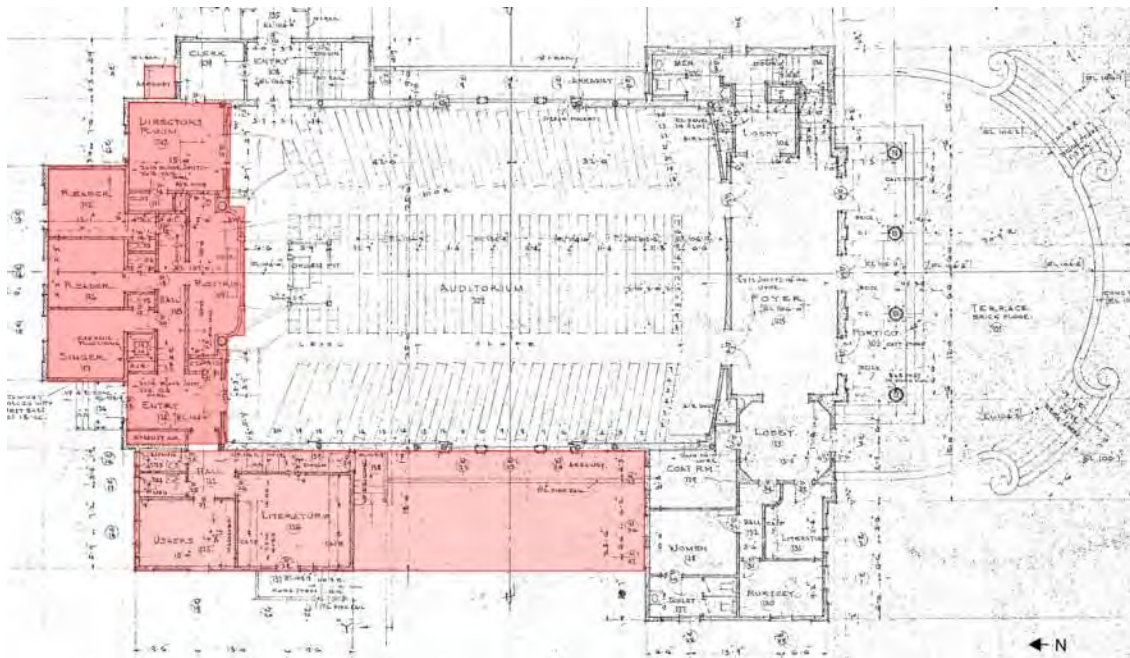
Figure 2 First floor plan view from the 1938 Construction Drawings highlighting the areas demolished in 2002.

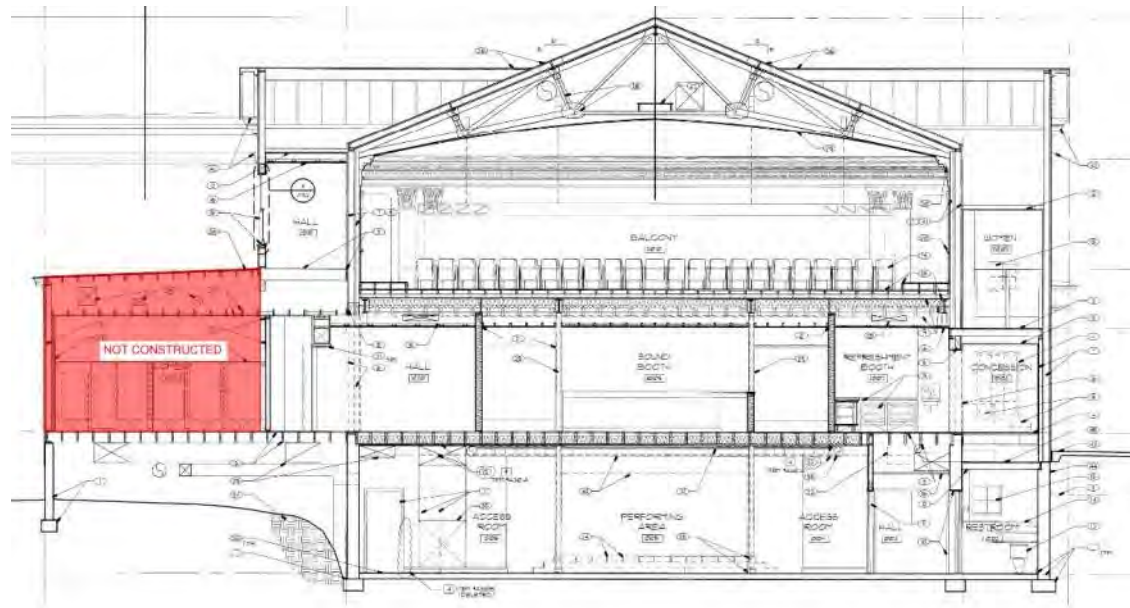
Figure 4 Section through the building from the 2002 Construction Drawings highlighting the portion of the west wing that was not reconstructed.

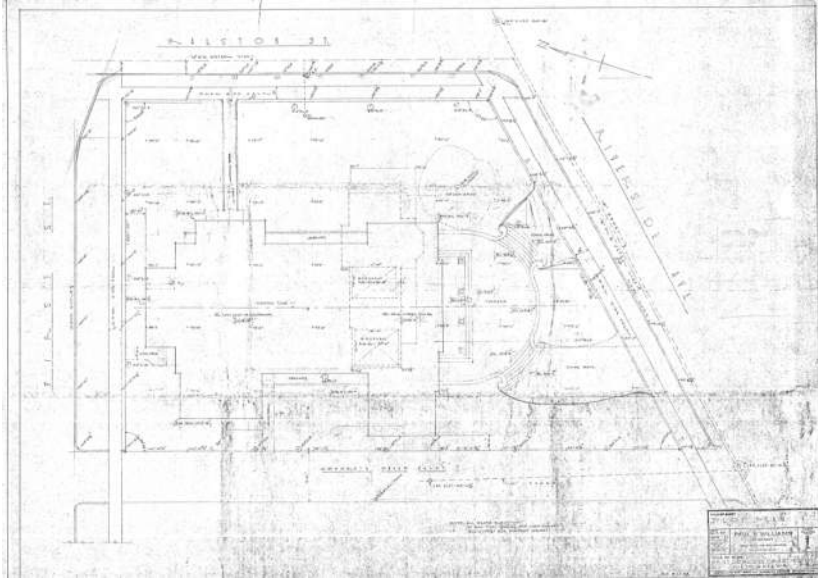
Figure 5 Page 1 Plot Plan from the 1938 Construction Drawings.

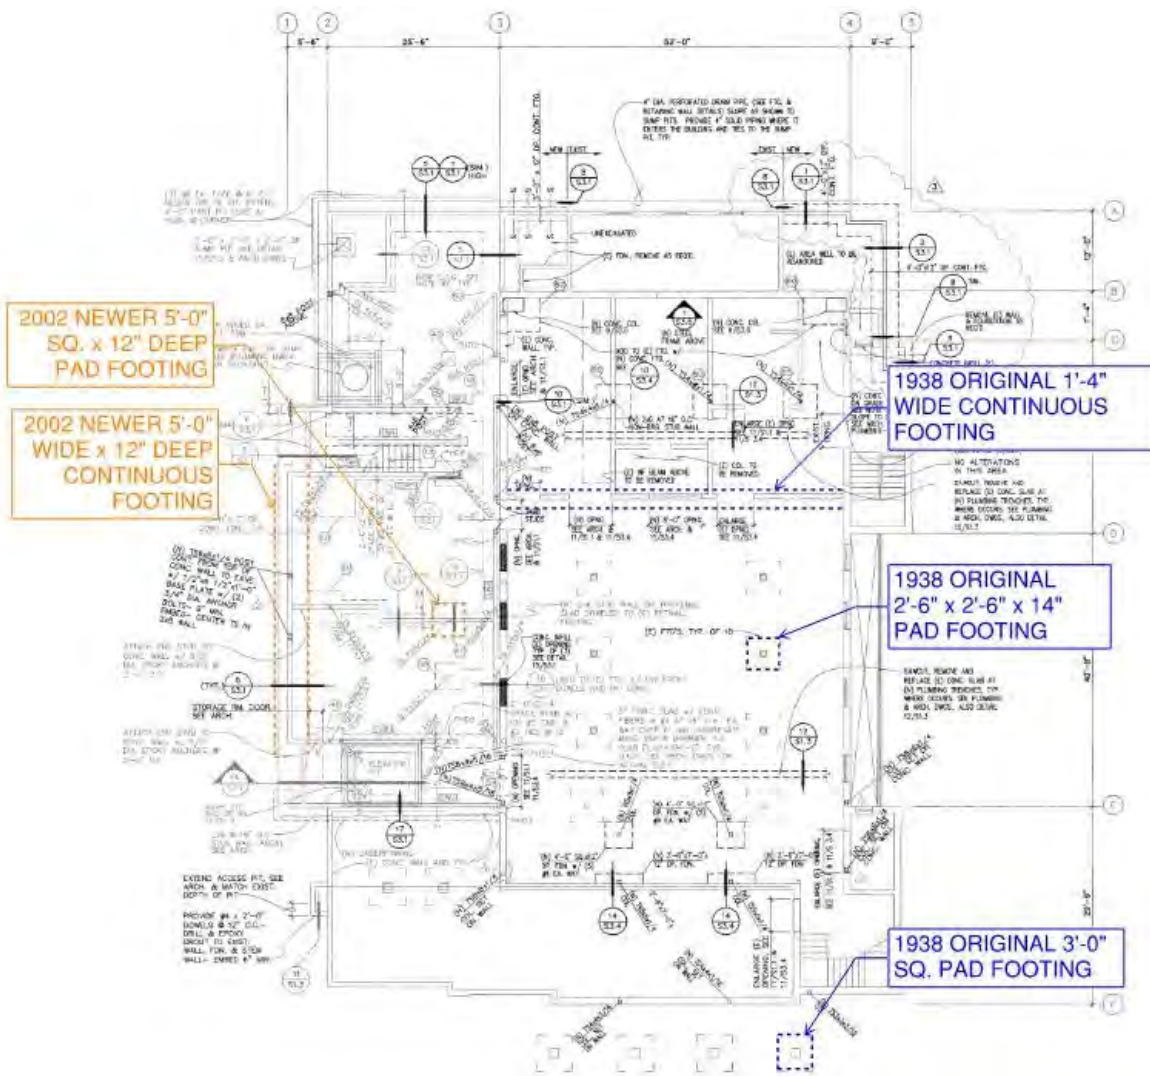
Figure 10 Foundation plan from the 2002 Construction Drawings illustrating some typical 1938 and 2002 foundations.

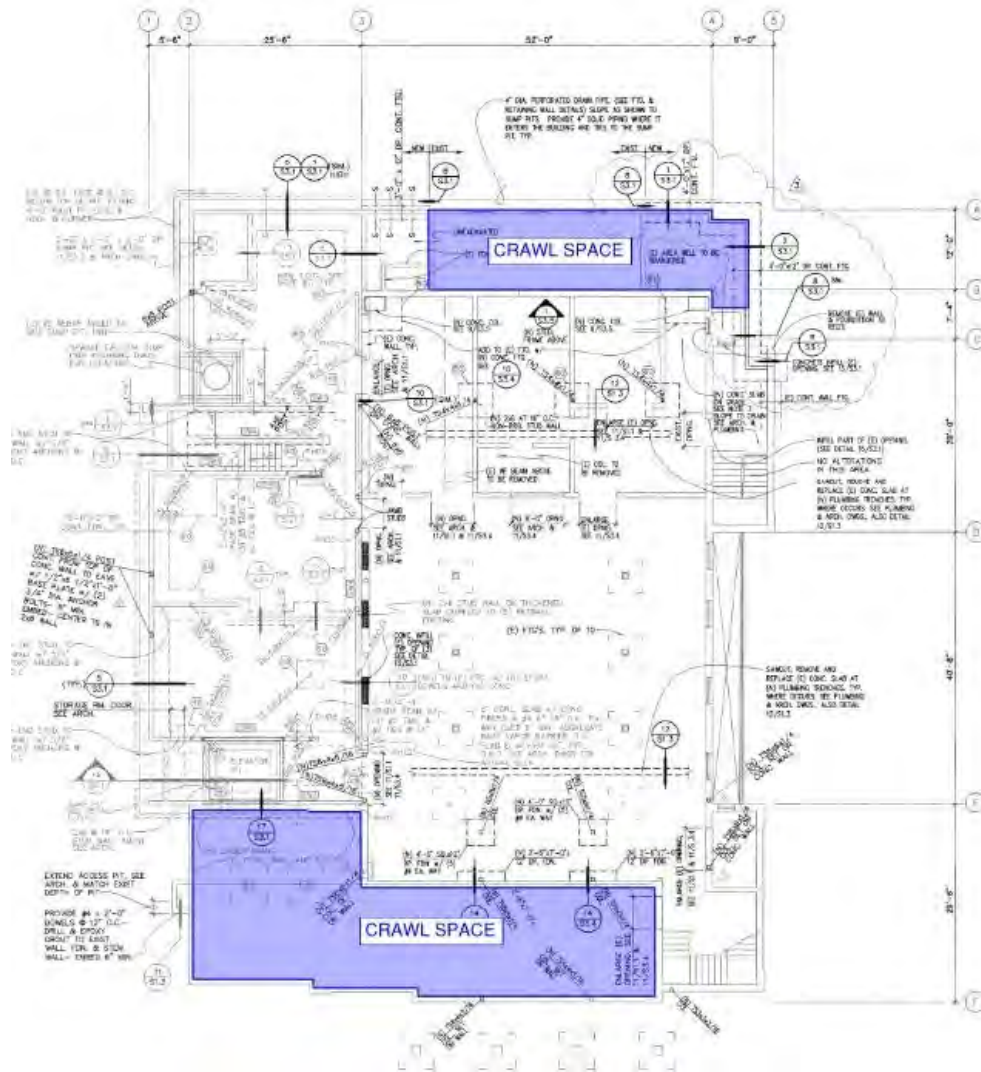
Figure 11 Foundation plan from the 2002 Construction Drawings illustrating the location of the crawl spaces.

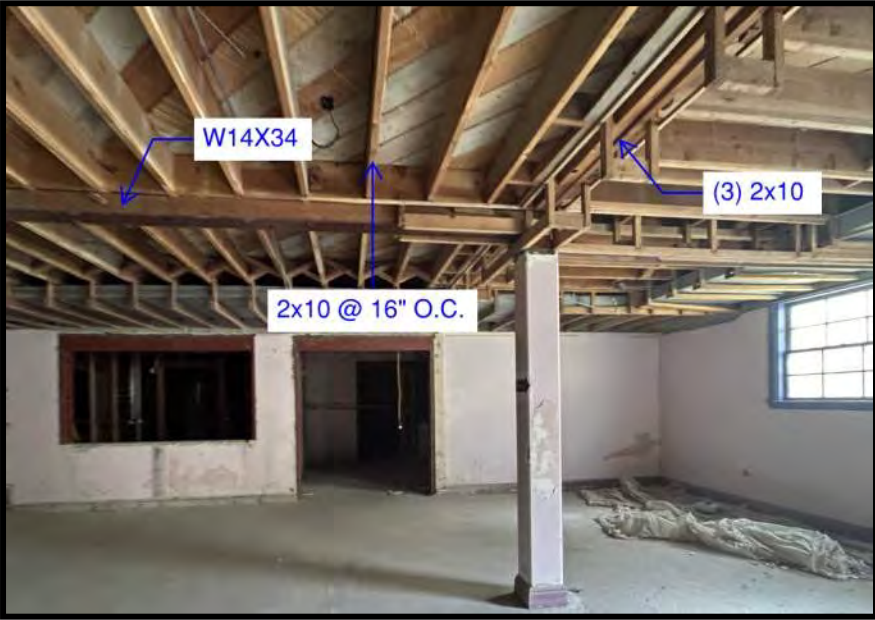
Figure 12 View of the first-floor framing from the basement.

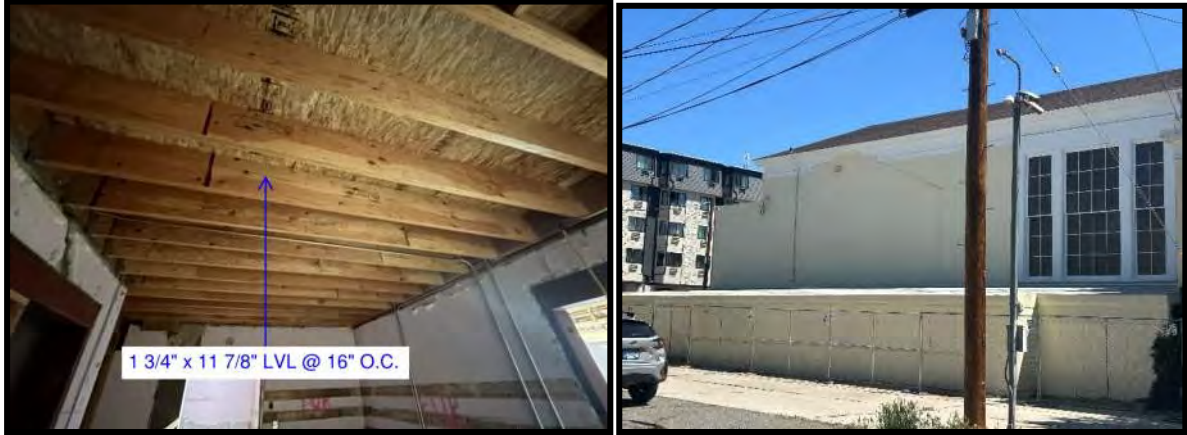
Figure 13 View of the 2002 first floor framing from the basement (left). View of the 2002 sleeper floor from the exterior of the building (right).

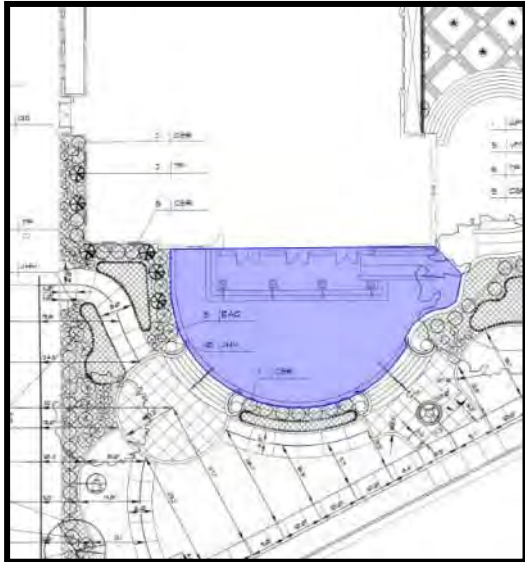
Figure 23 Plan view of the south exterior highlighting the location of the concrete slab-on-grade.

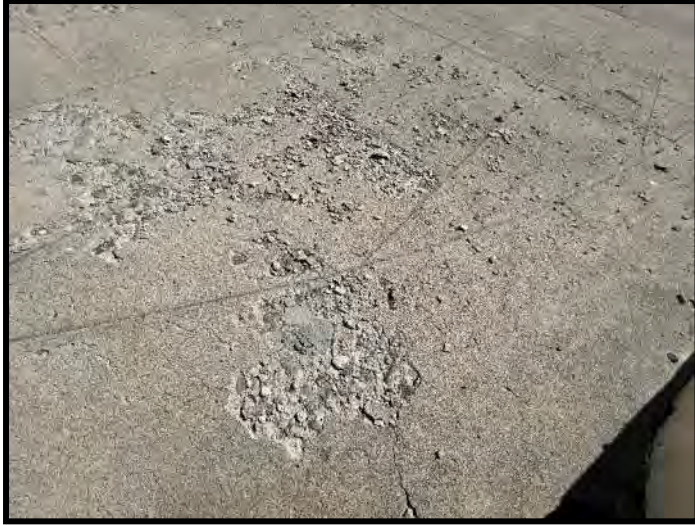
Figure 24 View of spalling slab-on-grade at the south entrance to the theater.

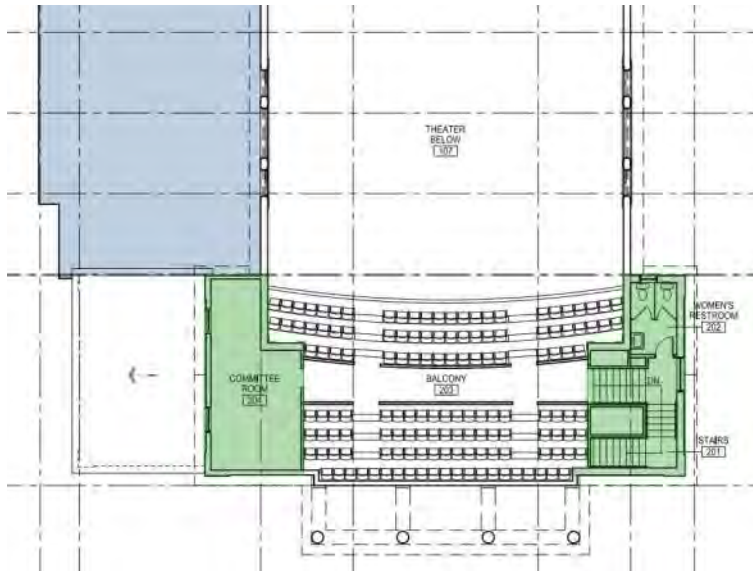
Figure 26 Location of rooms with hairline cracks on the Architectural Resources Group second floor key plan.

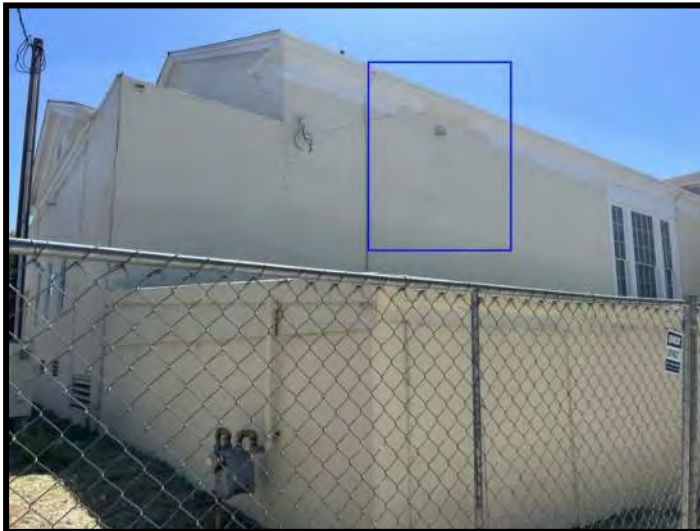
Figure 30 View of bubbling plastic membrane at the west exterior wall.

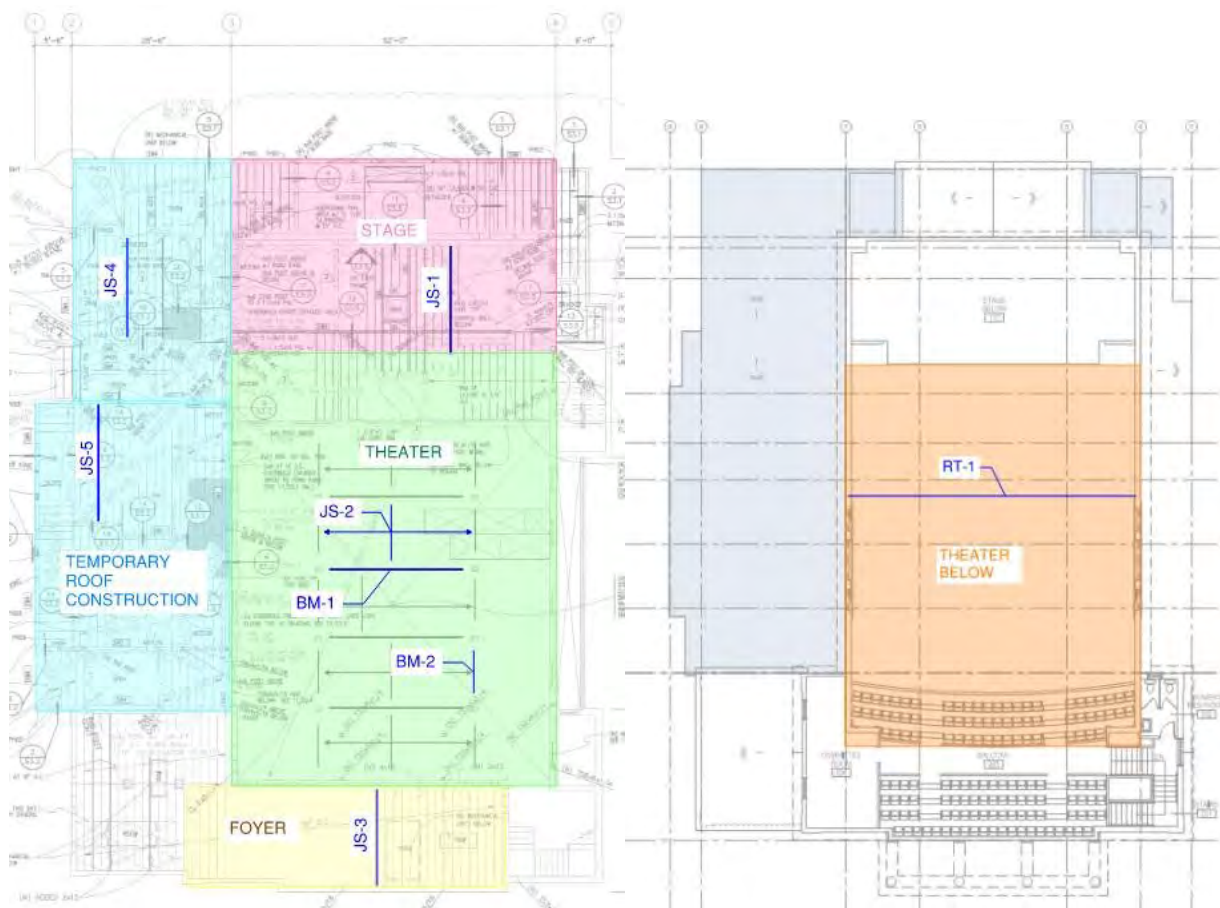
Figure 32 First floor key plan of members analyzed (left). Roof key plan of members analyzed (right).

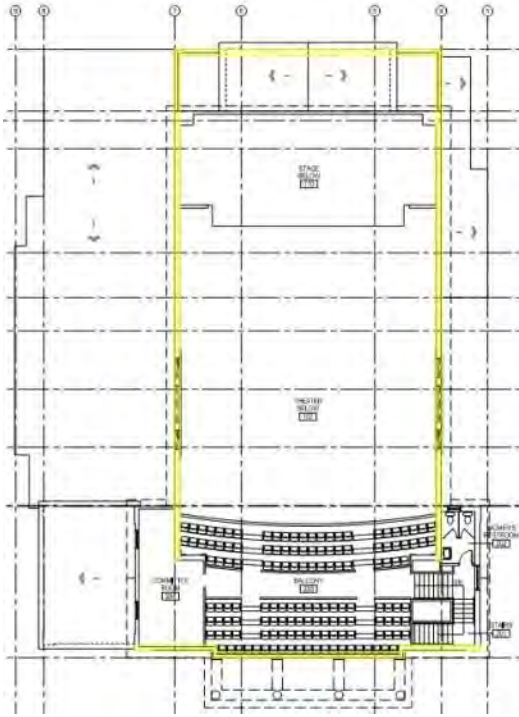
Figure 34 Second floor key plan by Architectural Resources Group highlighting the walls requiring plywood sheathing.

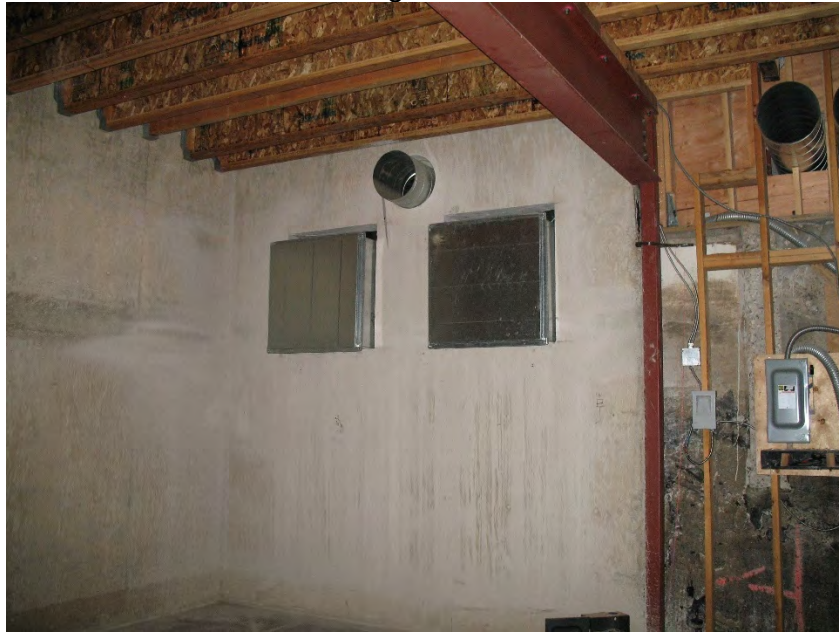
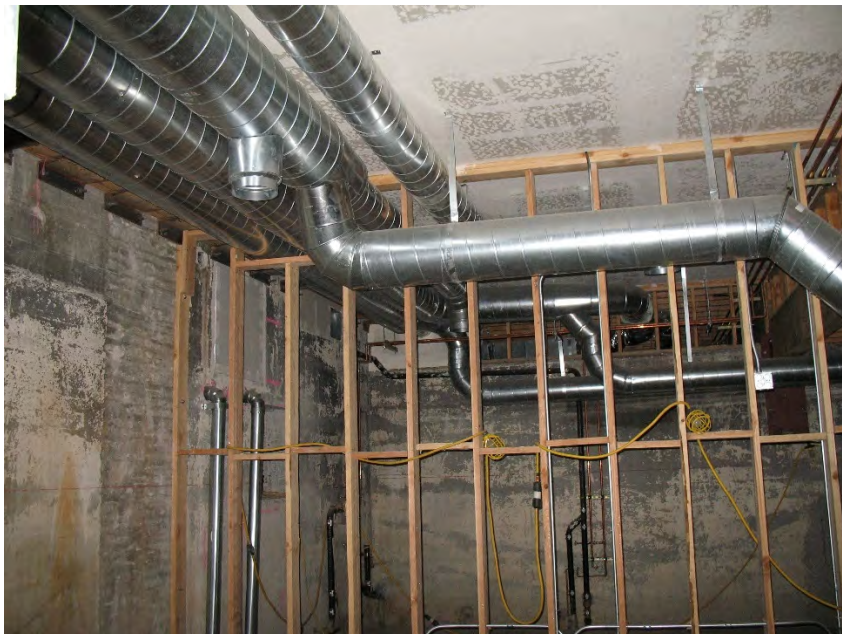
Conceptual Alternatives Recommendations
