Stormwater and Impervious Surfaces

M. Lee Bundrick

Sr. Ecological Health & Conservation Coordinator

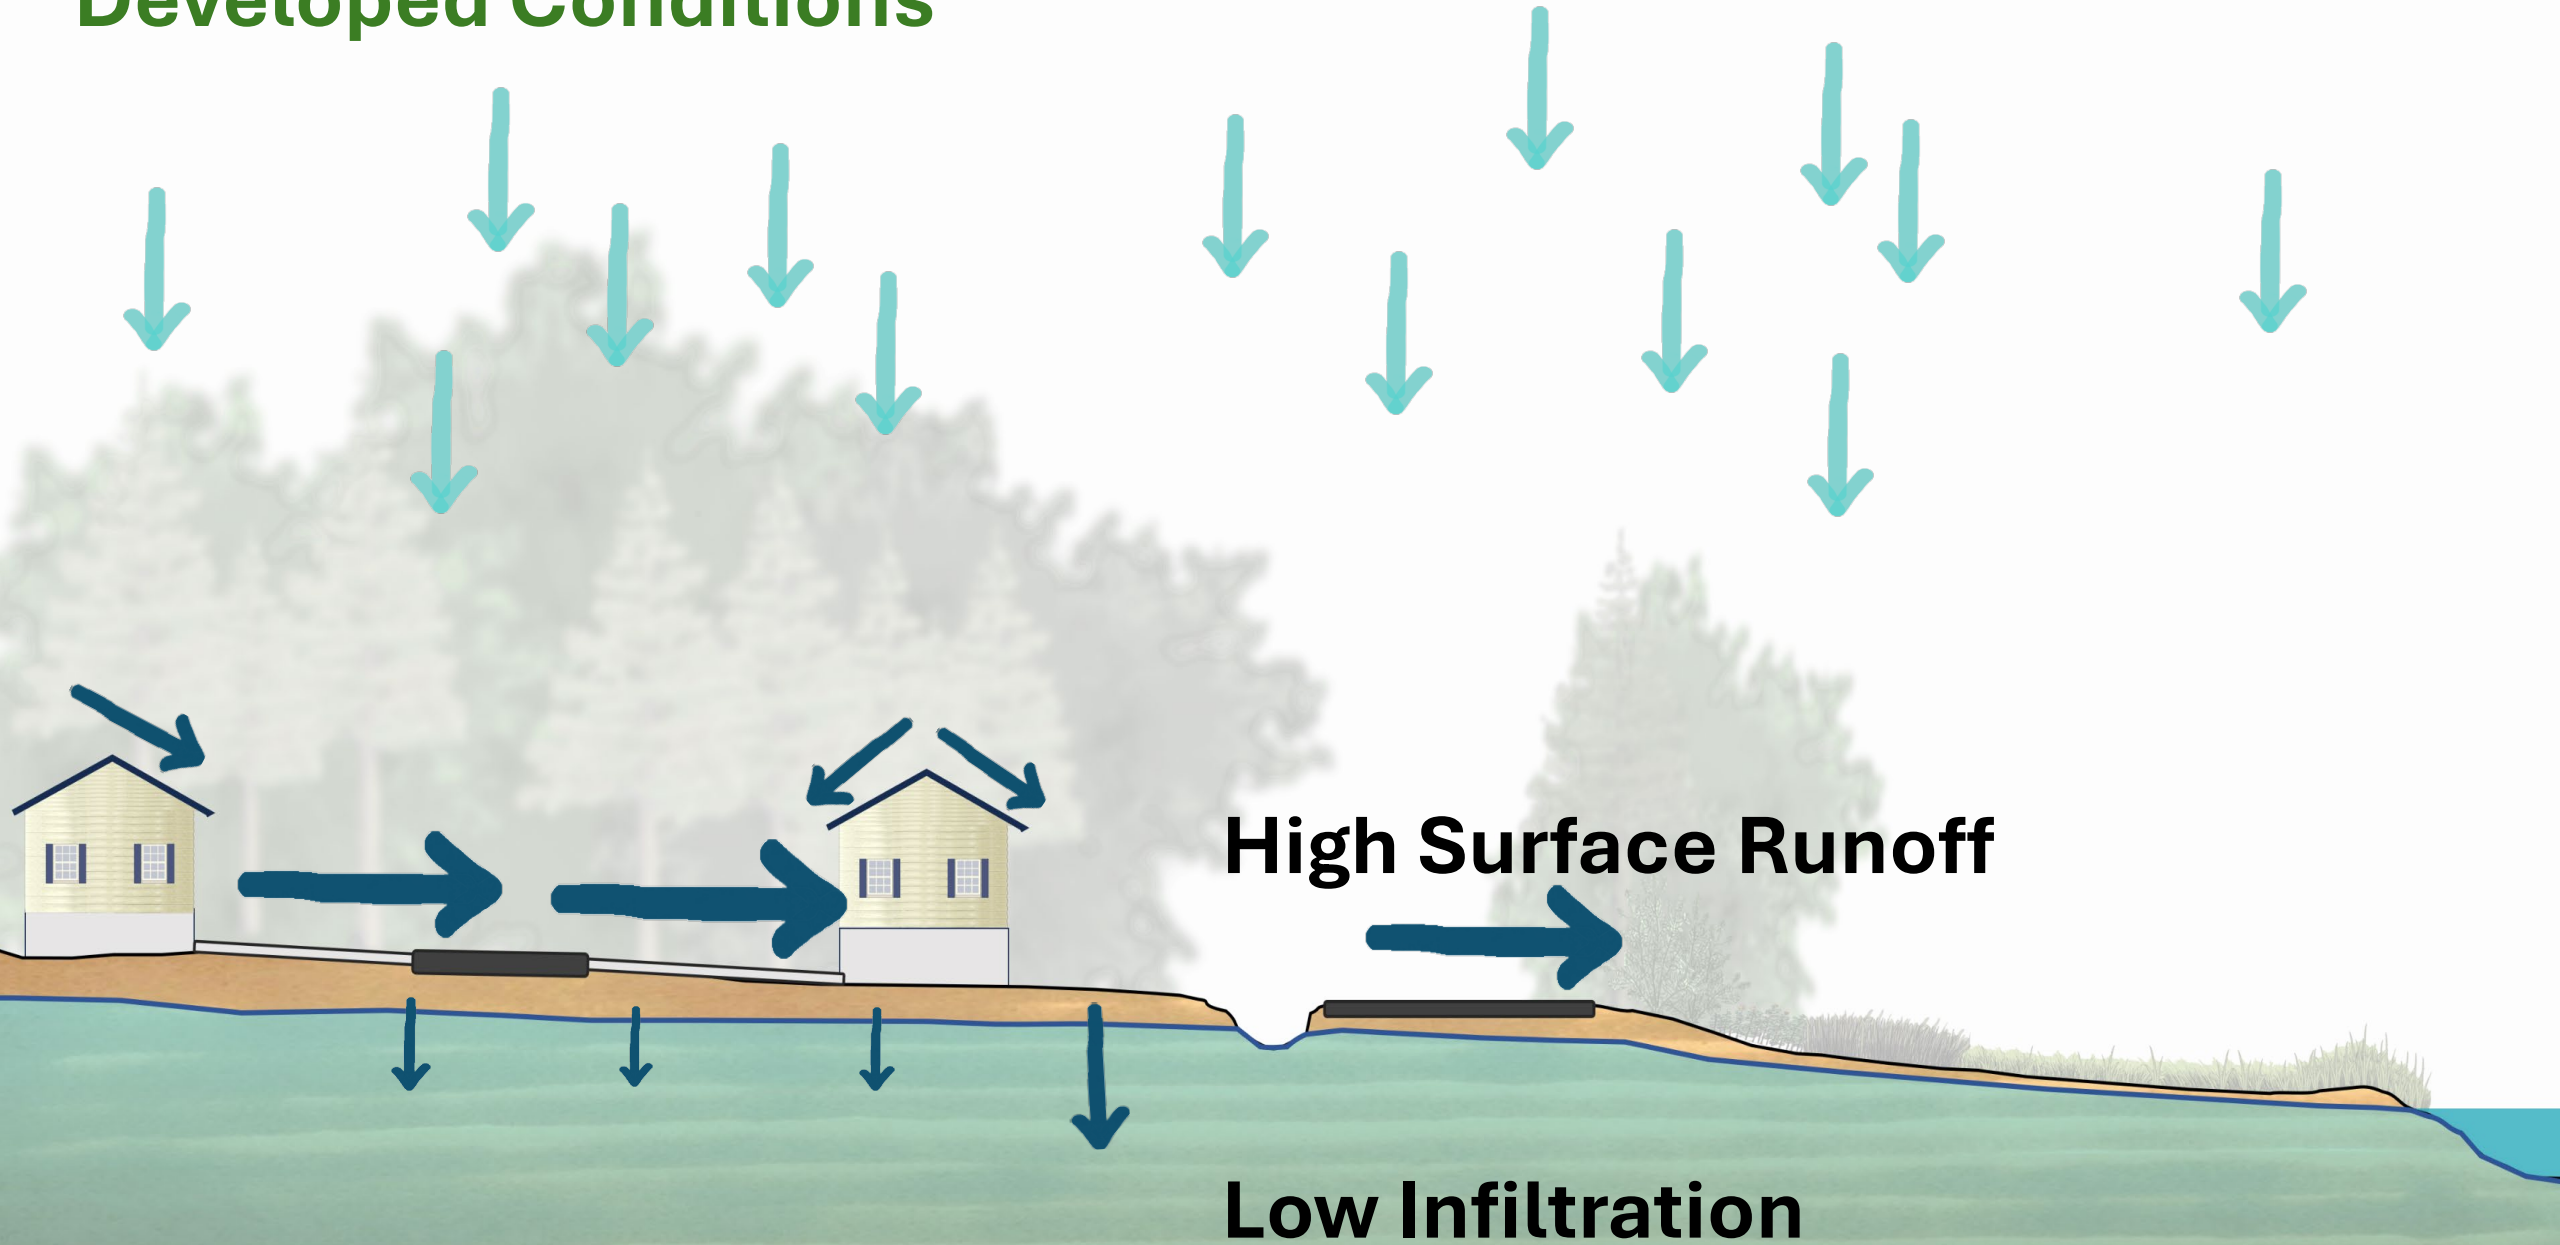
Developed Conditions

High Surface Runoff

Low Infiltration

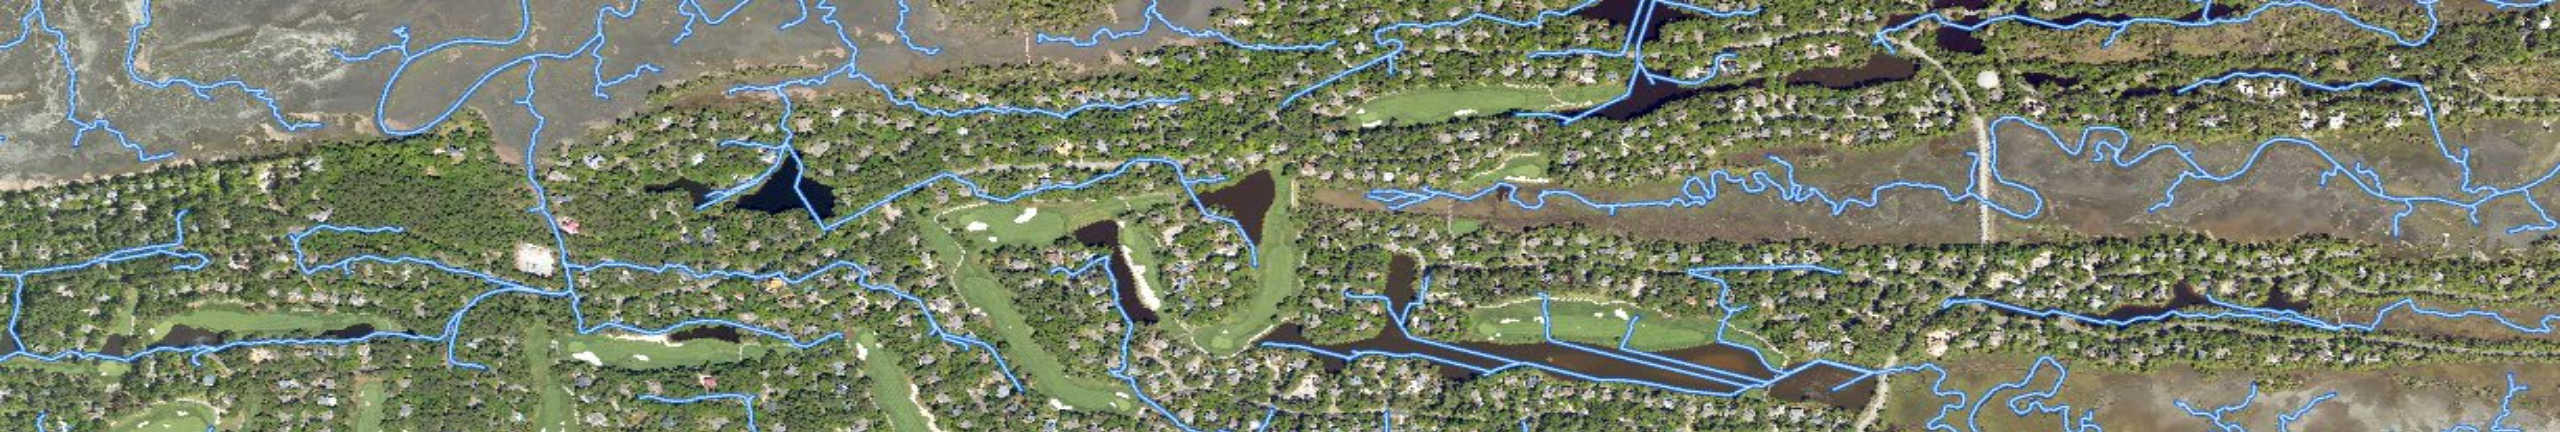
Impervious surfaces prevent stormwater from infiltrating into underlying soils

- Buildings
- Roads
- Driveways
- Multi-use Pathways
- Parking lots
- Tennis courts
- Pool decks...

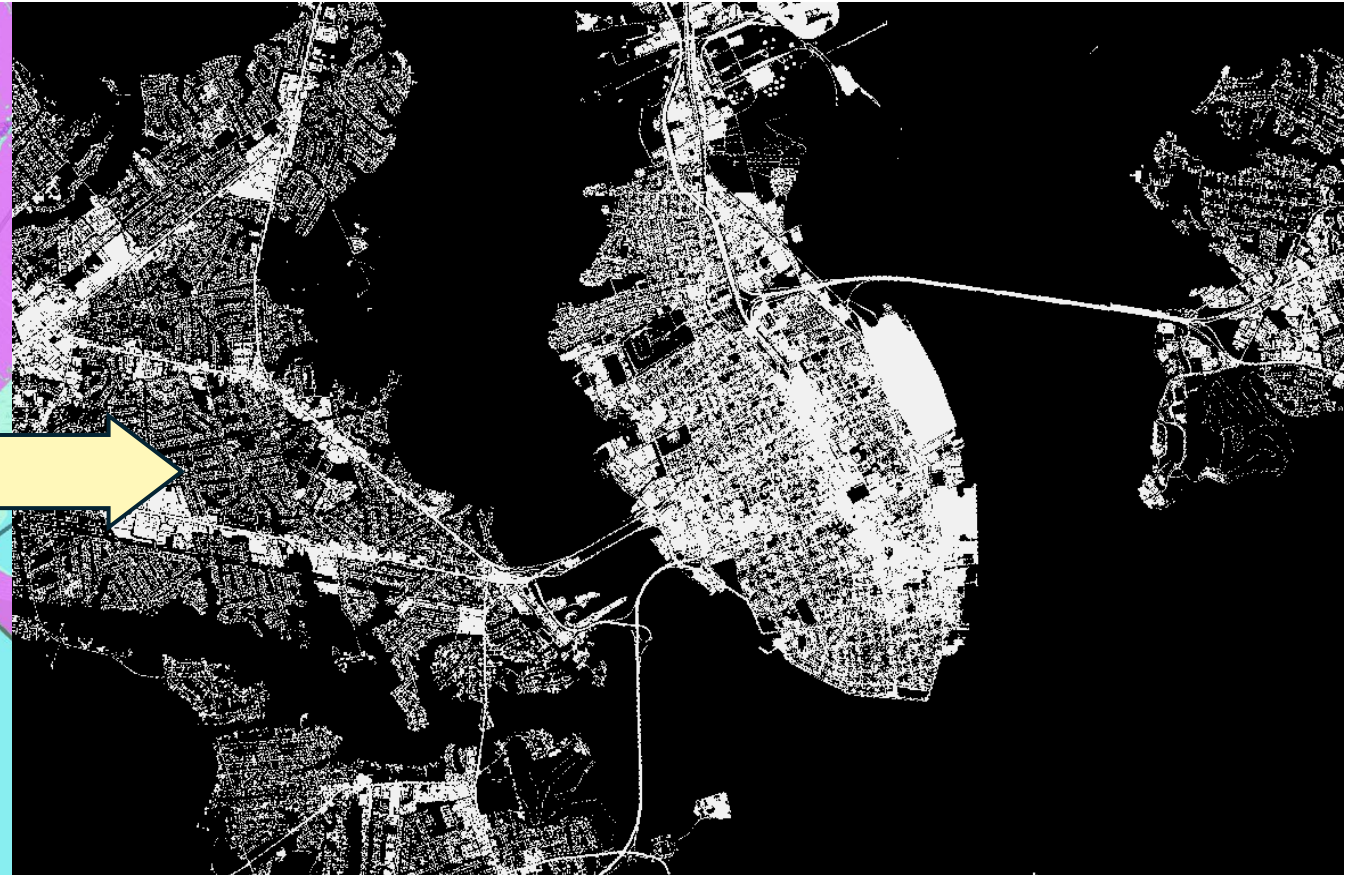
Upland Impervious Land Cover

Charleston (18) + Hilton Head + Pawleys Island
Excluded areas within the National Wetlands Inventory

NOAA CCAP Landcover (2021)

1-meter impervious layer
Coastal South Carolina

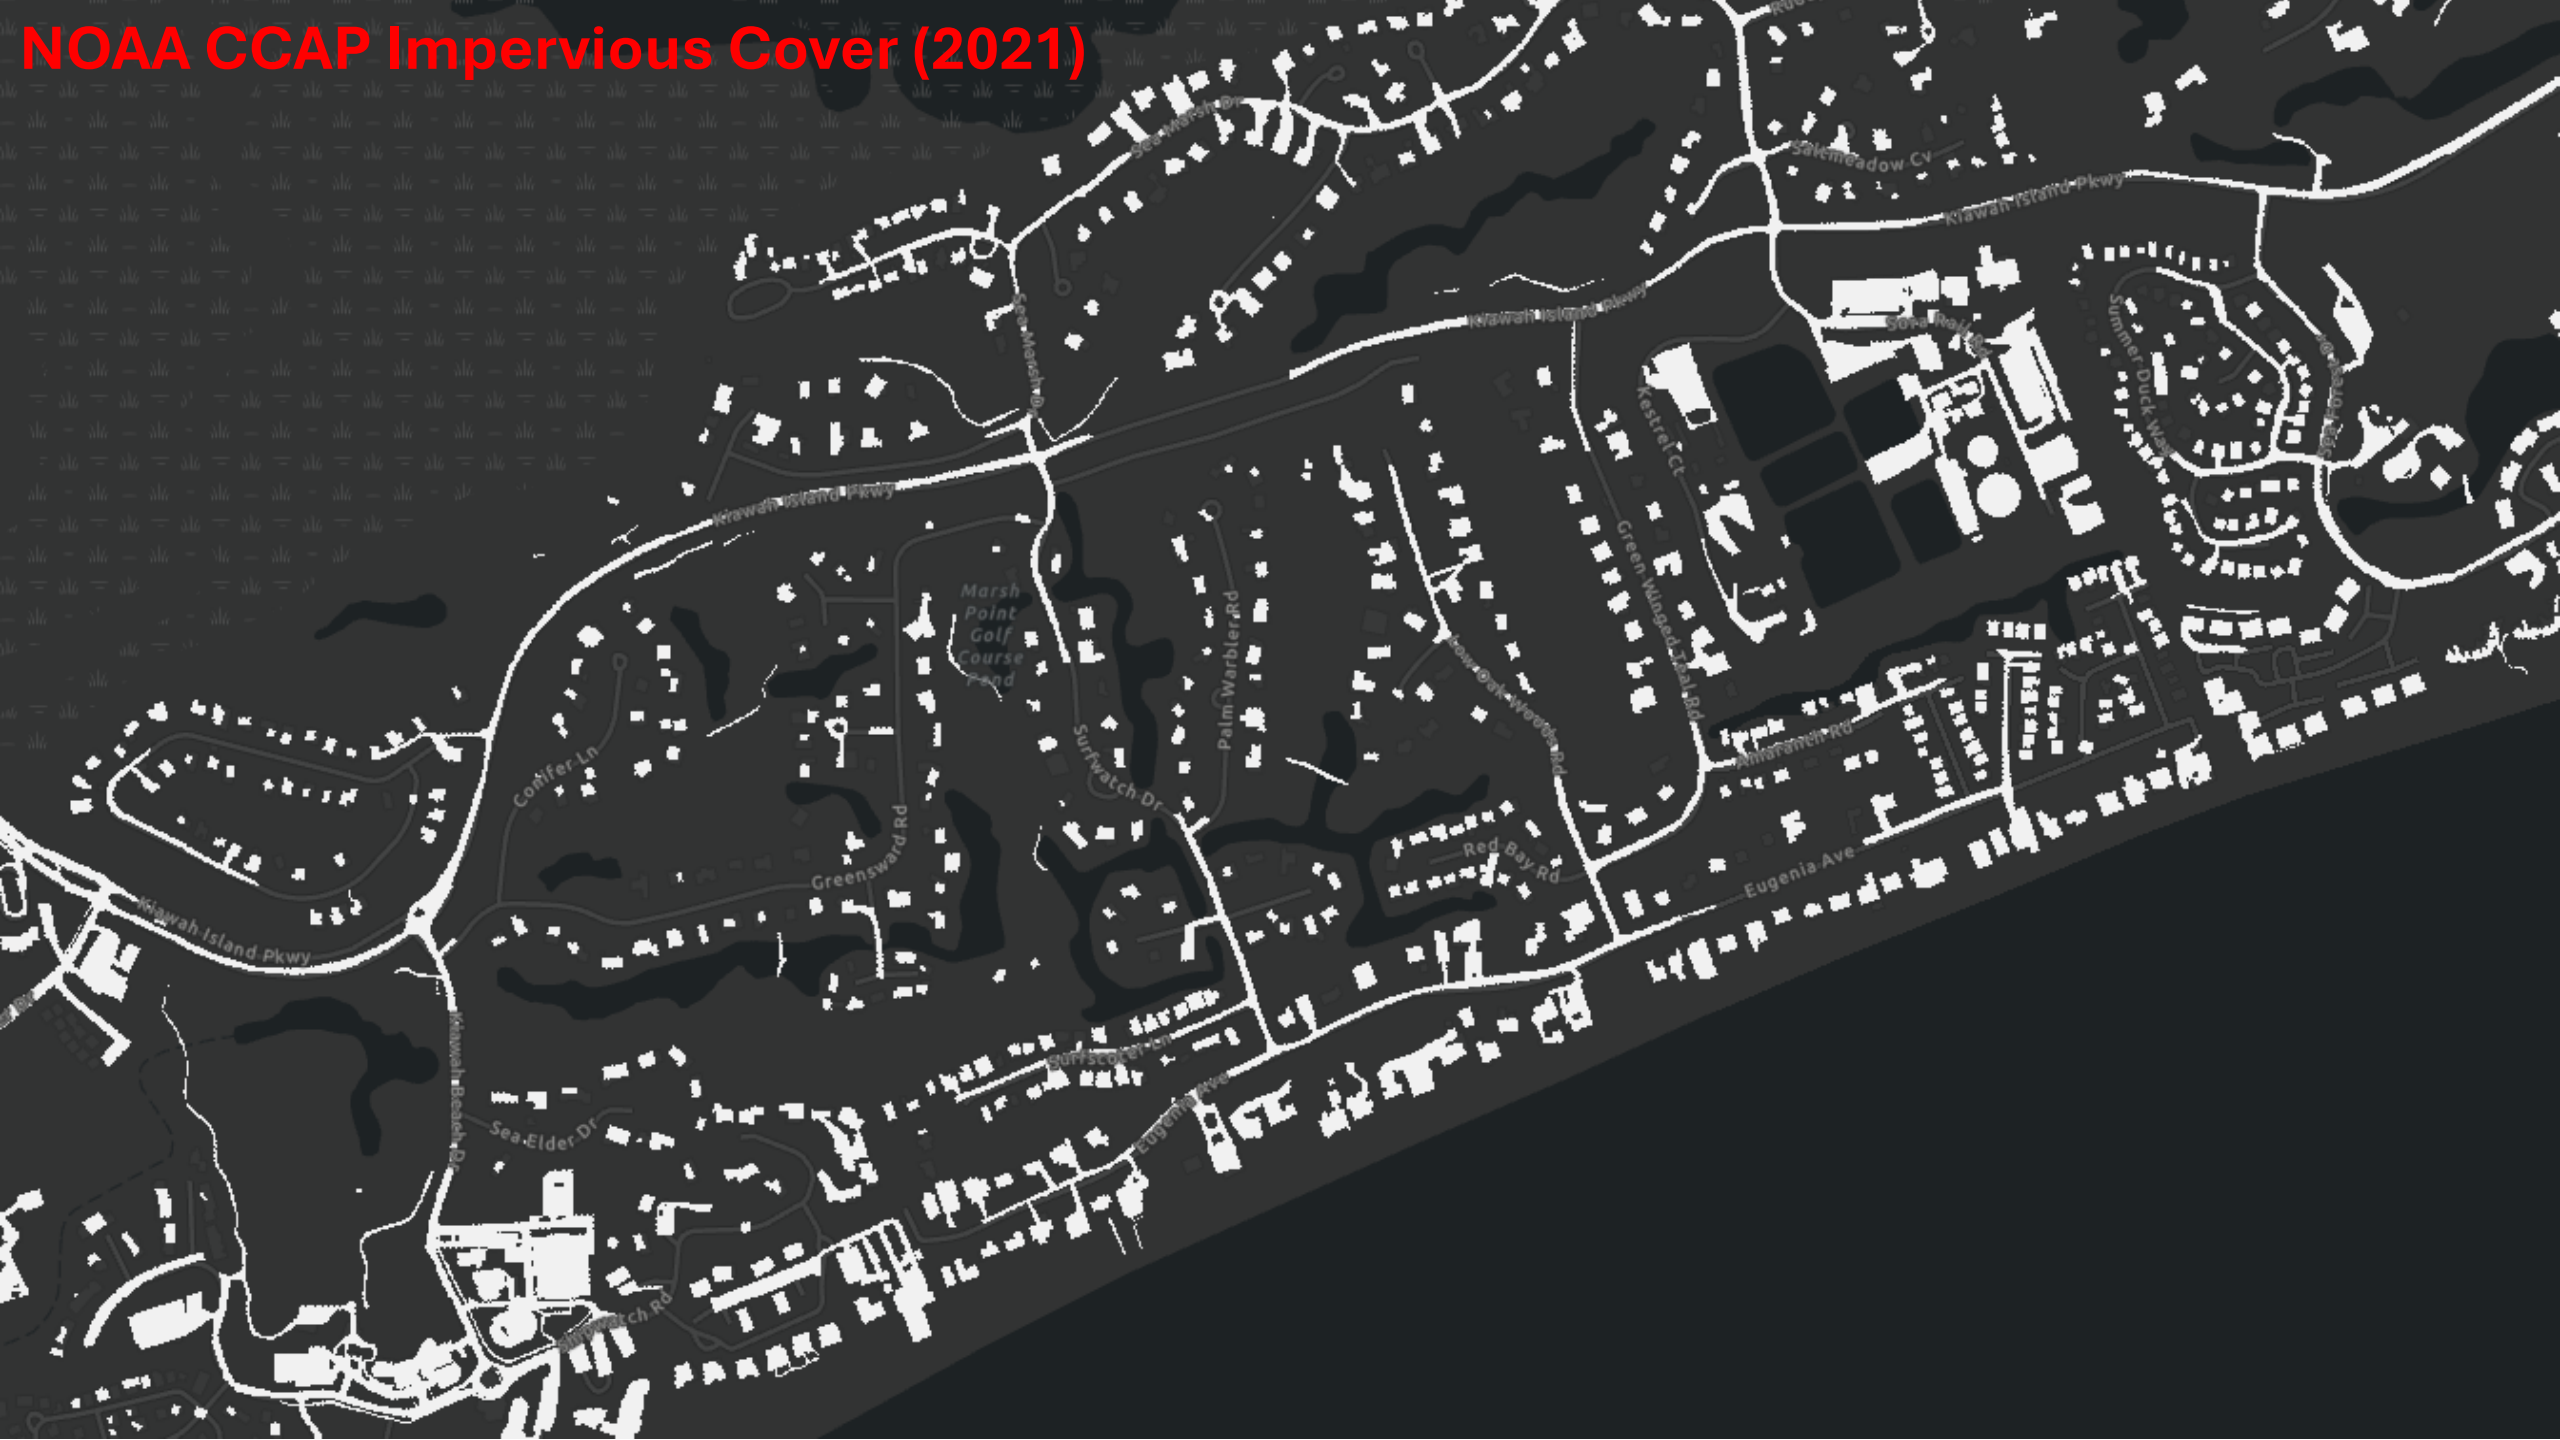
Impervious Surface Mapping

- Blue box: Roads and Parking
- Pink box: Buildings
- Green box: Driveways
- Yellow box: Multi-Use Pathways
- Light pink box: Other surfaces

**** All feature layers digitized using high-resolution imagery and surface elevation characteristics**

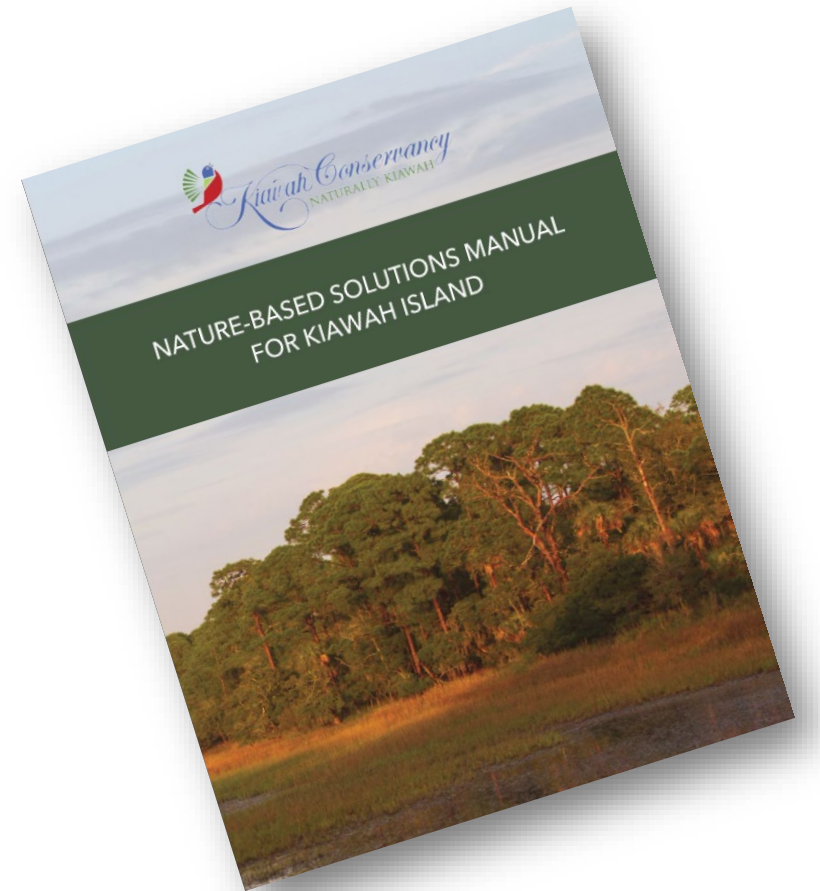
Pervious Surfaces

Allows for the penetration of stormwater runoff through the surface and into the underlying soils

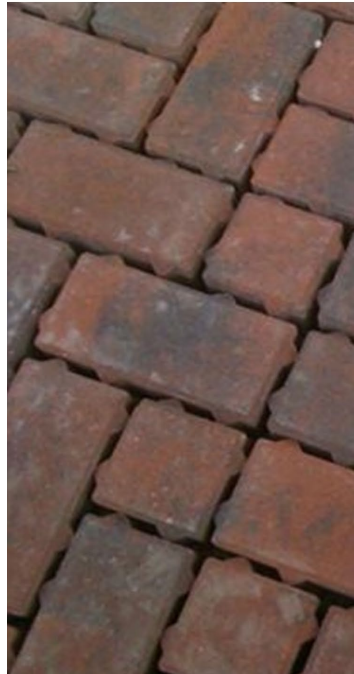
**Pervious Concrete
Interlocking Pavers**

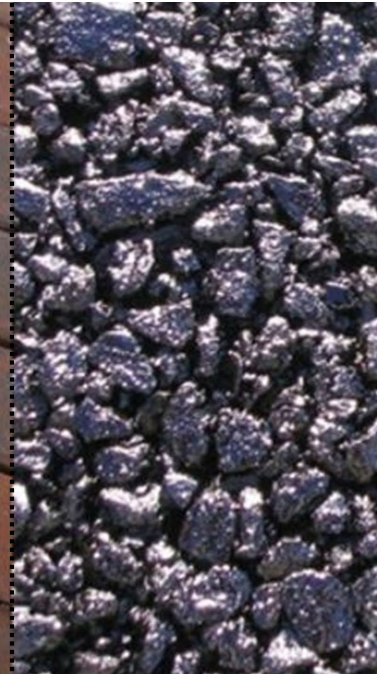
**Pervious
Asphalt**

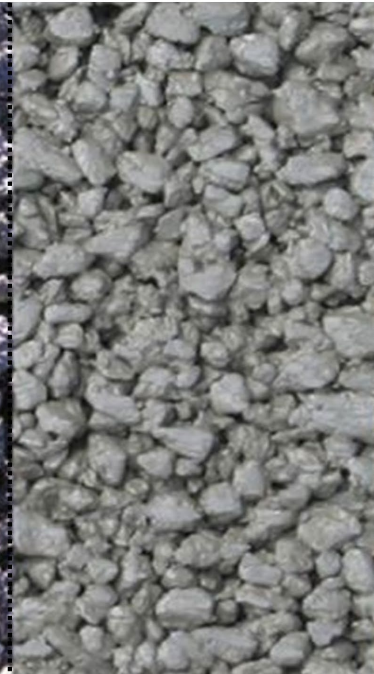
**Pervious
Concrete**

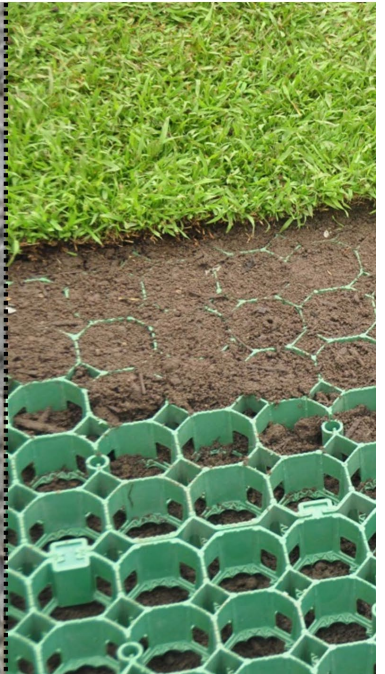
Grass Geogrid

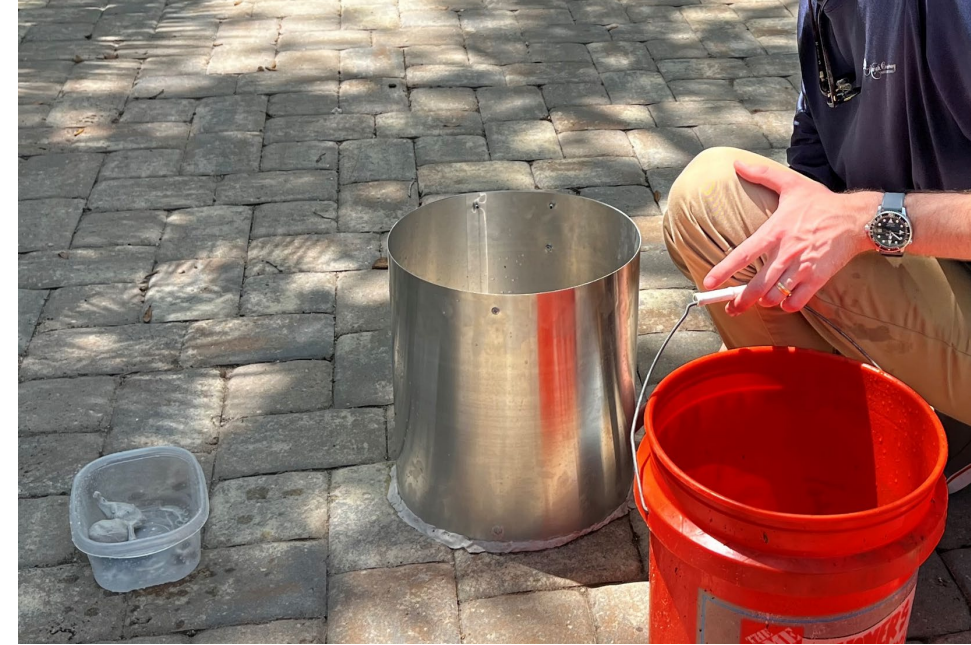
Pervious Surface Testing

ASTM C1701 Infiltrometer Testing

- Three (3) tests at each site
- Each test with an initial pour (1 gal) and second pour (2-3 gal)
- Inches per hour calculated based on time to fully drain

Site	Type	First Pour (in/hr)	Second Pour (in/hr)	Average (in/hr)
Sandcastle	Paver	127.0	149.3	138.8
Oceanwoods	Paver	6.6	-	6.6
Cassique	Pervious Concrete	59.0	75.5	70.4
Saltmeadow	Pea Gravel	1189.7	1092.1	1106.5
Indigo Park	Pervious Concrete	47.6	39.9	41.3

Infiltration at surface exceeds typical rainfall event

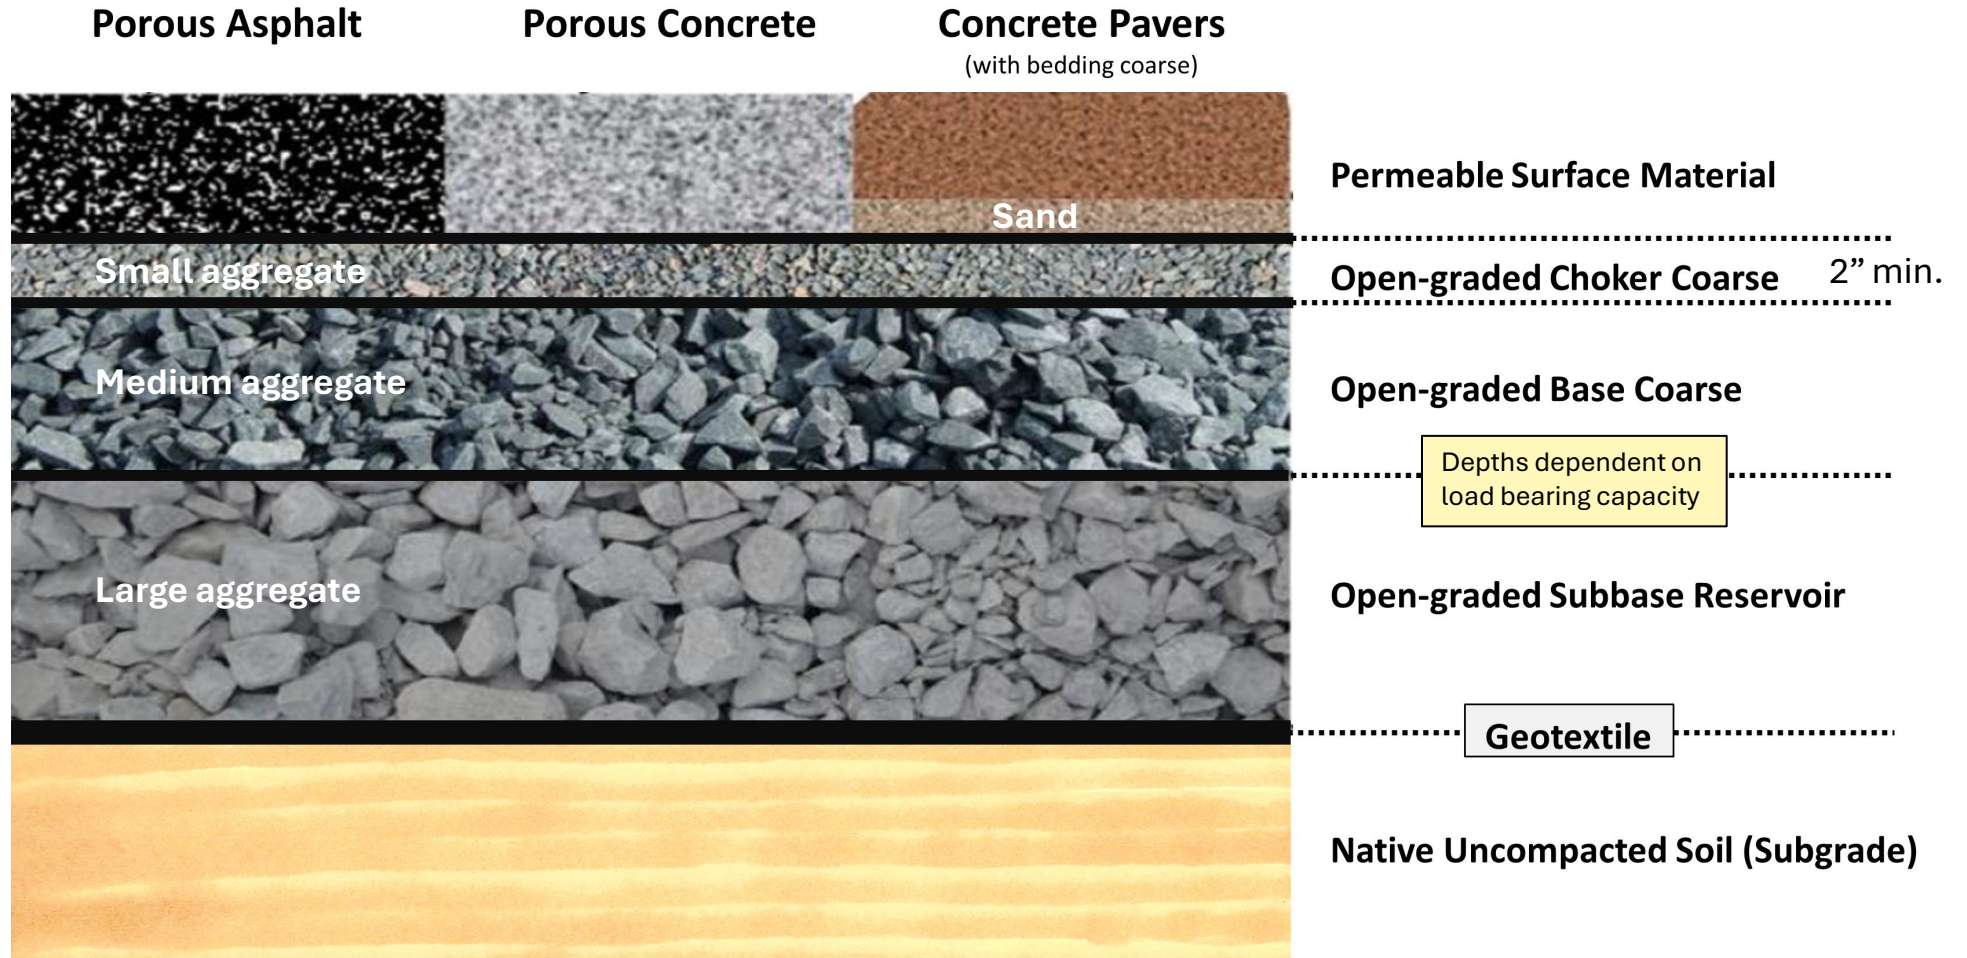
Pervious Surface Anatomy

Particles trapped by geotextile layers

Bottom layers act as a reservoir for stormwater

- Efficacy dependent on subsurface design
- Part of a stormwater “treatment train” that involves other practices
